**CERTAIN 2021-2022 MODEL YEAR F-150 VEHICLES EQUIPPED WITH A CREW CAB, 145" WHEELBASE, 4X4, 302A AND ABOVE OPTION PACKAGE, AND ONE-PIECE ALUMINUM DRIVESHAFT – LOOSE/SAGGING UNDERBODY INSULATORS**

**SERVICE PROCEDURE**

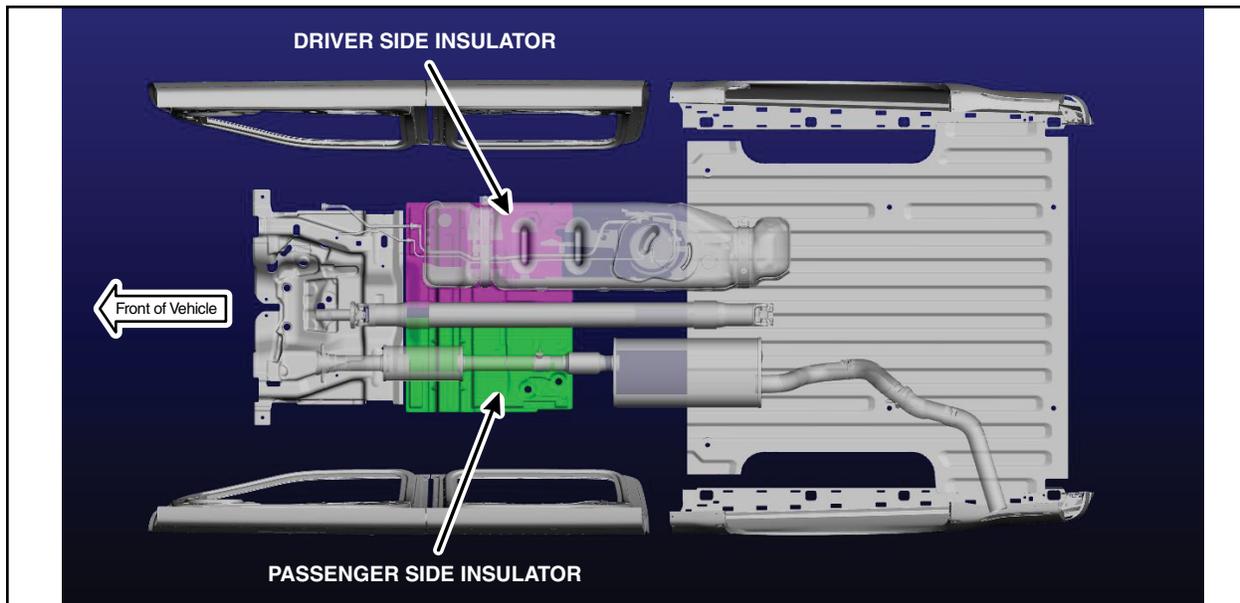
**FIGURE 1**

**NOTE:** The driver side insulator is located directly above the fuel tank.

**NOTE:** The passenger side insulator is located directly above the exhaust.

Dearborn Truck Plant Build Date - Design change that removed underbody insulators from production

Driver Side Insulator      11/19/2021 and later

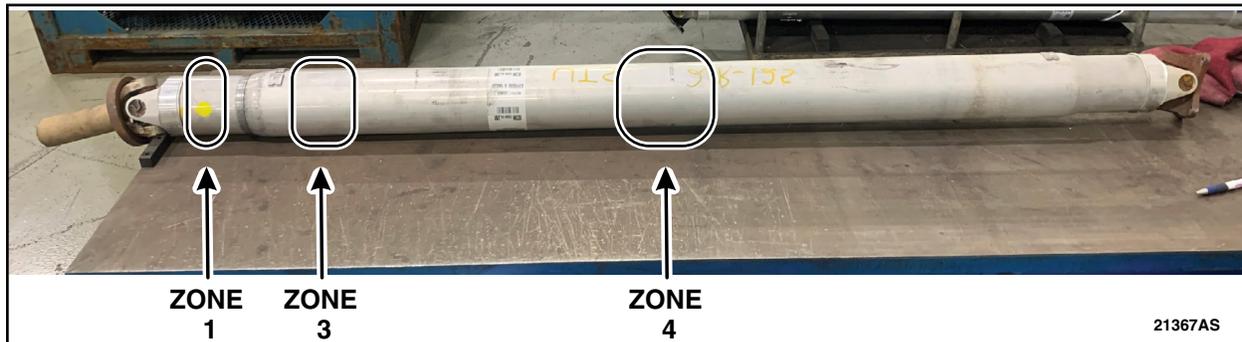
**FIGURE 2**

5. Inspect Zones 1, 3 and 4 of the rear driveshaft for any marks caused by the front and/or rear edges of the passenger side insulator. Are there any marks present in Zones 1, 3 or 4? See Figure 2.

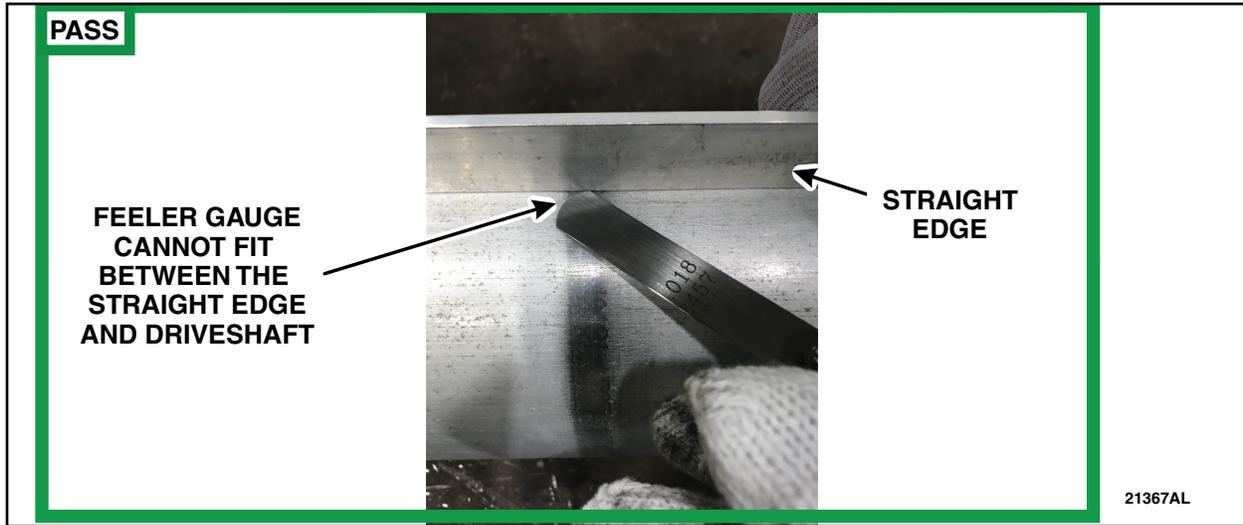
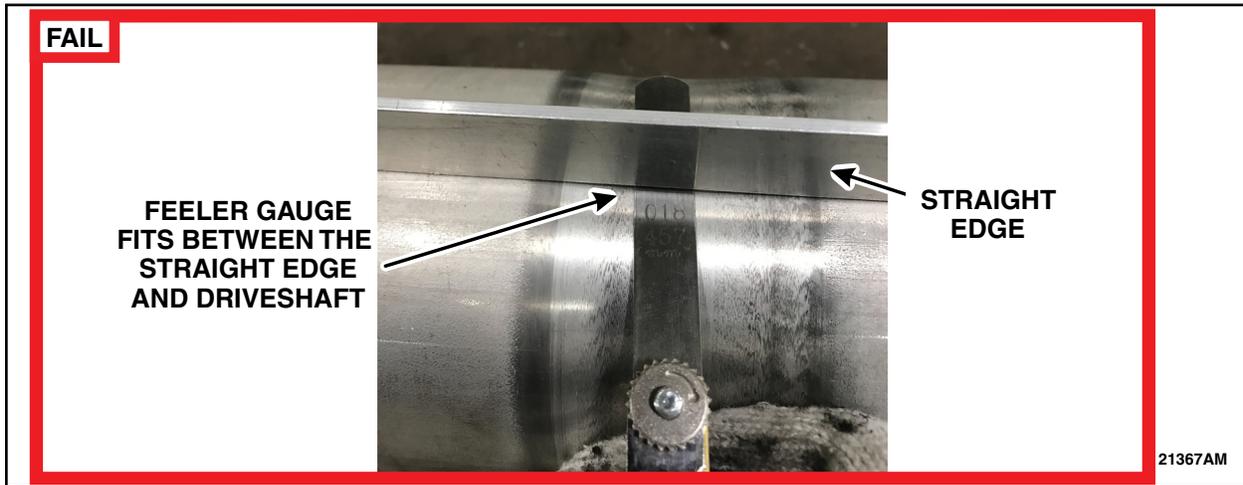
7. Place a straight edge along the driveshaft over the wear mark and attempt to fit a 0.018in (0.45mm) feeler gauge between the flat edge and the wear mark. Can the feeler gauge fit between the straight edge and anywhere along the wear mark? See Figures 3 and 4.

Yes – Does not pass inspection. Contact the SSSC and provide a picture of the driveshaft with the feeler gauge fitting between the straight edge and wear mark. Once approved, rear driveshaft replacement will be required, but do not install at this time. Proceed to step 10.

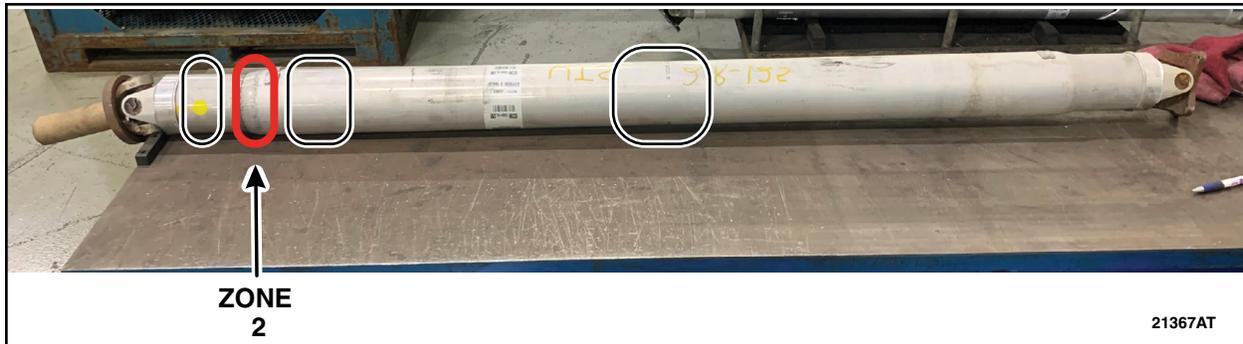
FIGURE 5

8. Inspect Zone 2 (transition from larger tube diameter to smaller diameter section) of the driveshaft tube for any marks caused by the front edge of the passenger side insulator. Are there any marks present? See Figure 5.

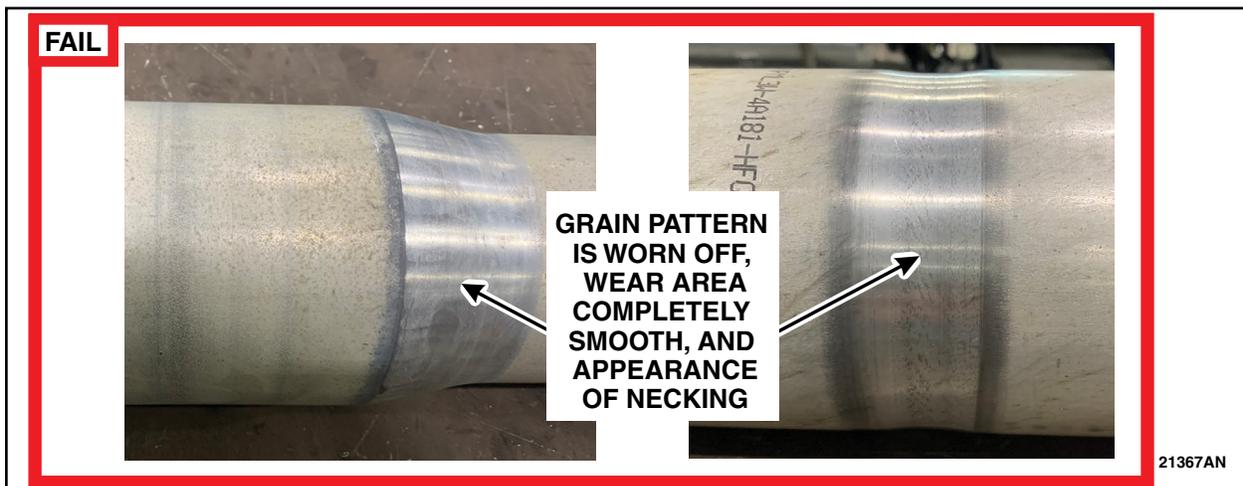
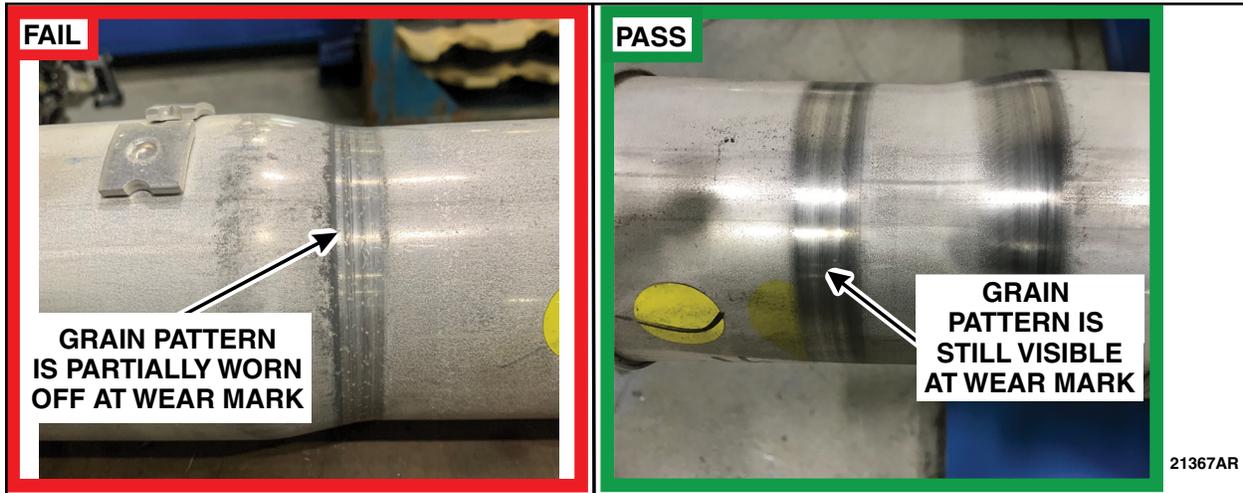
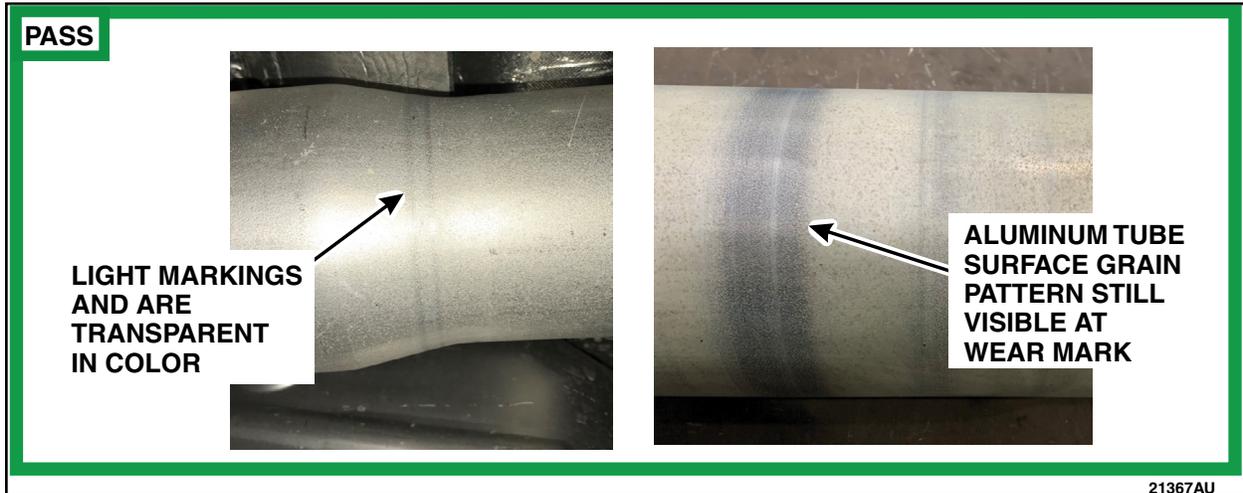
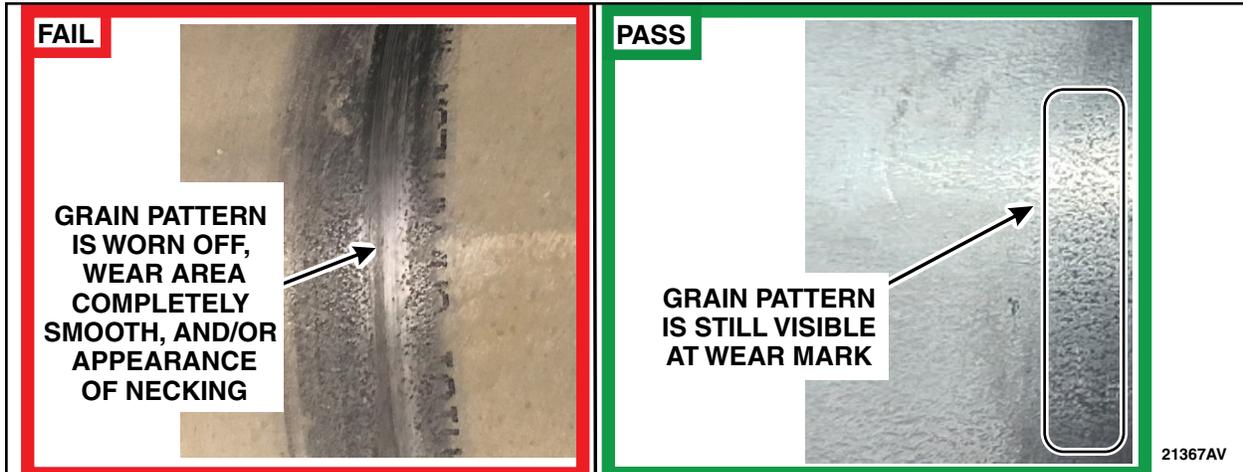
9. Inspect the marks found on Zone 2. Is the aluminum tube surface grain pattern worn off, completely smooth, or have an appearance of necking? See Figures 6 through 9.

Yes – Does not pass inspection. Contact the SSSC and provide a picture of the driveshaft with the grain pattern worn off. Be sure to show a clear image of the grain pattern missing. Once approved, rear driveshaft replacement will be required, but do not install at this time. Proceed to step 10.

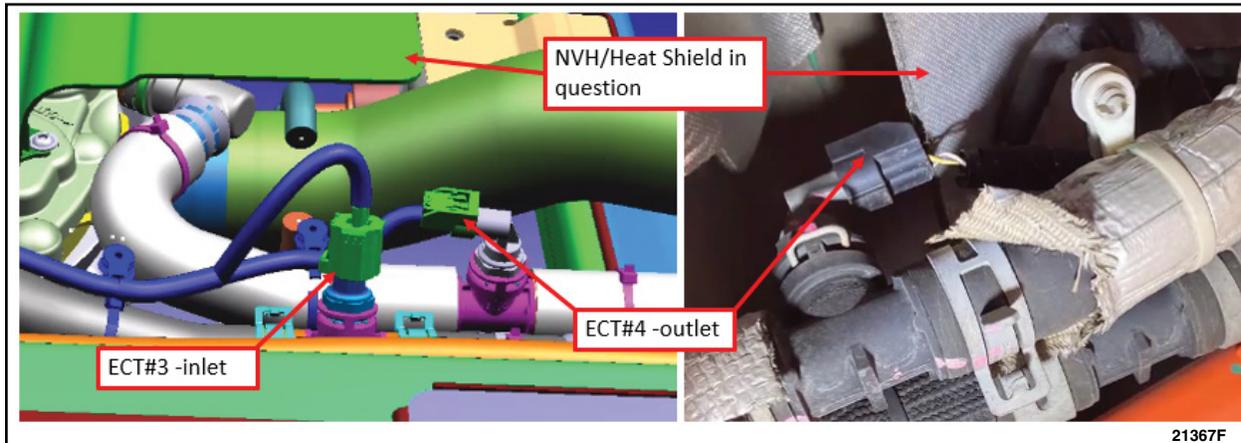
FIGURE 10

10. Inspect the front Engine Coolant Temperature (ECT) sensor connectors for any damage caused by the passenger side insulator. Is there any damage? See Figure 10.

Yes – Does not pass inspection. Contact the SSSC and provide a picture of the damage for proper technical instructions and part numbers, then proceed to step 11.
