GENERAL SERVICE BULLETIN

Various Vehicles - Catalytic Converter Concern Analysis

22-700918 January
2022

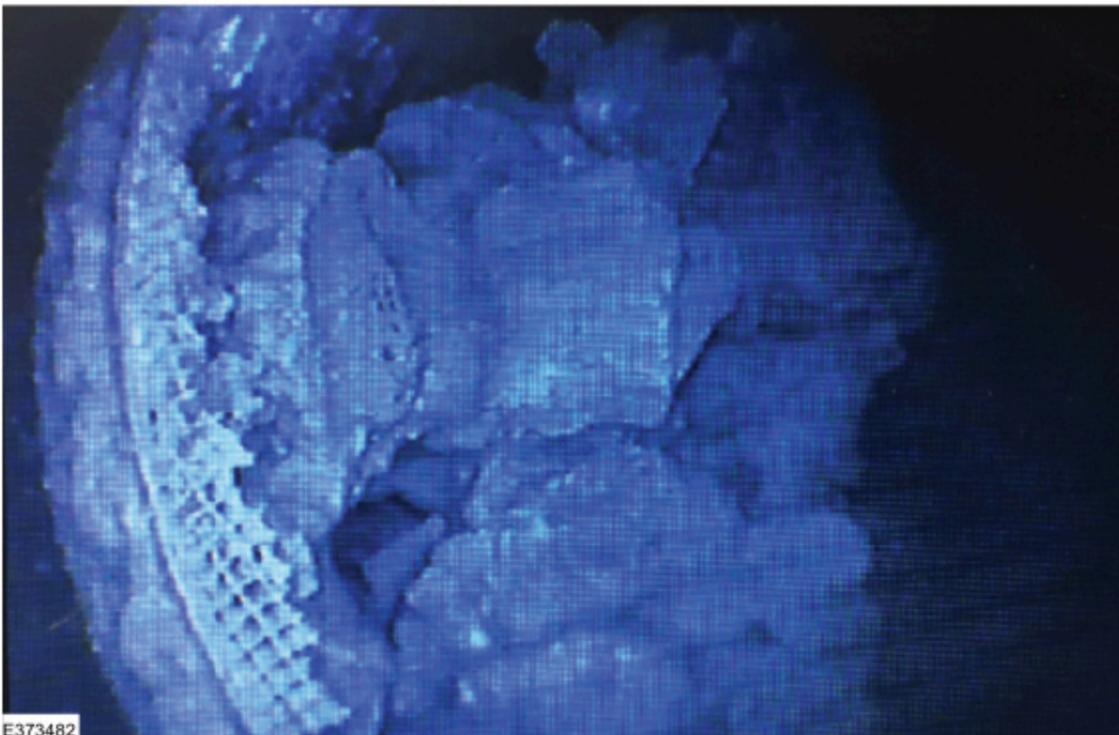
Figure 1 – Melted honeycomb (cannot be causal part)

If heat damage or melting is observed, other repairs to the engine or related systems may be required to prevent a repeat catalyst repair that would not be warrantable.

- Check and address all other powertrain / engine management DTCs.
- Check for evidence of engine oil or coolant in the inner exhaust system. Identify the root cause and repair as needed.
- Check for excessive unburned fuel per Workshop Manual, Section 303-04, Fuel Charging And Controls.
- Inspect the entire exhaust system for damage and repair as needed.

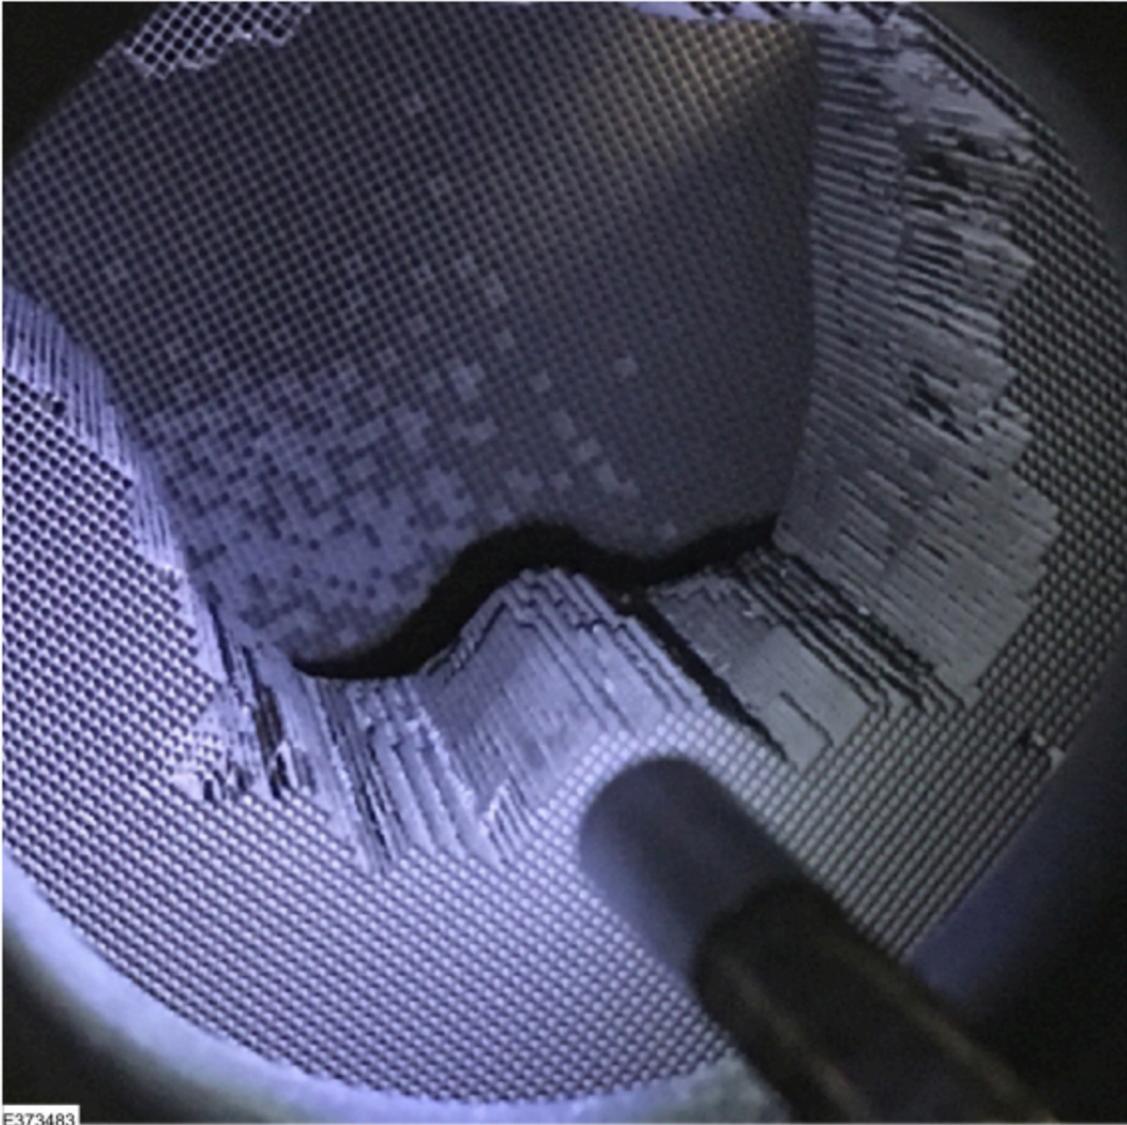
Figure 2 – Heat damaged honeycomb (cannot be causal part)

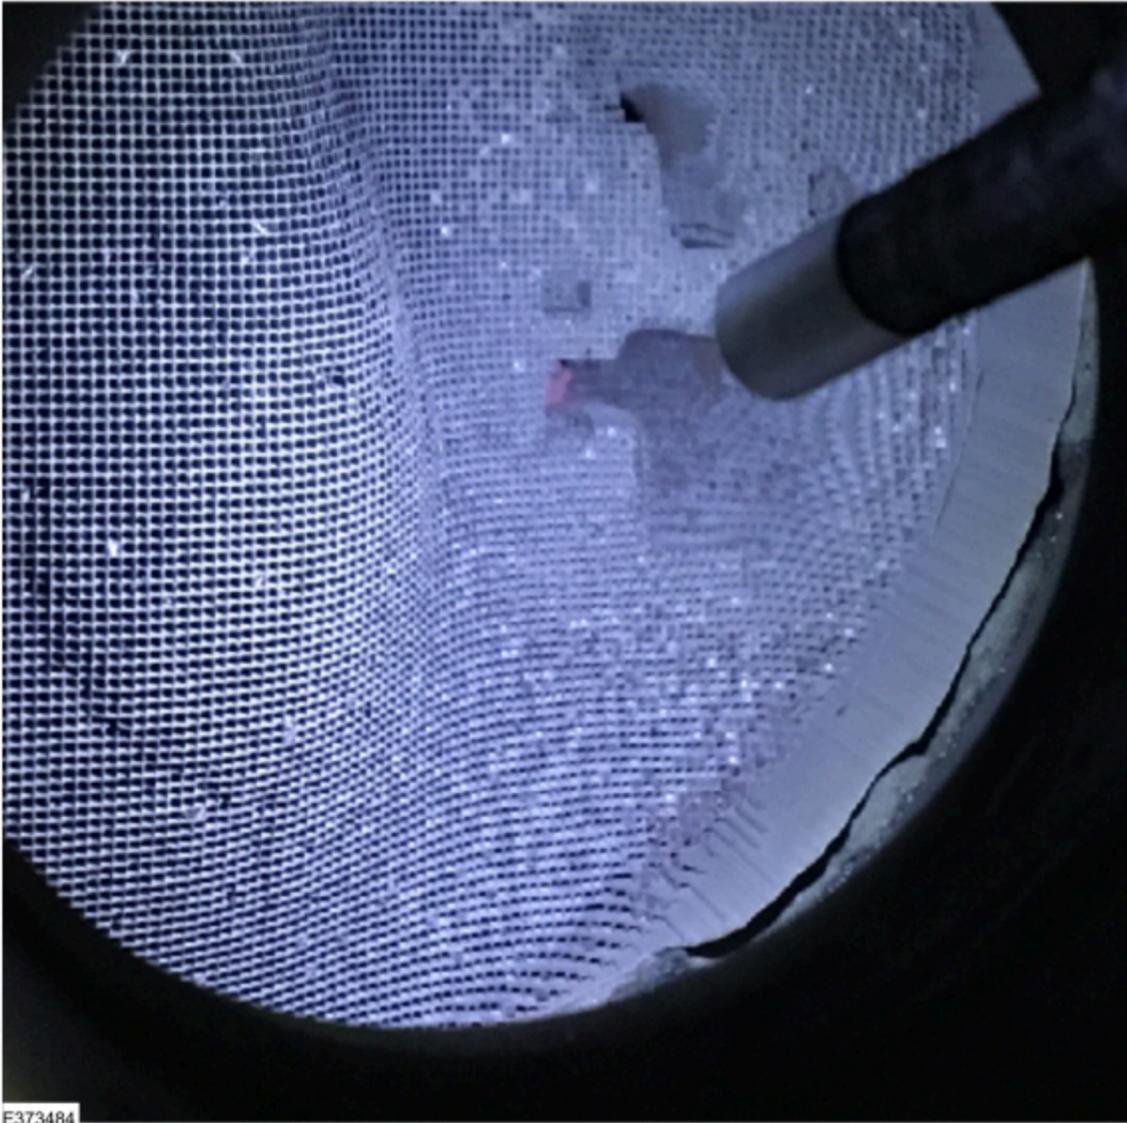
Figure 3 – Heat damaged honeycomb (cannot be causal part)

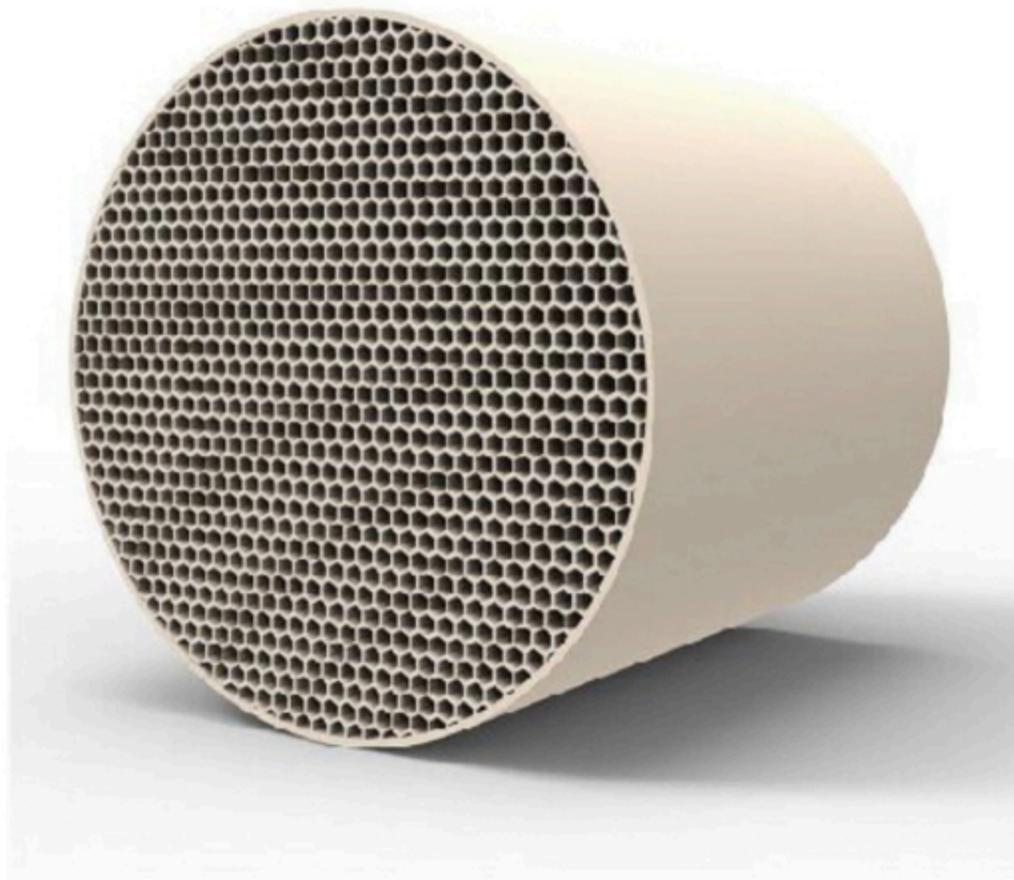
Figure 4 – Non-damaged honeycomb
