## TECHNICAL SERVICE BULLETIN

### 3.5L PowerBoost - Lariat/XLT/XL Trim Levels - Right Side Turbocharger Concerns

24-2264

23 August  
2024

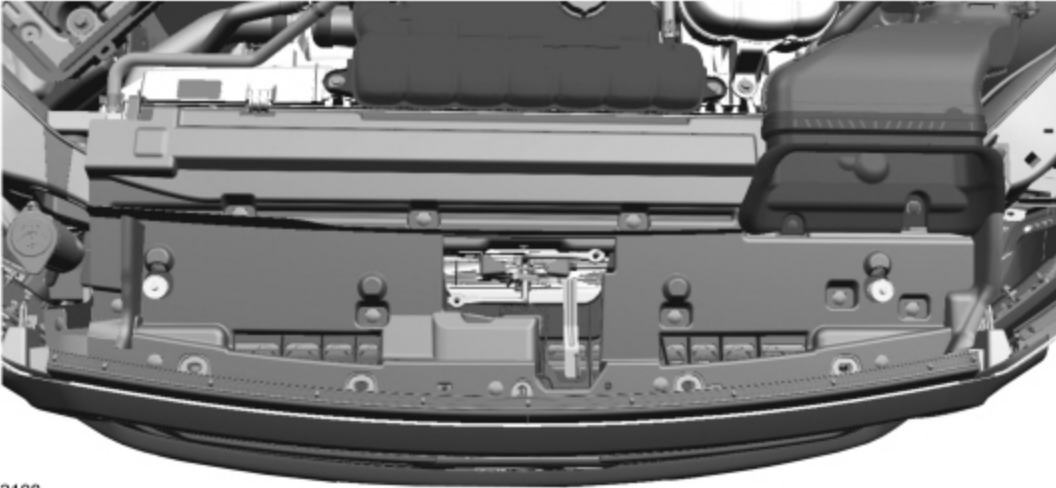
Figure 1

1. Does the upper air deflector match the one outlined in Figure 1?

(1). Yes - proceed to Step 2.

(2). No - this article does not apply. Refer to the WSM for additional diagnostics.
