400 WATT DC/AC INVERTER SYSTEM INOPERATIVE WITH B1330:9A IN THE BCM

<b>TECHNICAL SERVICE BULLETIN</b> 400 Watt DC/AC Inverter System Inoperative With B1330:9A In The BCM	<b>23-2367</b> 21 November 2023
--	---------------------------------------

<b>Ford</b> 2021-2023 F-150
--------------------------------

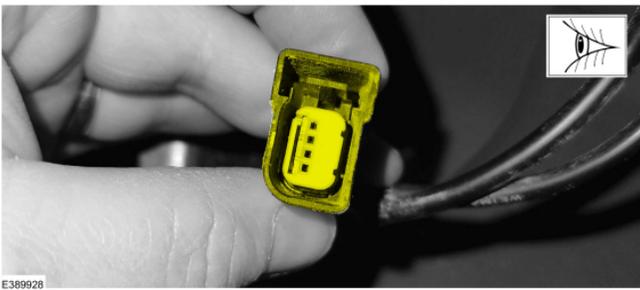
Figure 2

2. Using a suitable tool, carefully cut and remove the pickup bed AC power outlet socket harness retainer from the pickup bed AC power outlet socket harness. Discard the retainer.
3. Inspect connector C4628 for the presence of corrosion, dirt and/or damage. Is corrosion, dirt and/or damage present in connector C4628? (Figure 2)

- (1). Yes - replace the pickup bed AC power outlet socket assembly. Refer to Workshop Manual (WSM), Section 414-05. Replace the body side harness assembly (13A409) of connector C4628. Proceed to Step 4.
  - (2). No - proceed to Step 4.
4. Install a new pickup bed AC power outlet socket harness retainer 4.3 in. (110 mm) from the back of the pickup bed power outlet harness connector. If the pickup bed AC power outlet socket has been replaced, remove and discard the factory-installed harness retainer and install the new harness retainer. (Figure 3)

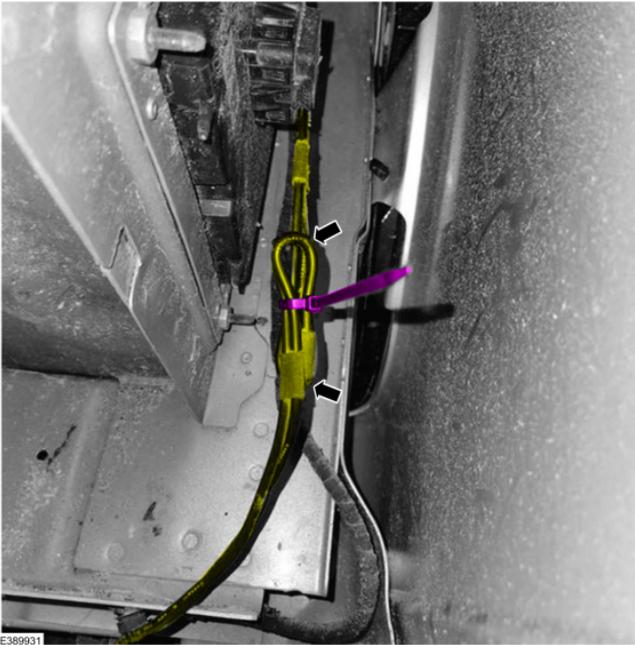
Figure 5

**⚠ CAUTION: The bend radius of the pickup bed AC power outlet socket harness should be no less than 4 mm. Hard kinks and tight bends of the pickup bed AC power outlet socket harness can lead to wire damage.**

6. Fold approximately 7 in. (185 mm) of the remaining/loose pickup bed AC power outlet socket harness in 2 bends just behind the pickup bed AC power outlet socket panel. Secure the folded wire with a wire tie. Inspect the routing of the harness to make sure it is not pulled too tight against the body sheet metal near the harness retainer and provides just enough length. (Figure 5)
