## TECHNICAL SERVICE BULLETIN

### Tailgate Snap, Click, And/Or Pop Noise When Closing

**22-2327**  
17 August 2022

| Ford<br>2021-2022 F-150 |

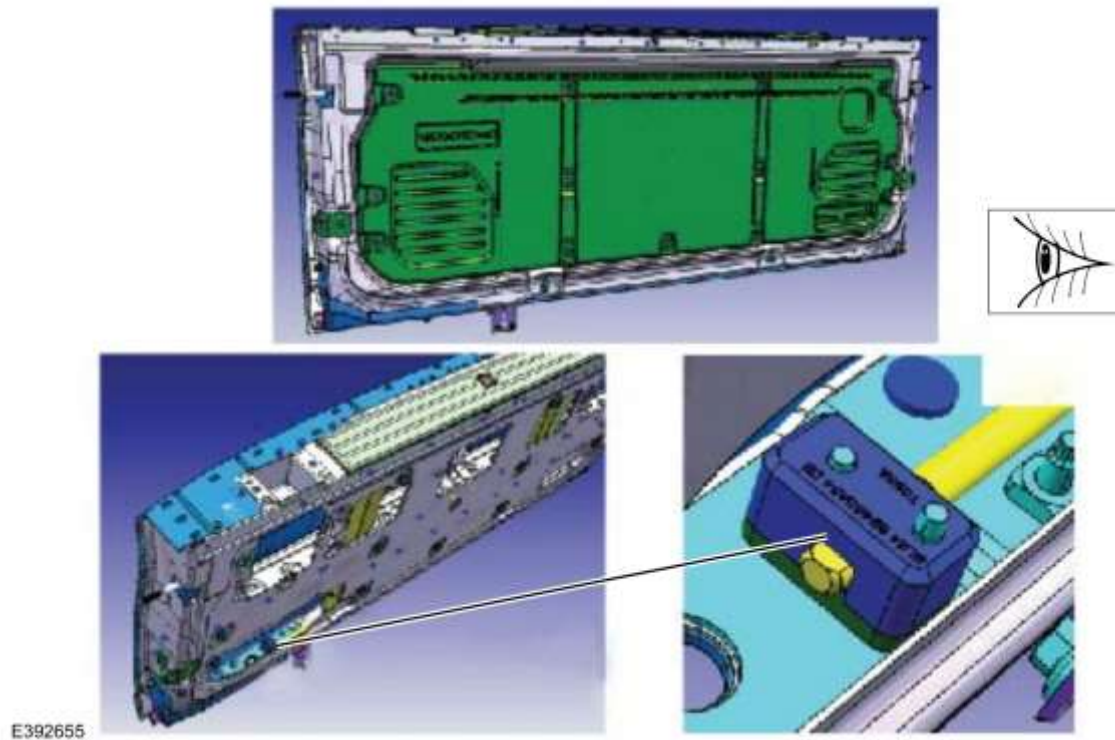
Figure 1

1. Remove the tailgate. Refer to Workshop Manual (WSM), Section 501-04 > Pickup Bed and Platform Body.
2. Remove the tailgate panel. Refer to WSM, Section 501-04 Pickup Bed and Platform Body > Power Tailgate Motor > Step 2.
3. If equipped, reposition the power tailgate motor to gain visual access to the torsion rod and clamp block. Refer to WSM, Section 501-04 Pickup Bed and Platform Body > Power Tailgate Motor.
4. Visually inspect the tailgate torsion rod and clamp block interface. (Figure 1) Is there a gap between the blocks? (Figure 2)

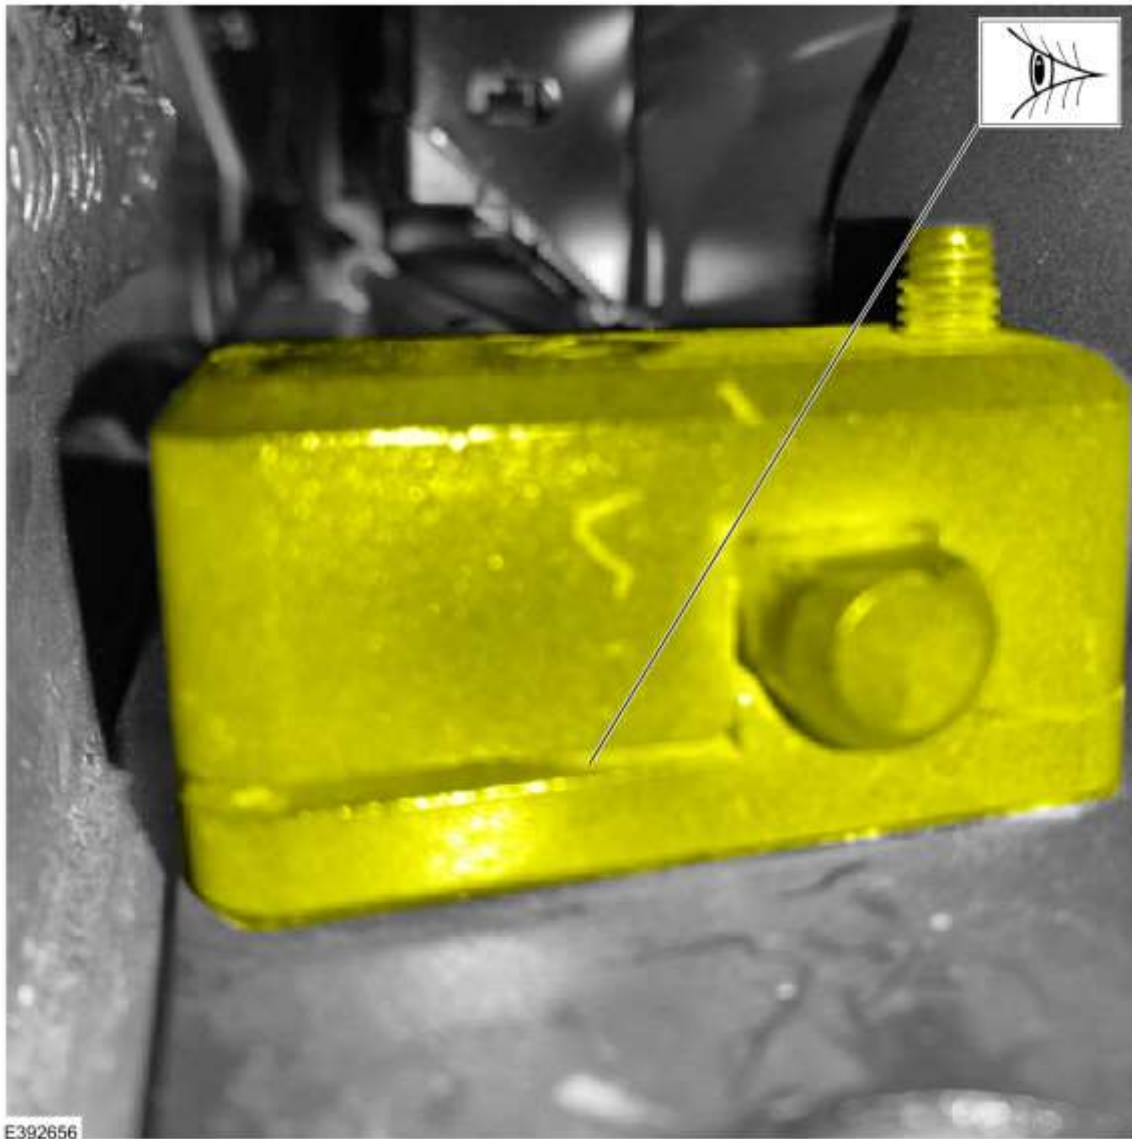
Figure 2

(1). Yes - proceed to Step 5.

(2). No - this article does not apply. Refer to normal diagnostics in WSM, Section 501-04 > Pickup Bed and Platform Body.

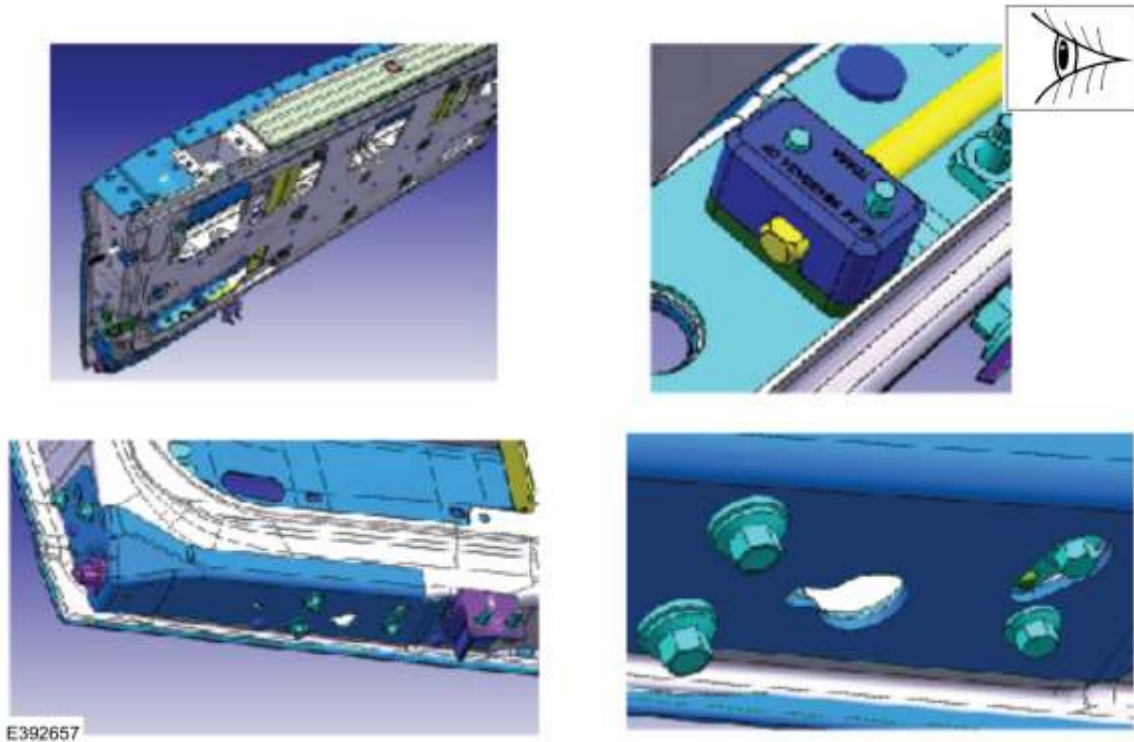
Figure 3

**5.** Verify the tailgate torsion rod is correctly aligned in the clamp block and the bolts are properly tightened. (Figure 3)

- (1). Loosen or remove the shorter bolt.
- (2). Loosen the longer bolt 1-2 rotations (as little as possible) to allow the tailgate torsion rod to rotate.
- (3). Rotate the tailgate torsion rod to verify the machine flat on the rod properly aligns with the top block (flat) mating surface. (Figure 4)
