**TECHNICAL SERVICE BULLETIN****24-2020****400 Watt DC/AC Inverter System Inoperative With B1330:9A In The BCM**19 January
2024

This bulletin supersedes 23-2367. Reason for update: revise Step 8 of the Service Procedure

Ford
2021-2023 F-150

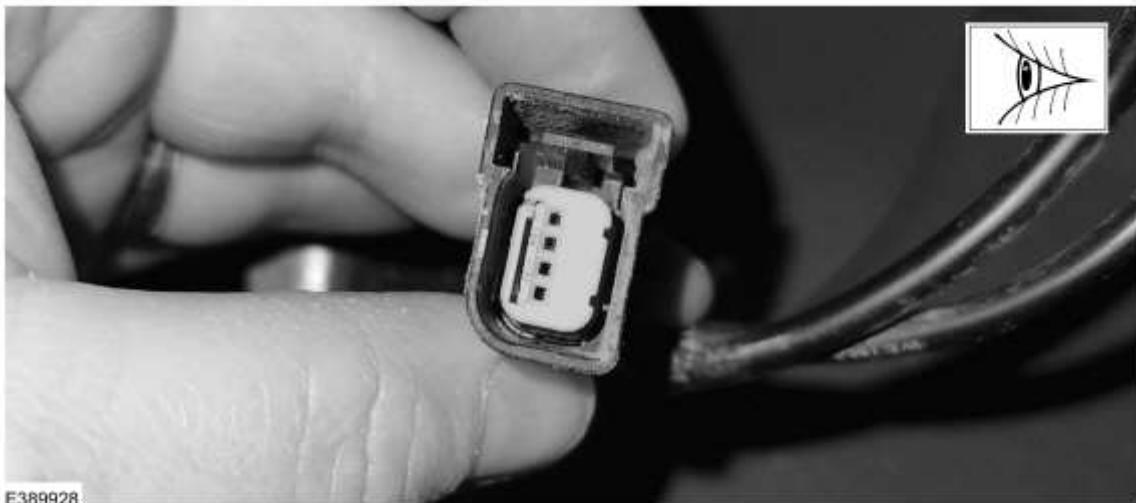
Figure 2

2. Using a suitable tool, carefully cut and remove the pickup bed AC power outlet socket harness retainer from the pickup bed AC power outlet socket harness. Discard the retainer.
3. Inspect connector C4628 for the presence of corrosion, dirt and/or damage. Is corrosion, dirt and/or damage present in connector C4628? (Figure 2)

(1). Yes - replace the pickup bed AC power outlet socket assembly. Refer to WSM, Section 414-05. Replace the body side harness assembly (13A409) of connector C4628. Proceed to Step 4.

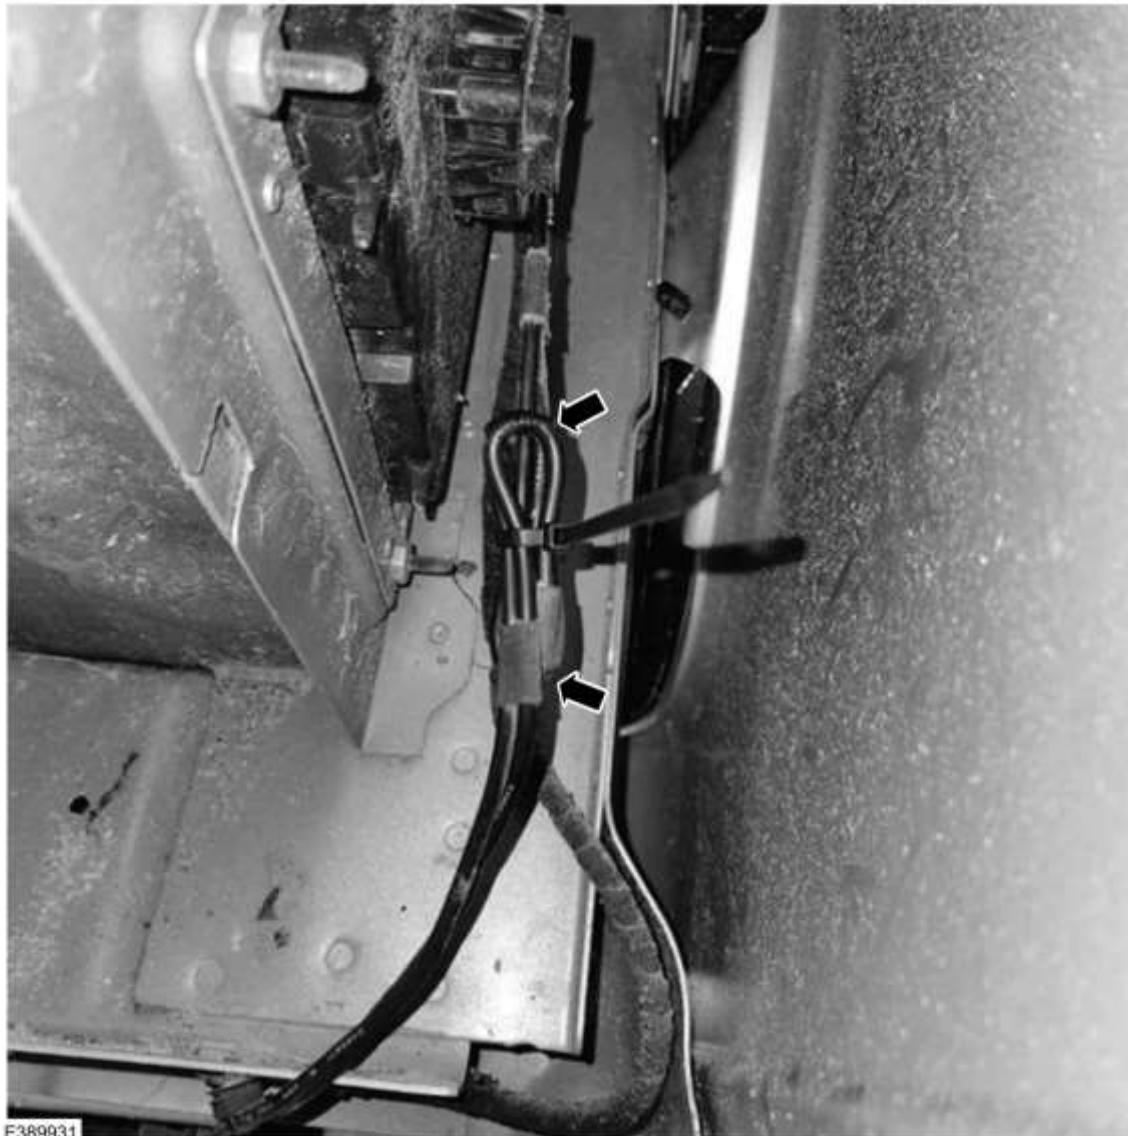
Figure 5

! CAUTION: The bend radius of the pickup bed AC power outlet socket harness should be no less than 4 mm. Hard kinks and tight bends of the pickup bed AC power outlet socket harness can lead to wire damage.

6. Fold approximately 7 in. (185 mm) of the remaining/loose pickup bed AC power outlet socket harness in 2 bends just behind the pickup bed AC power outlet socket panel. Secure the folded wire with a wire tie. Inspect the routing of the harness to make sure it is not pulled too tight against the body sheet metal near the harness retainer and provides just enough length. (Figure 5)
