TECHNICAL SERVICE BULLETIN

Vista Roof - Rattle And/Or Squeak Noise While Driving With Roof Opening Panel Closed

19-2169

Ford
2015-2019 F-150

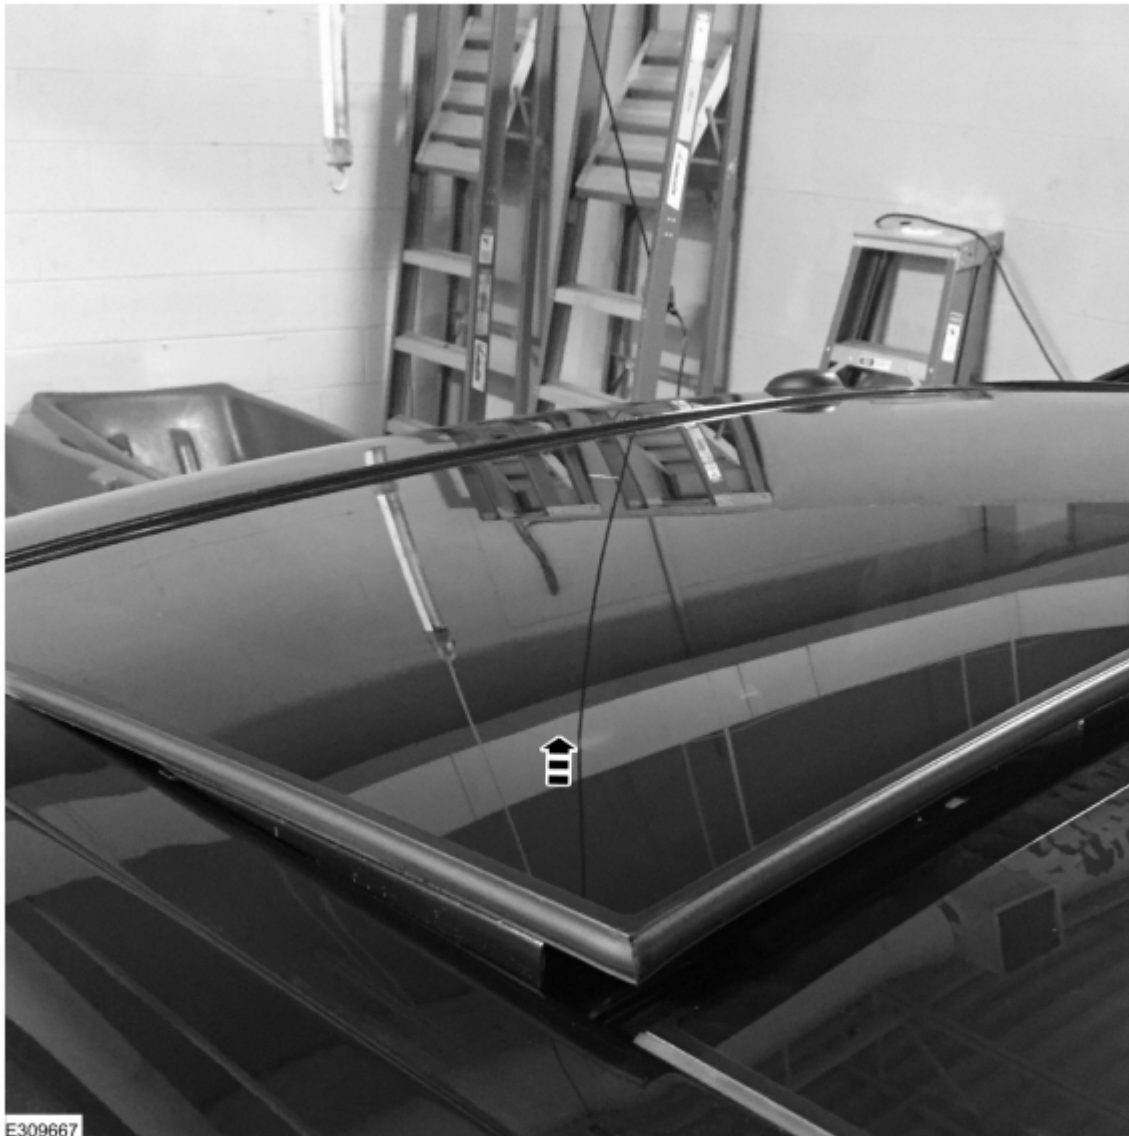
Figure 1

1. Position the glass panel to the vent position. (Figure 1)

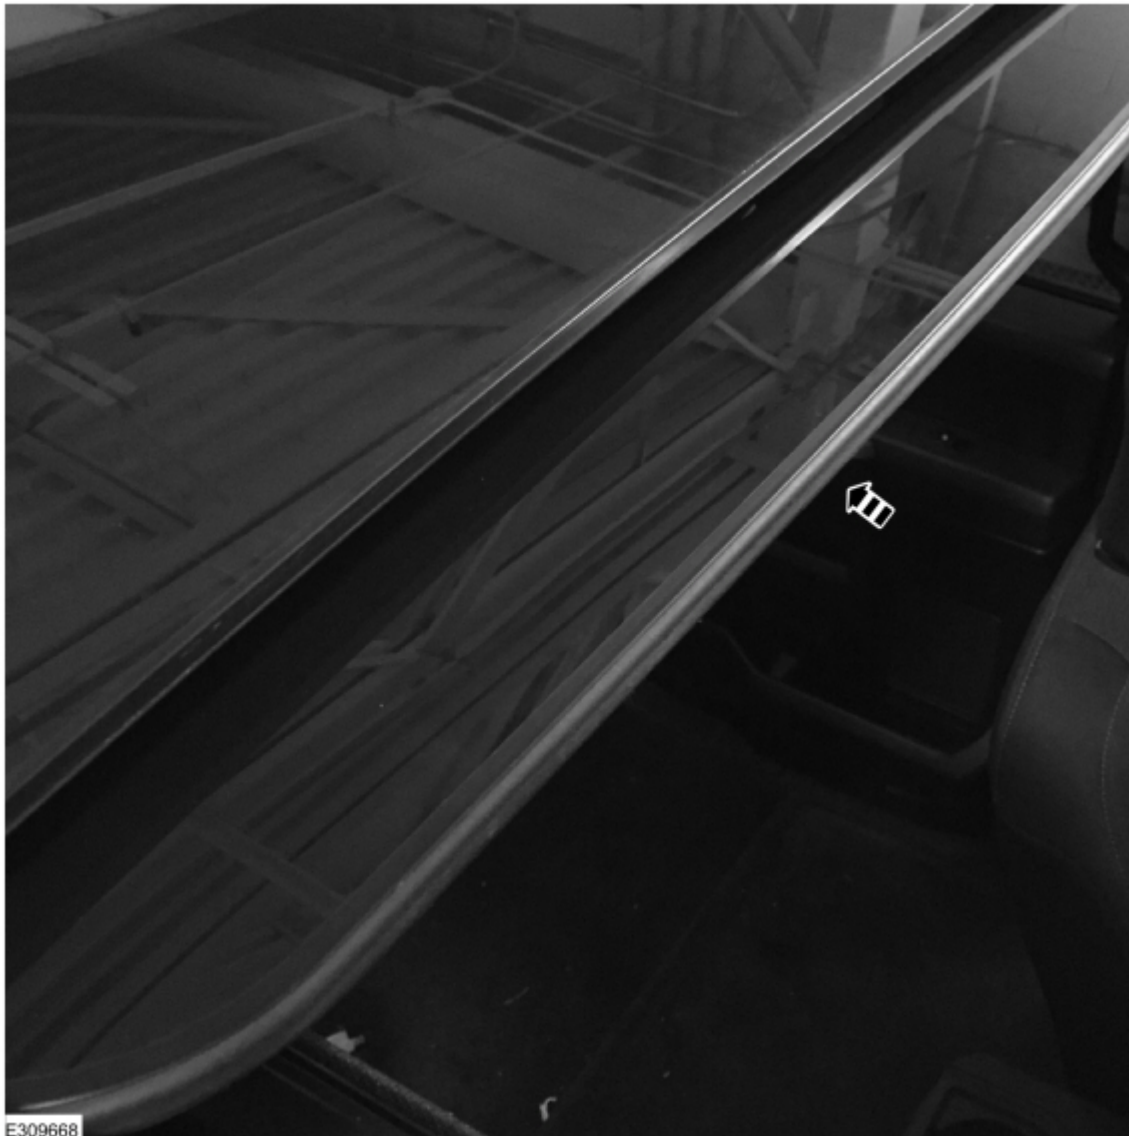
Figure 2

2. Clean the rear and side rubber seals of the movable glass panel with isopropyl alcohol or equivalent.
3. Clean the exposed sheet metal of the roof opening with isopropyl alcohol or equivalent.
4. Position the glass panel to the fully open position. (Figure 2)

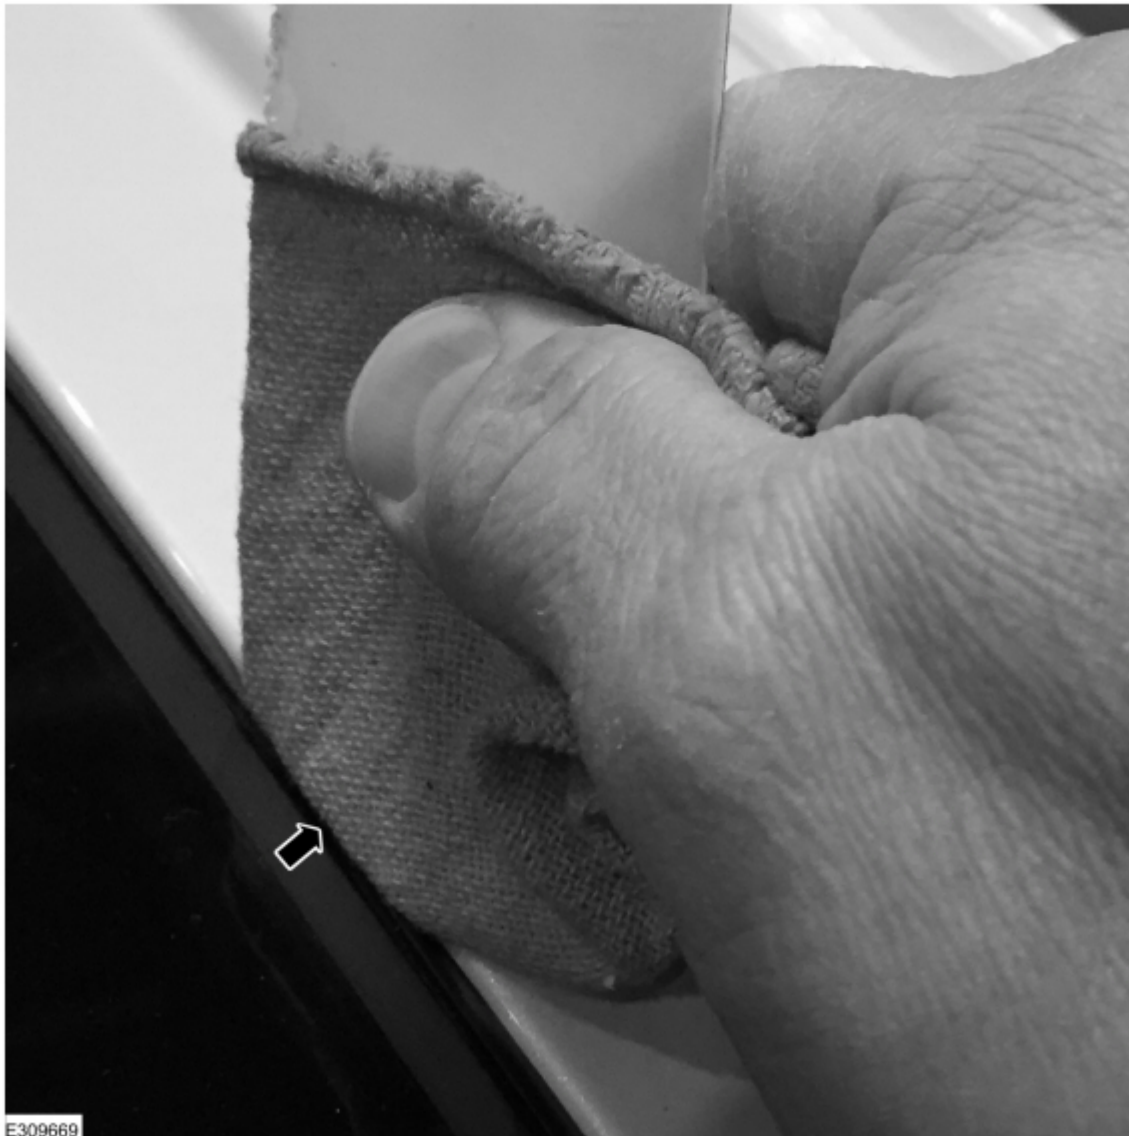
Figure 3

5. Clean the remaining front rubber seal area of the movable glass panel with isopropyl alcohol or equivalent.
6. Clean the remaining exposed sheet metal of the roof opening with isopropyl alcohol or equivalent.
7. Apply isopropyl alcohol or equivalent onto a clean cloth and insert it between the rear fixed glass panel seal and the roof opening sheet metal. (Figure 3)
 - (1). Folding the cloth over a flexible piece of plastic such as an old credit card or a thin piece of plexiglass will assist in the cleaning process.
 - (2). Slide the isopropyl alcohol soaked cloth around all sides of the fixed panel glass.

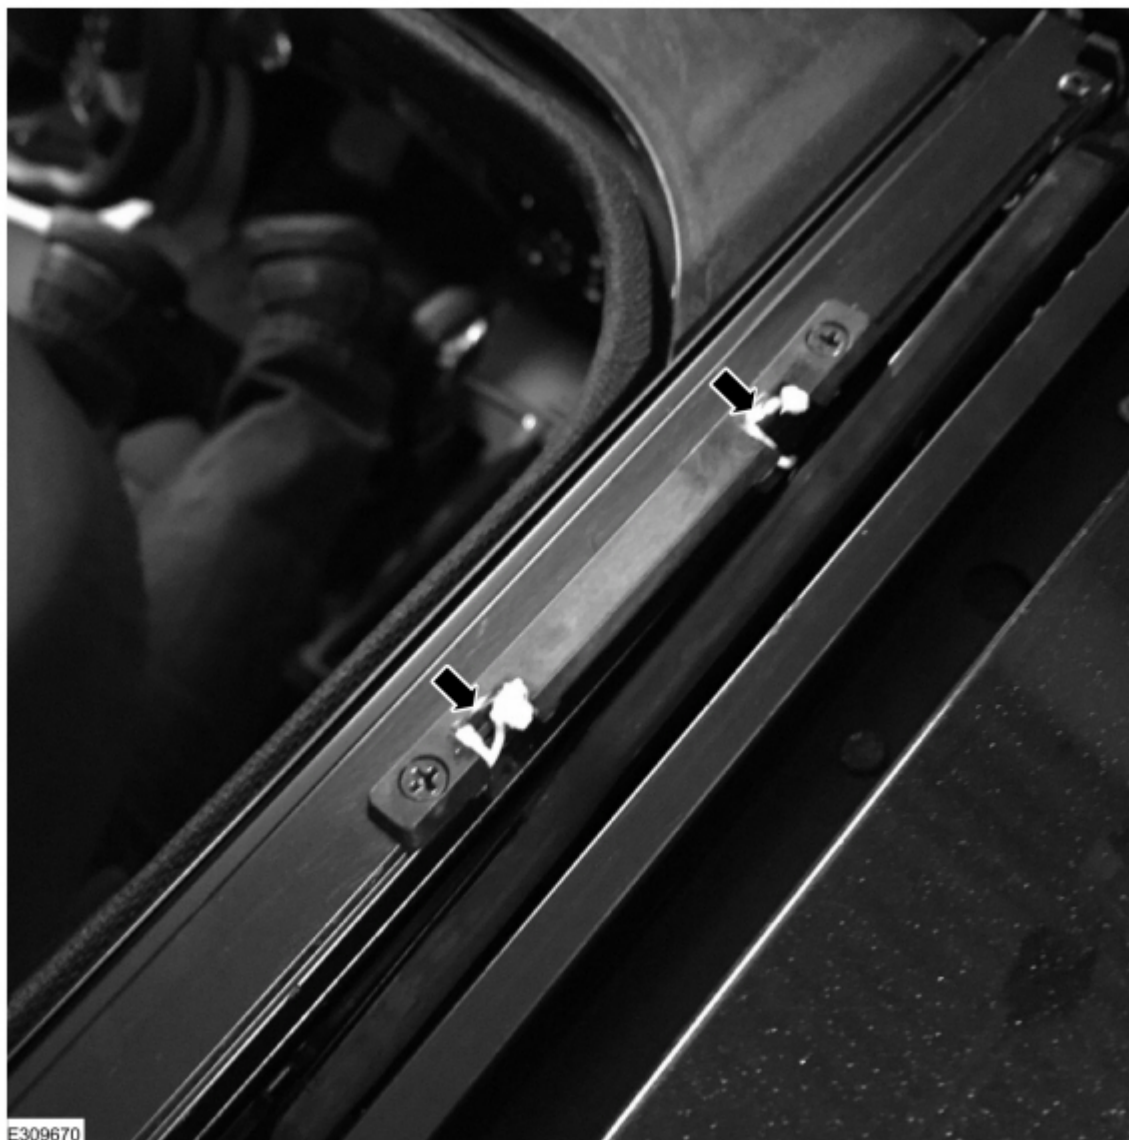
Figure 4

9. Hold the wind deflector down and apply Krytox® grease to both openings of the left and right front set plates. (Figure 4)
