GENERAL SERVICE BULLETIN

Various Vehicles - Exterior Lighting Concern Analysis

24-7068

09 July 2024

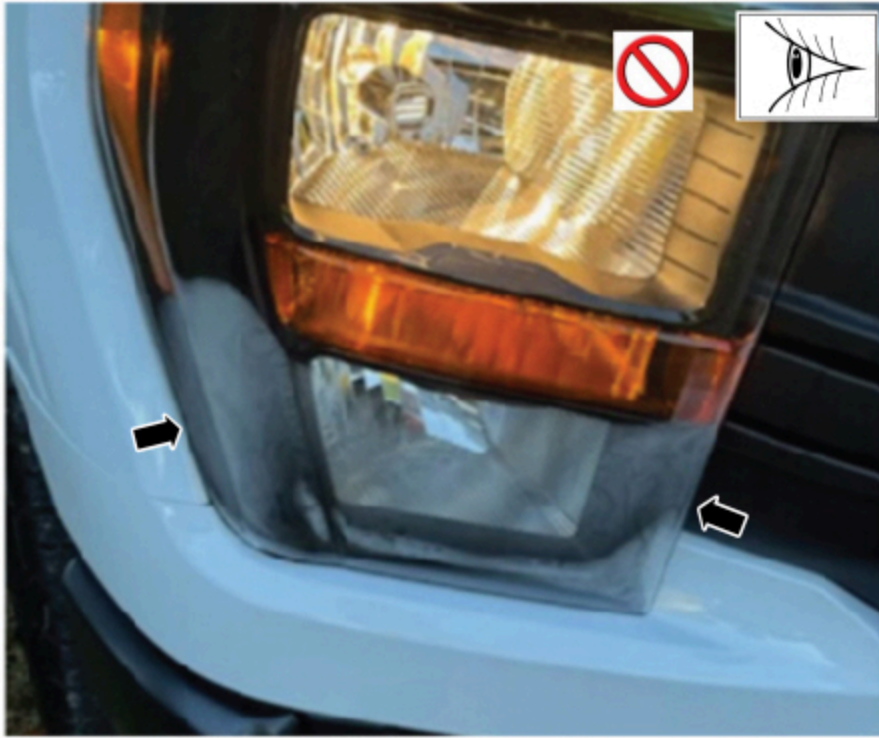
Figure 1

Aftermarket lamps may be installed on a vehicle after collision damage repair. Aftermarket lamps tend to mimic the appearance of an original equipment manufacturer (OEM) lamp but often lack quality and performance of an OEM lamp. Aftermarket lamps are more prone to water leaks and operational malfunction. If a lamp is found to be aftermarket, it cannot be replaced under warranty. An original equipment Ford/Lincoln part will have the brand logo imprinted (Figure 1) in the lens and housing.

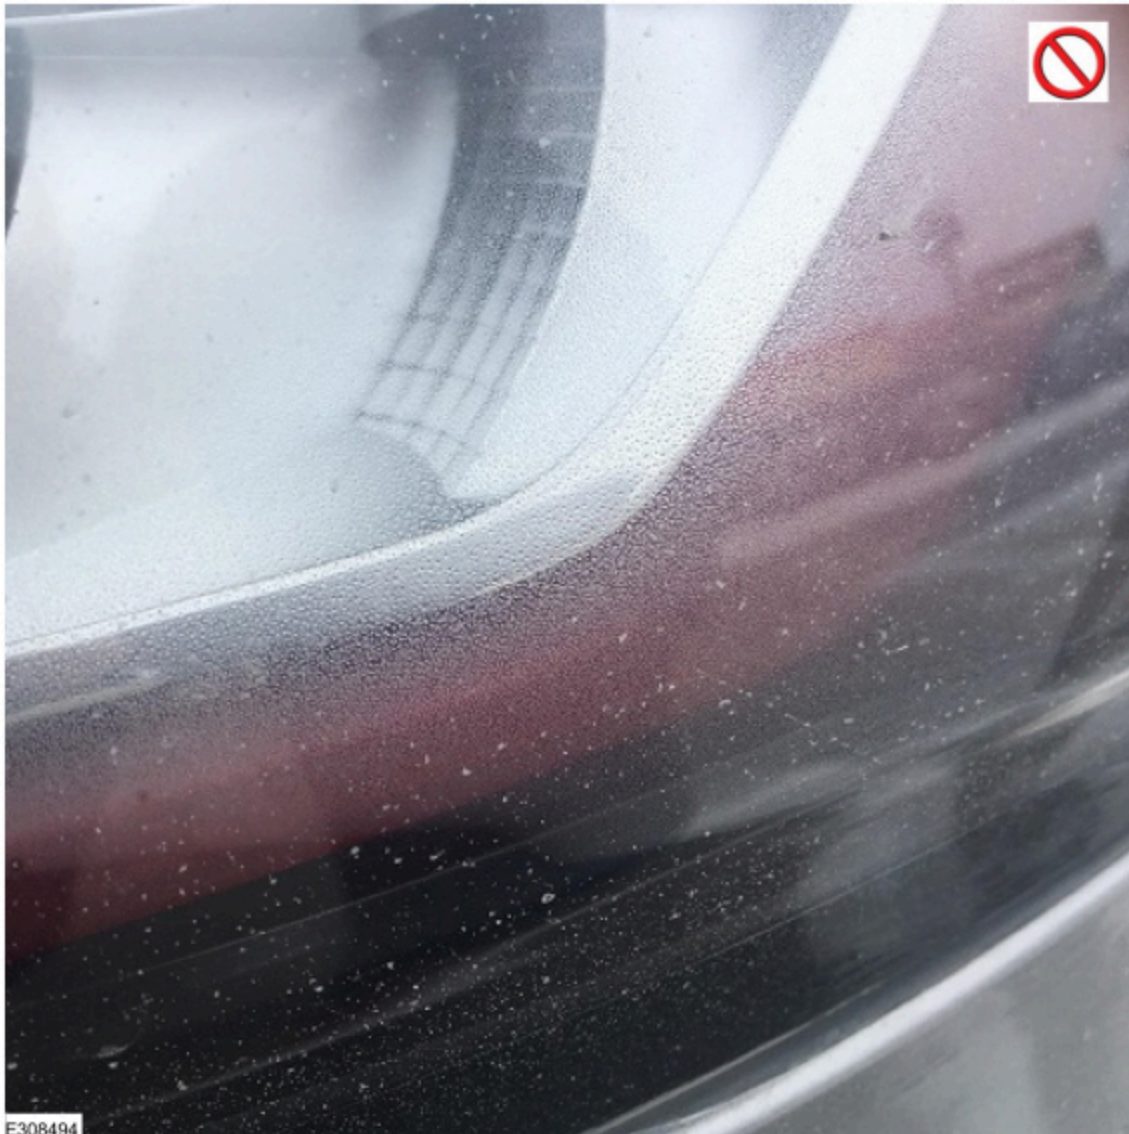
Figure 4 - not warrantable

Normal condensation (non-warrantable) is defined by a fine mist or white fog, frost on the interior side of a lamp lens that may include small droplets of liquid up to 2mm in diameter. This condition is not time limited and is not warrantable if the criteria is met. Other Non-warrantable conditions:

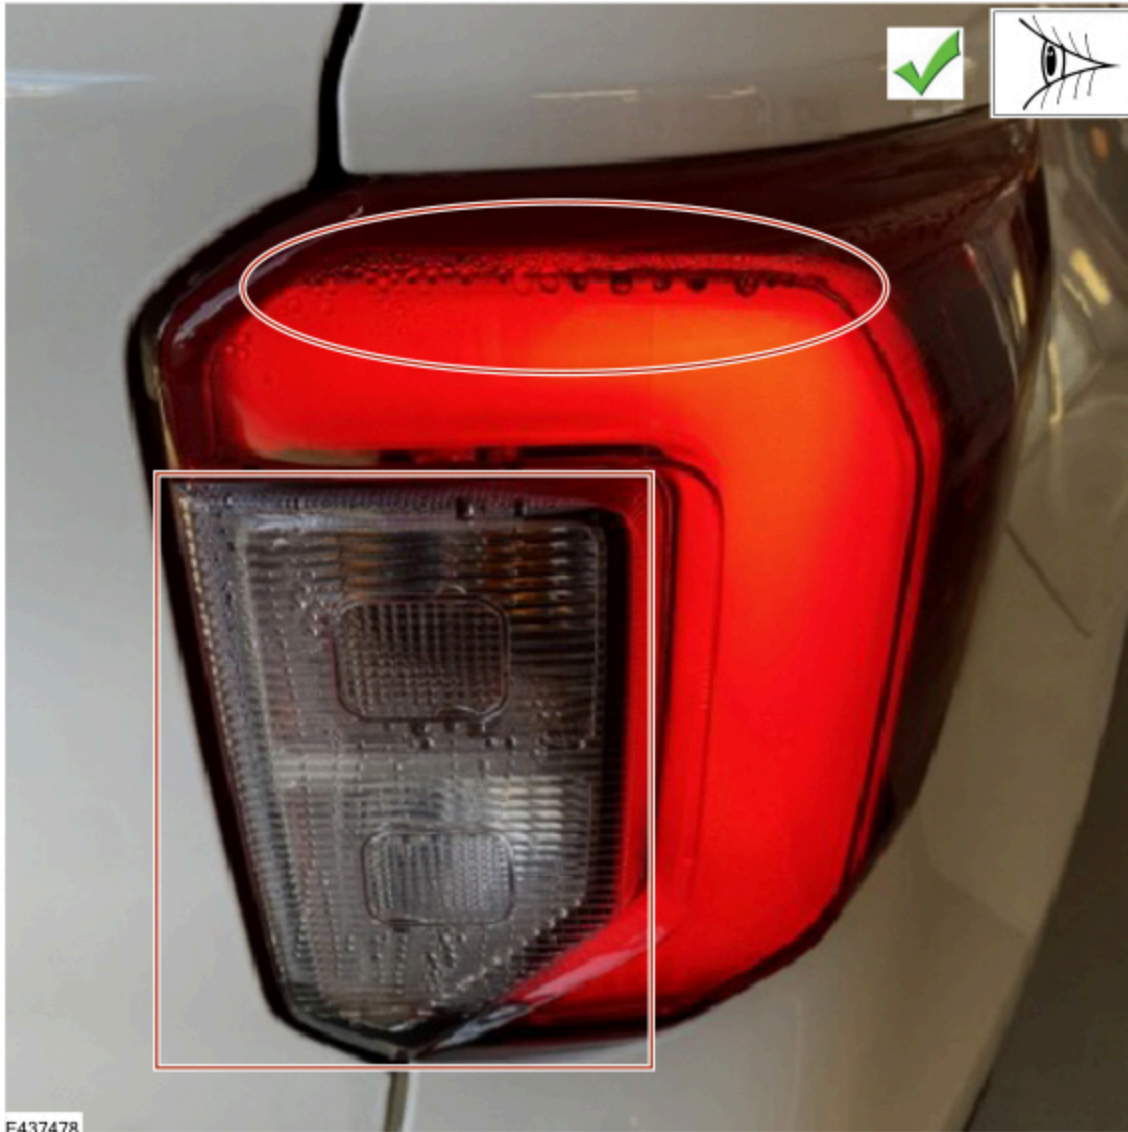
Water leak (warrantable) is defined by lamps that exhibit streaking and droplets of liquid larger than 2mm in diameter on the interior of the lens or pooling of water at the bottom of the lamp.

Figure 6 - example of water leak (large droplets) - warrantable

For warranty repairs, use the lowest level service part rather than an assembly replacement. Such components may include mirror signal lenses and puddle lamps which are often serviced separately from the mirror assembly. Prior to warranty analysis, thoroughly clean and dry the outside surface of the lamp assembly.

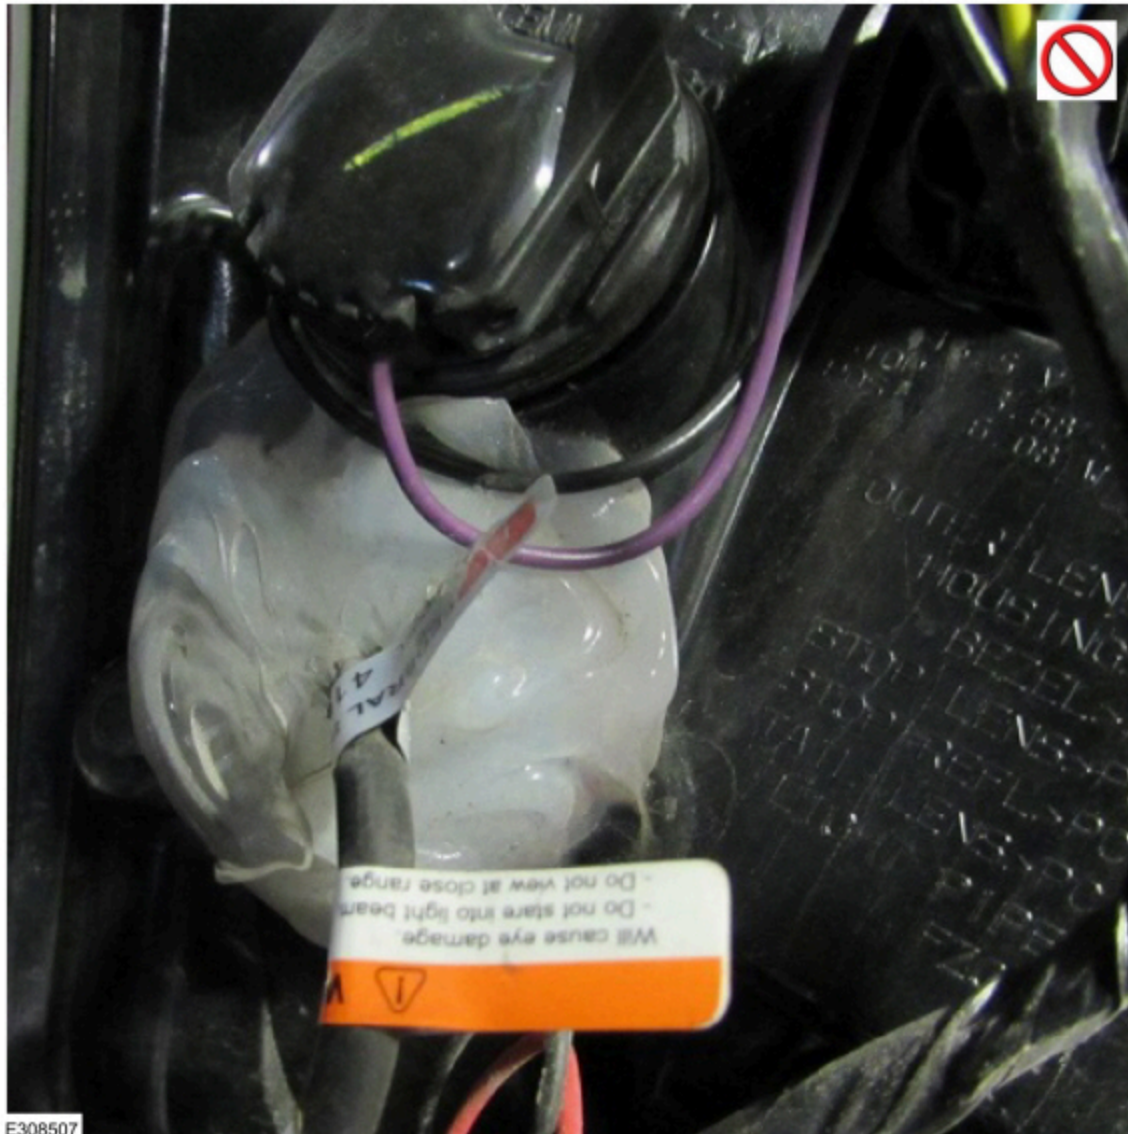
Figure 10 - example of modification (silicone) - not covered under warranty

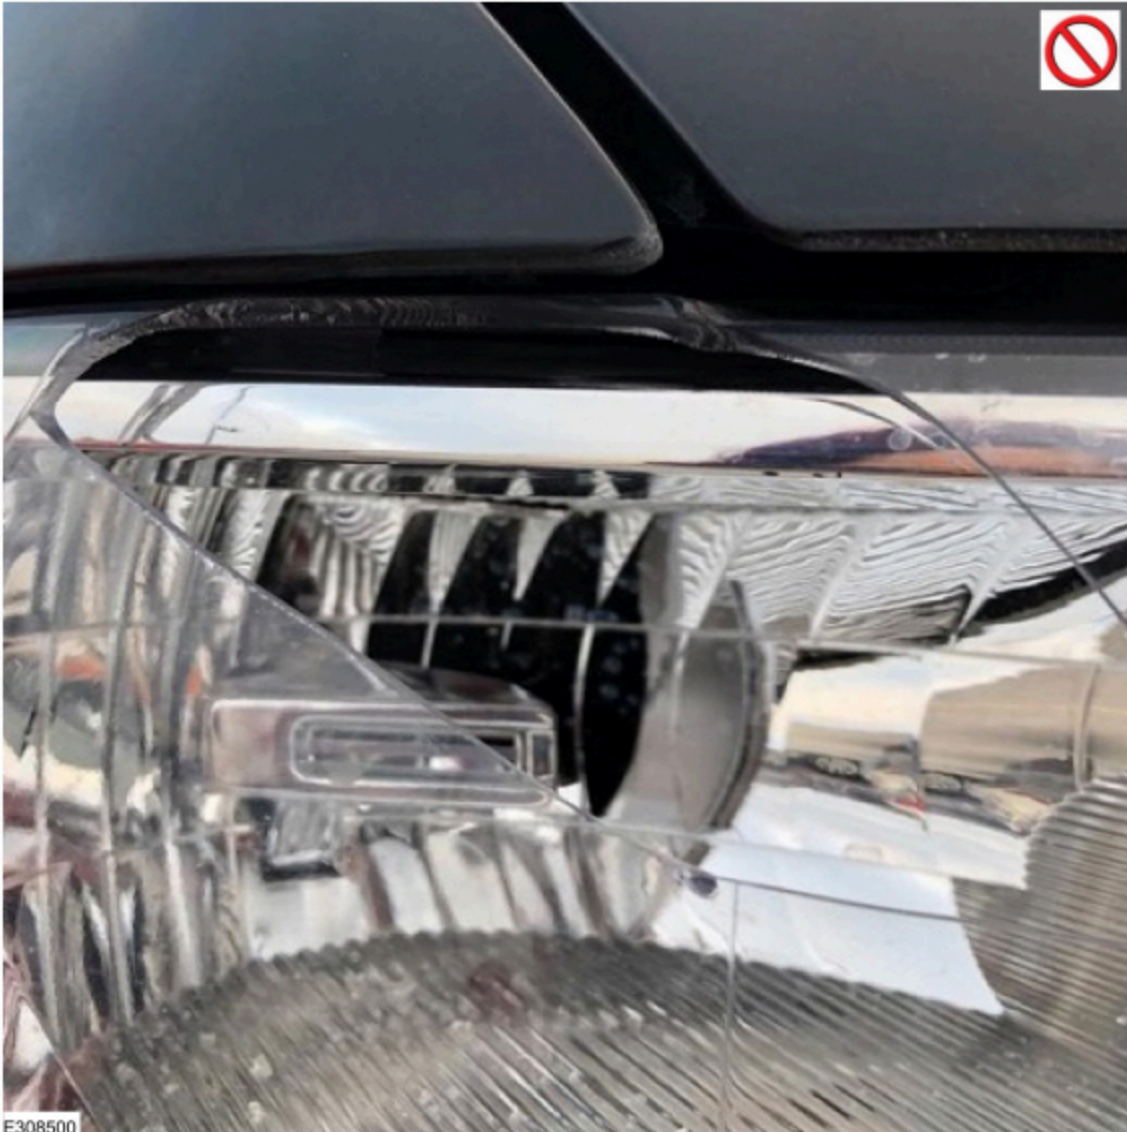
Figure 11 - example of external impact damage - not covered under warranty

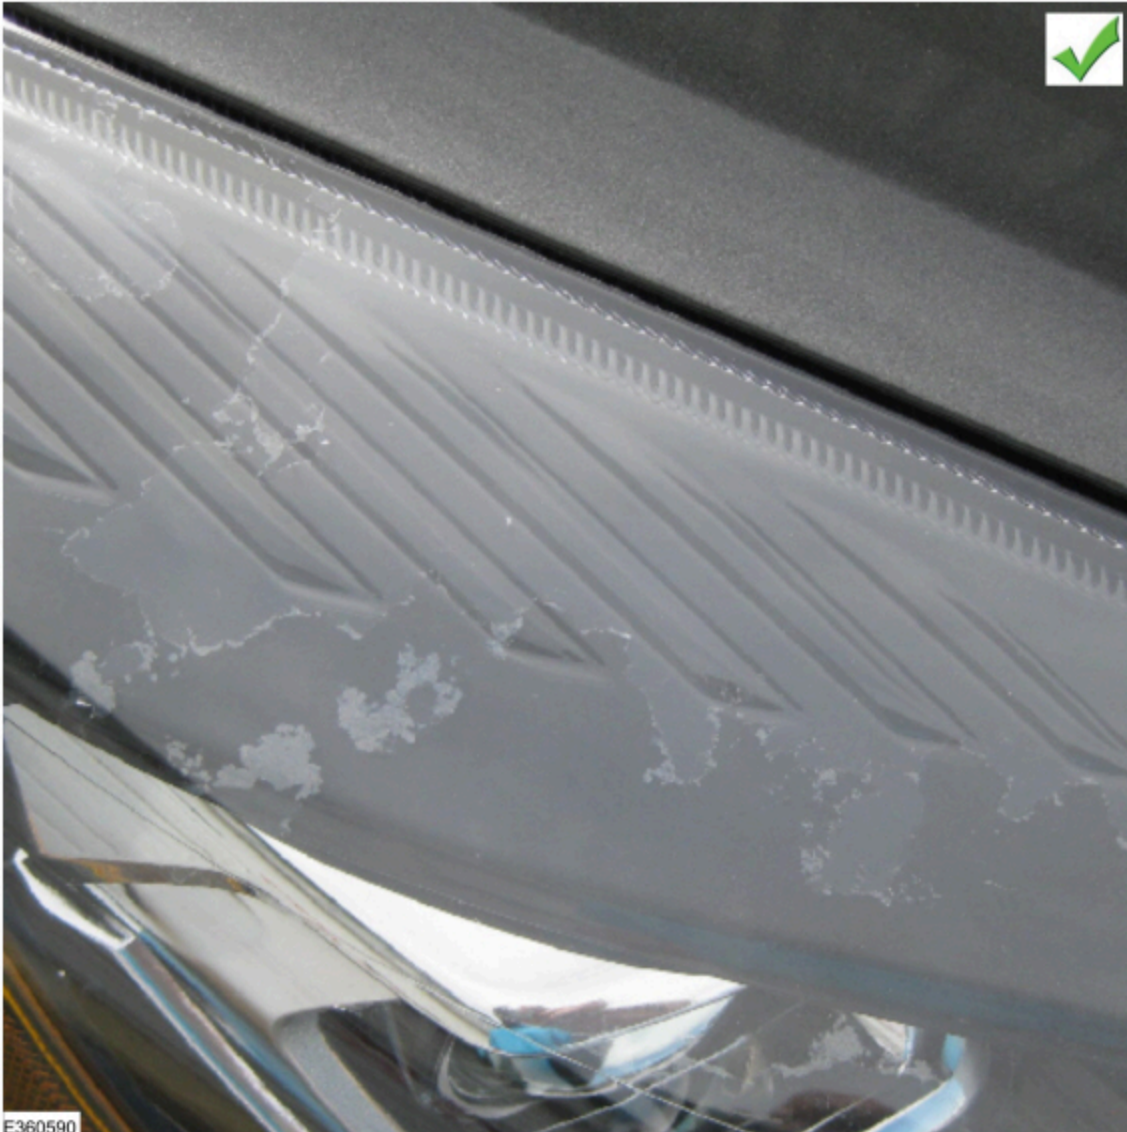
Figure 13 - example of peeling hard coat - warrantable

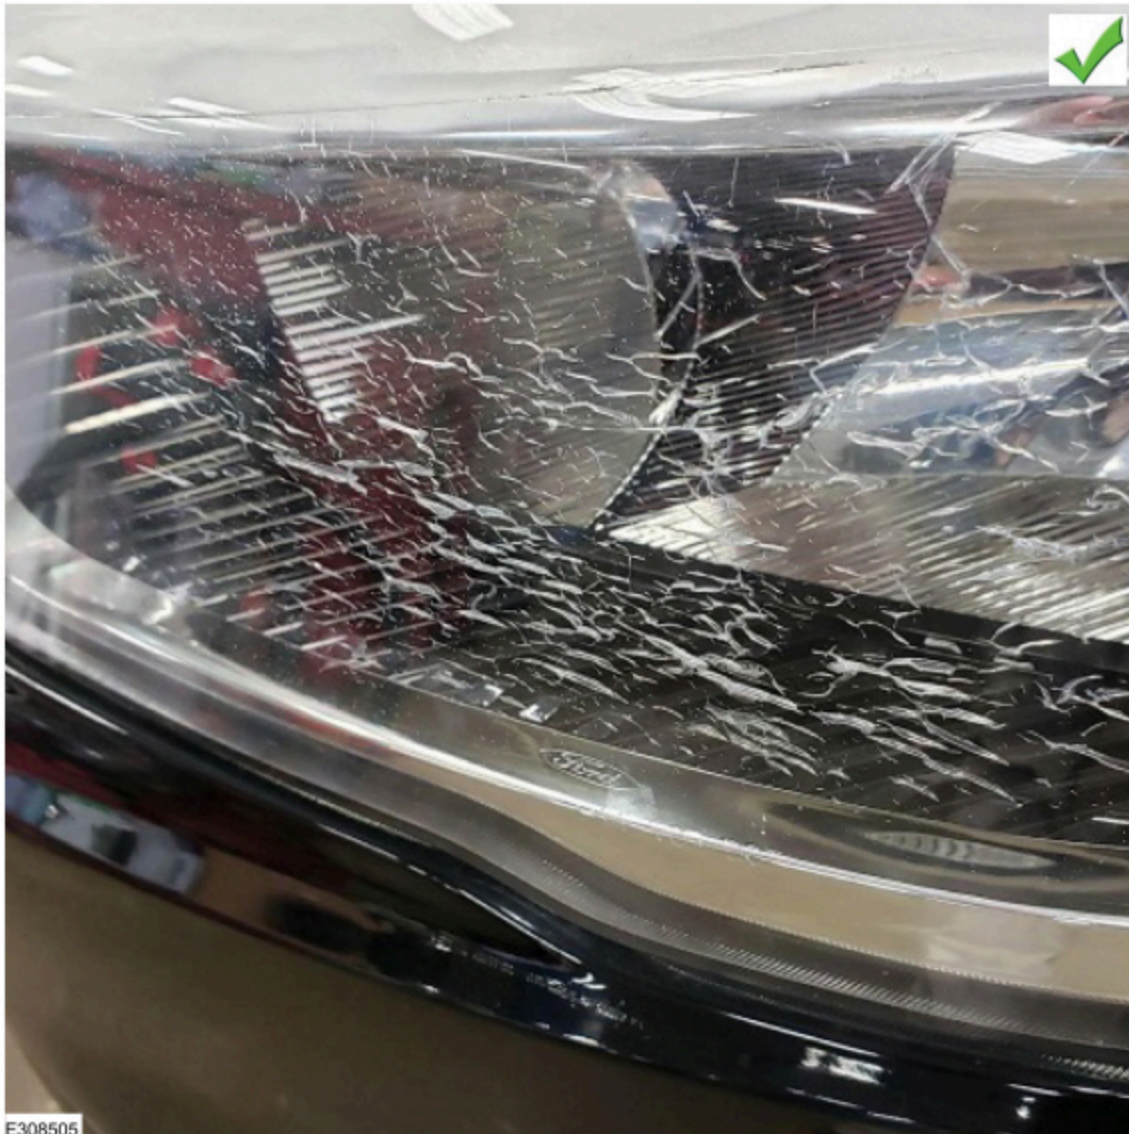
Figure 14 - example of "crazing" - warrantable

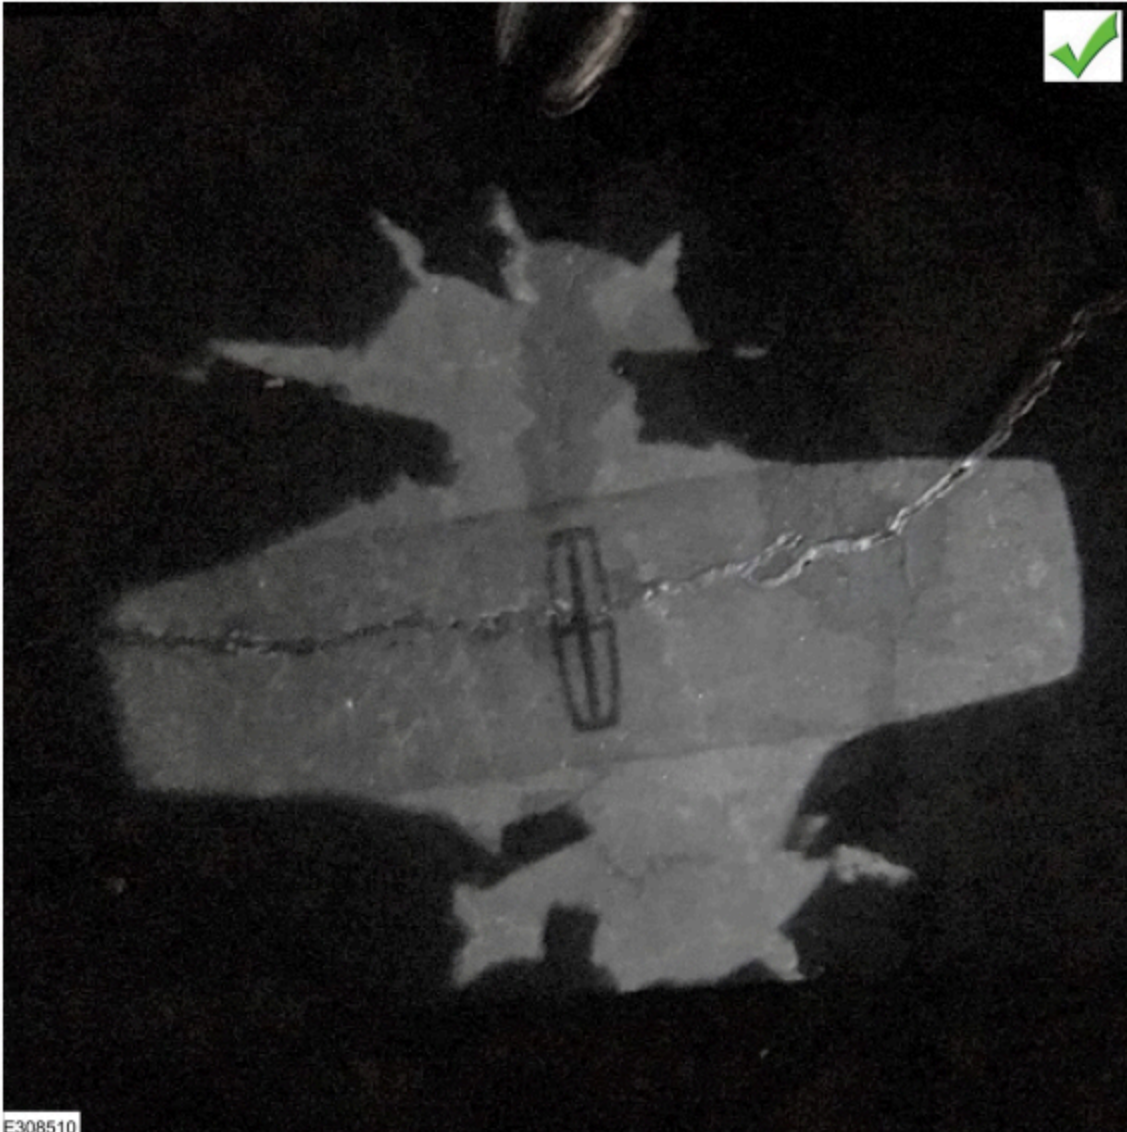
Figure 15 - example of distorted logo lamp - warrantable
