## GENERAL SERVICE BULLETIN

### Interior Trim Concern Analysis

**25-7000**08 January  
2025

Use this document to assist in determining warrantable interior trim and steering wheel conditions.

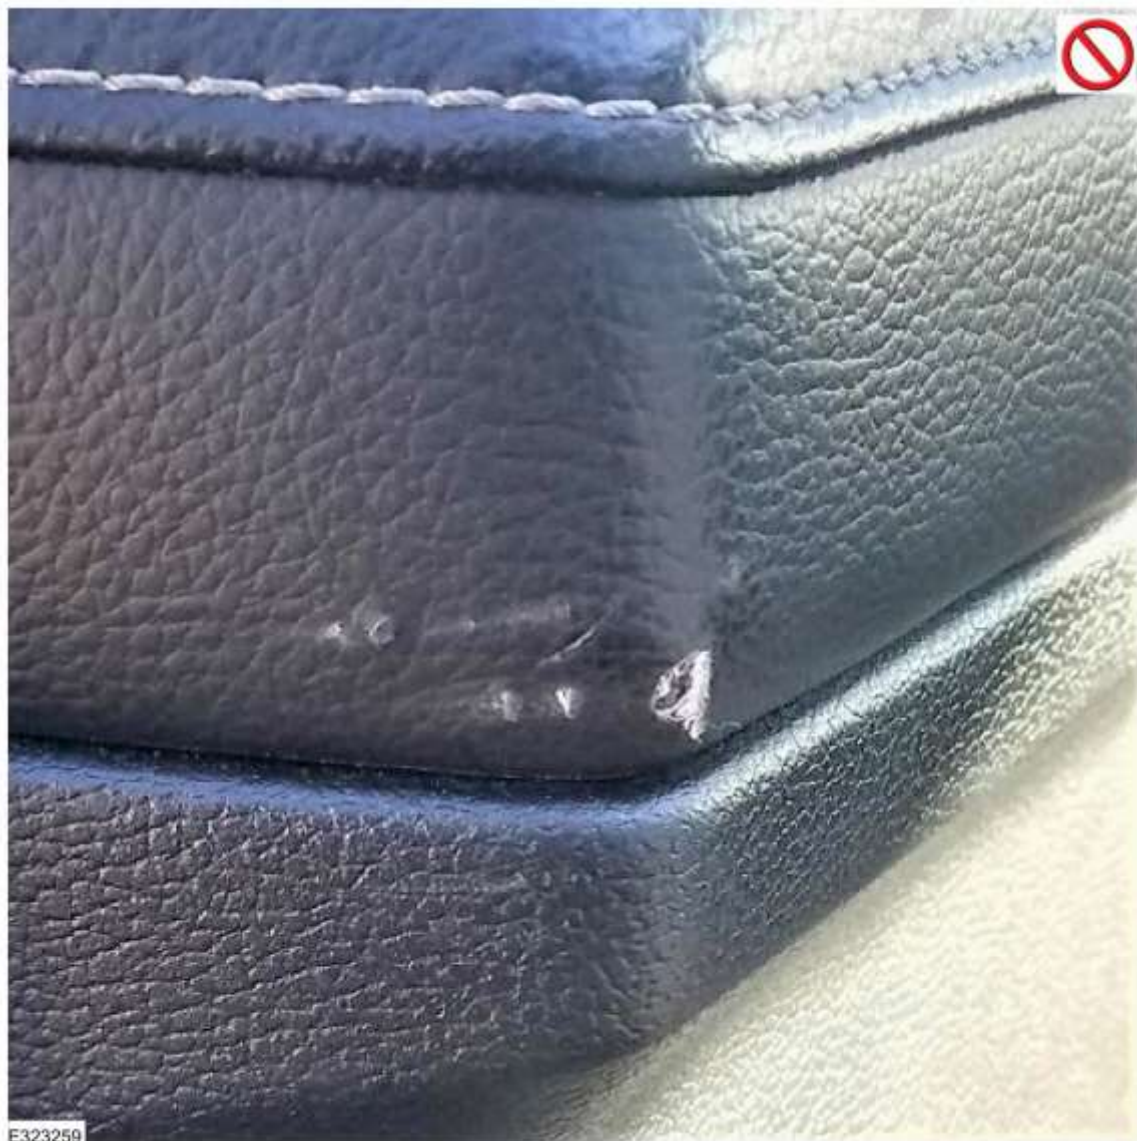
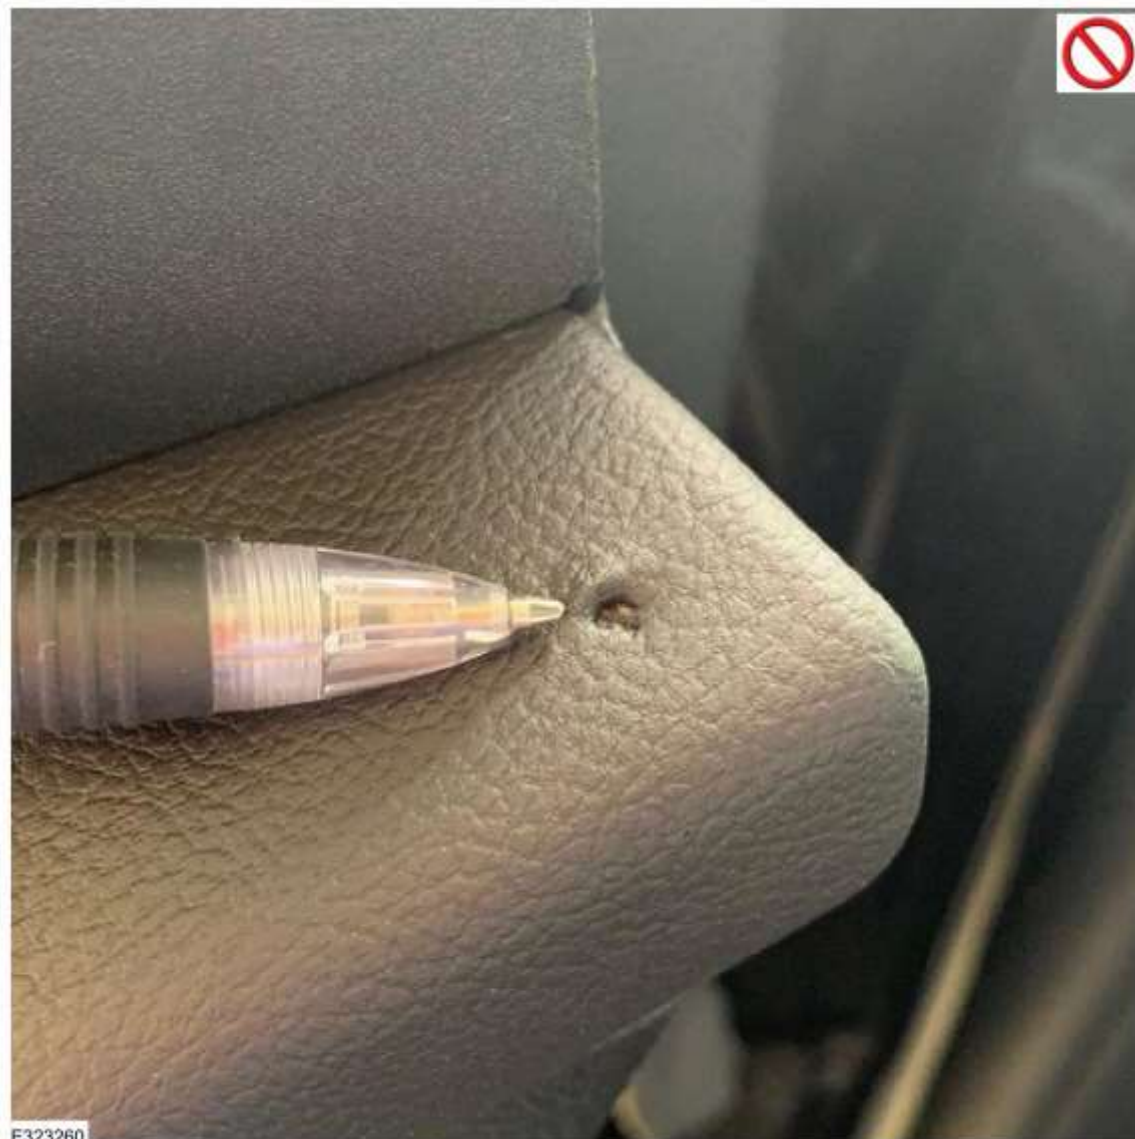
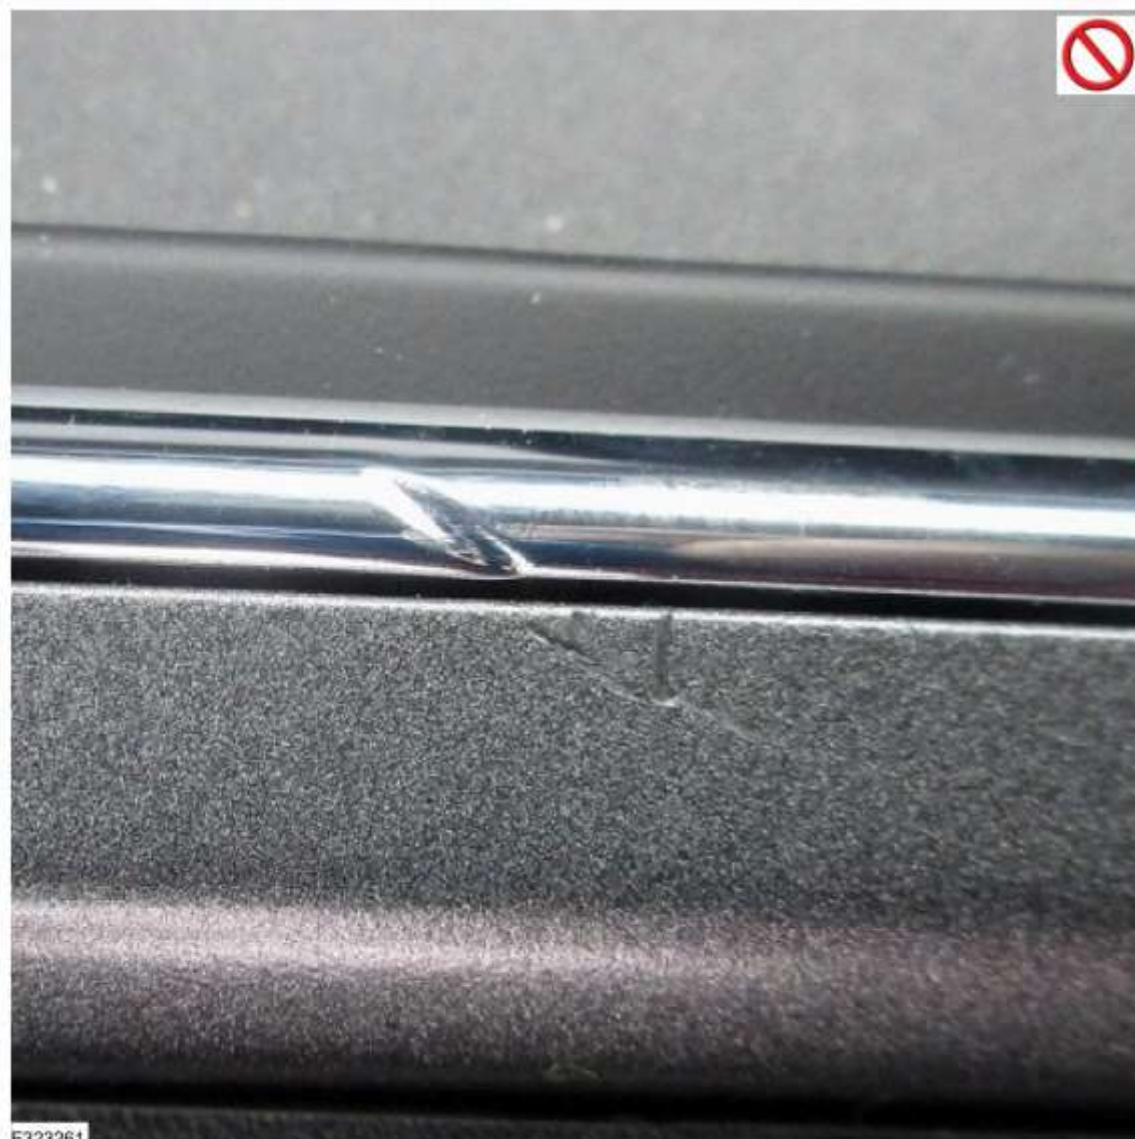
### Cuts, Scratches, Scuffs, Tears Or Punctures (Non-warrantable) (Figures 1-3)

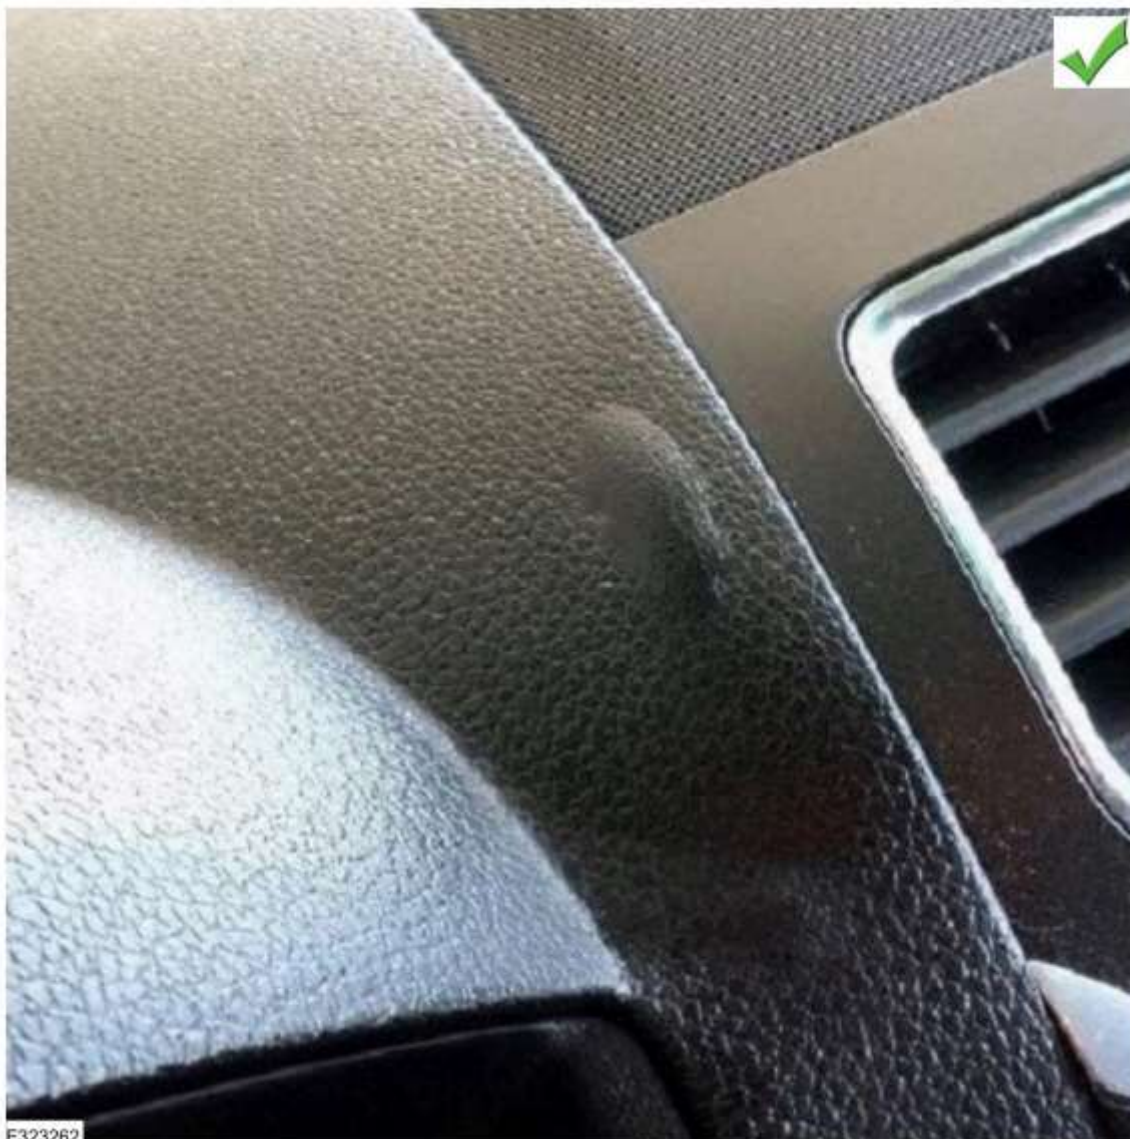
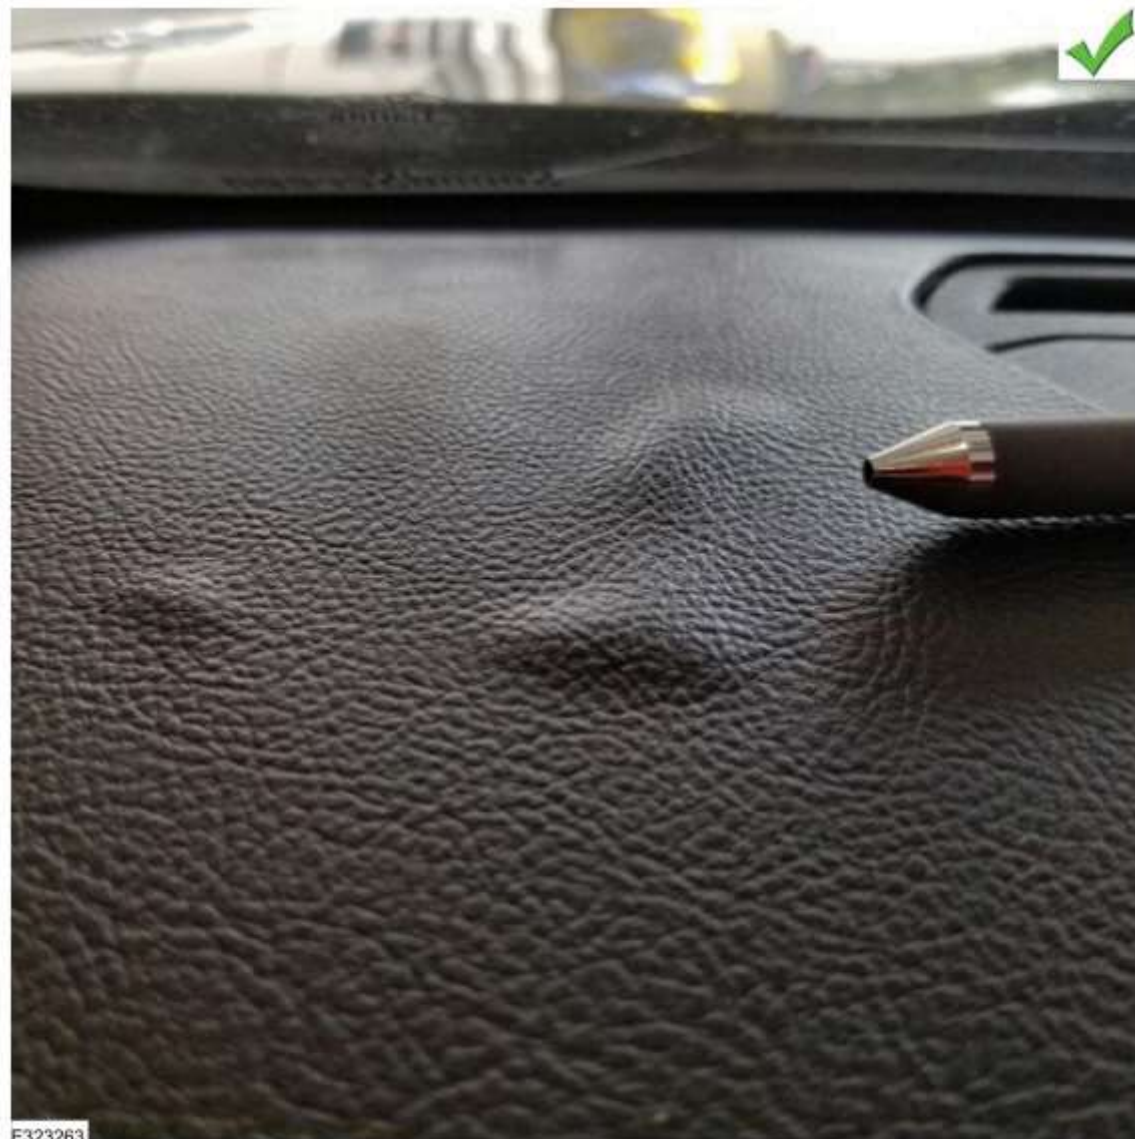
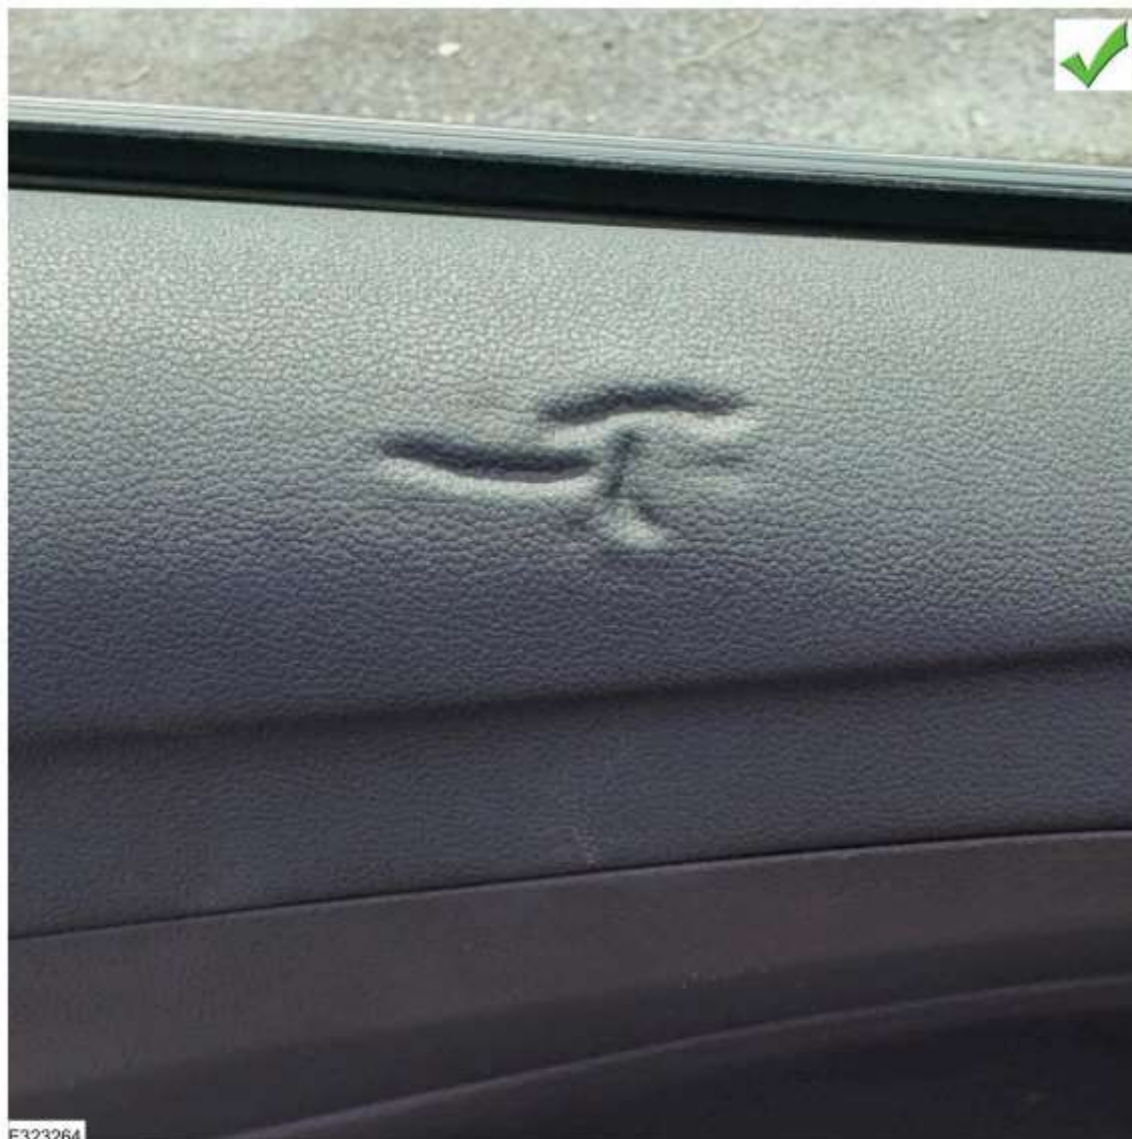
## **Bubbles (Warrantable) (Figures 4-6)**

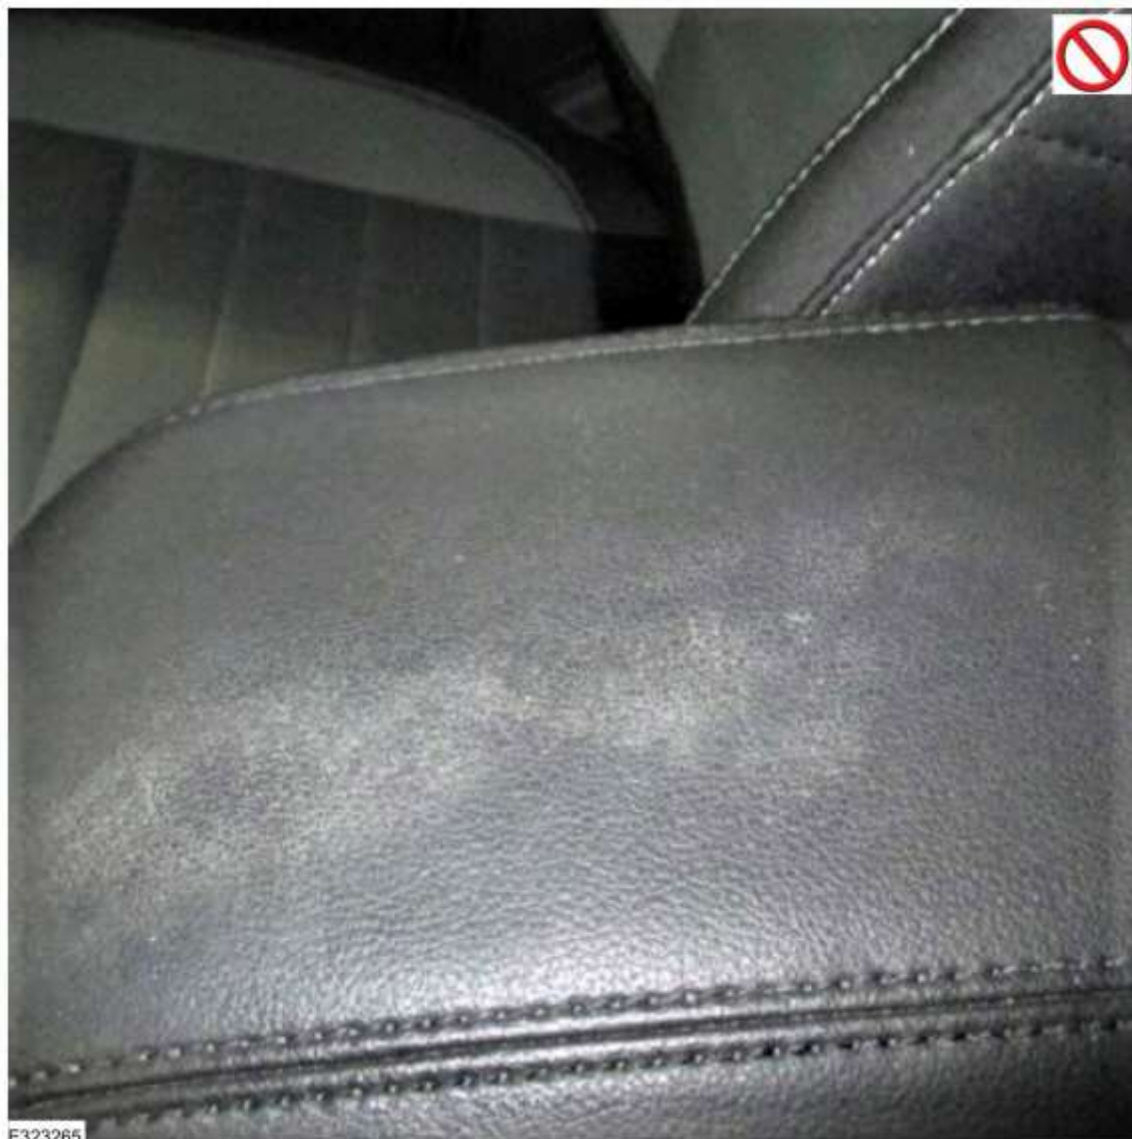
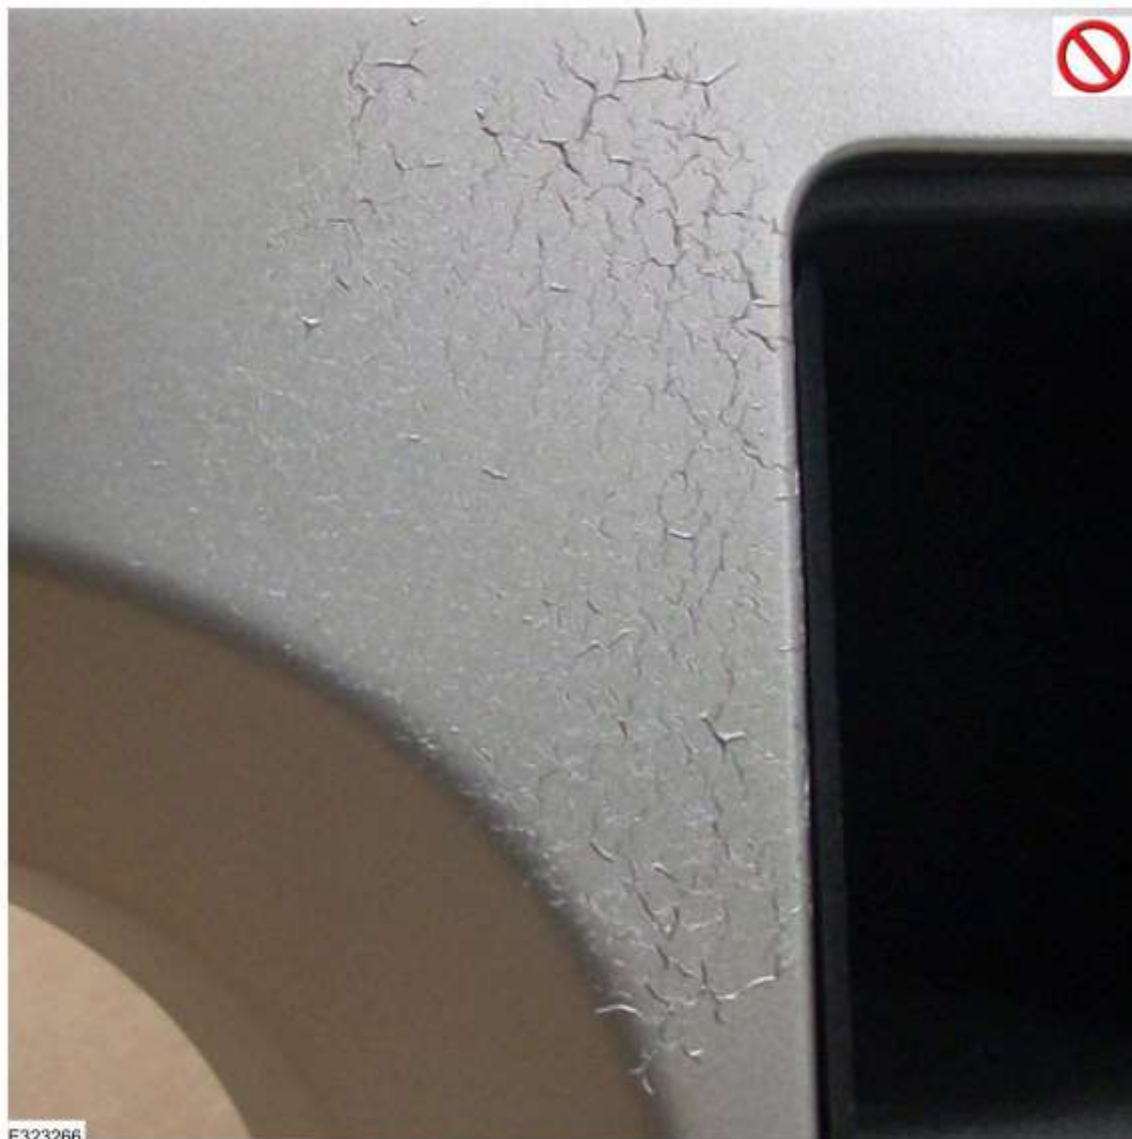
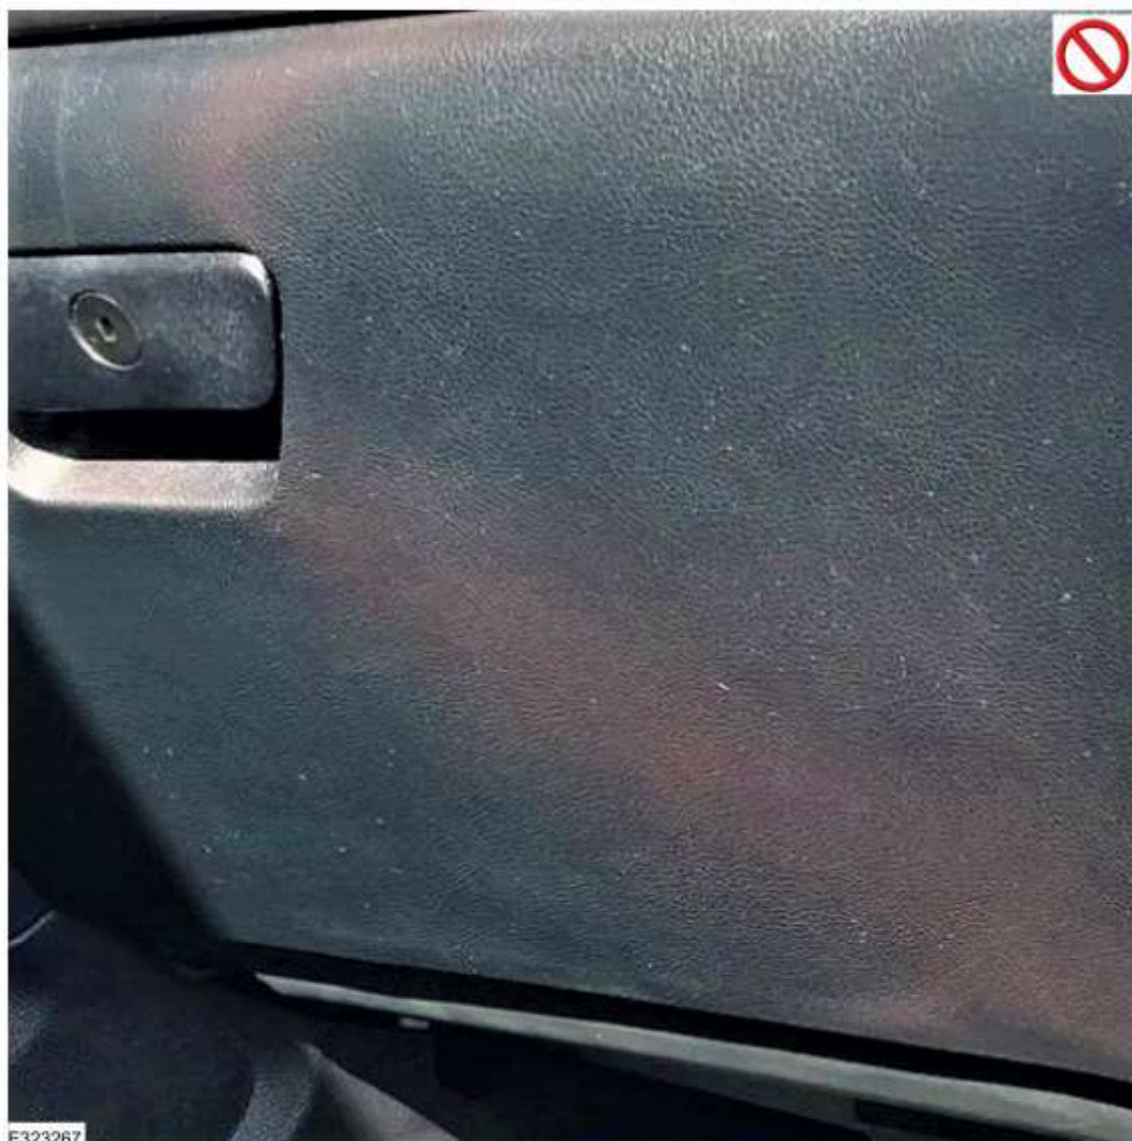
## Stains From Chemical Influence (Non-warrantable) (Figures 7-9)

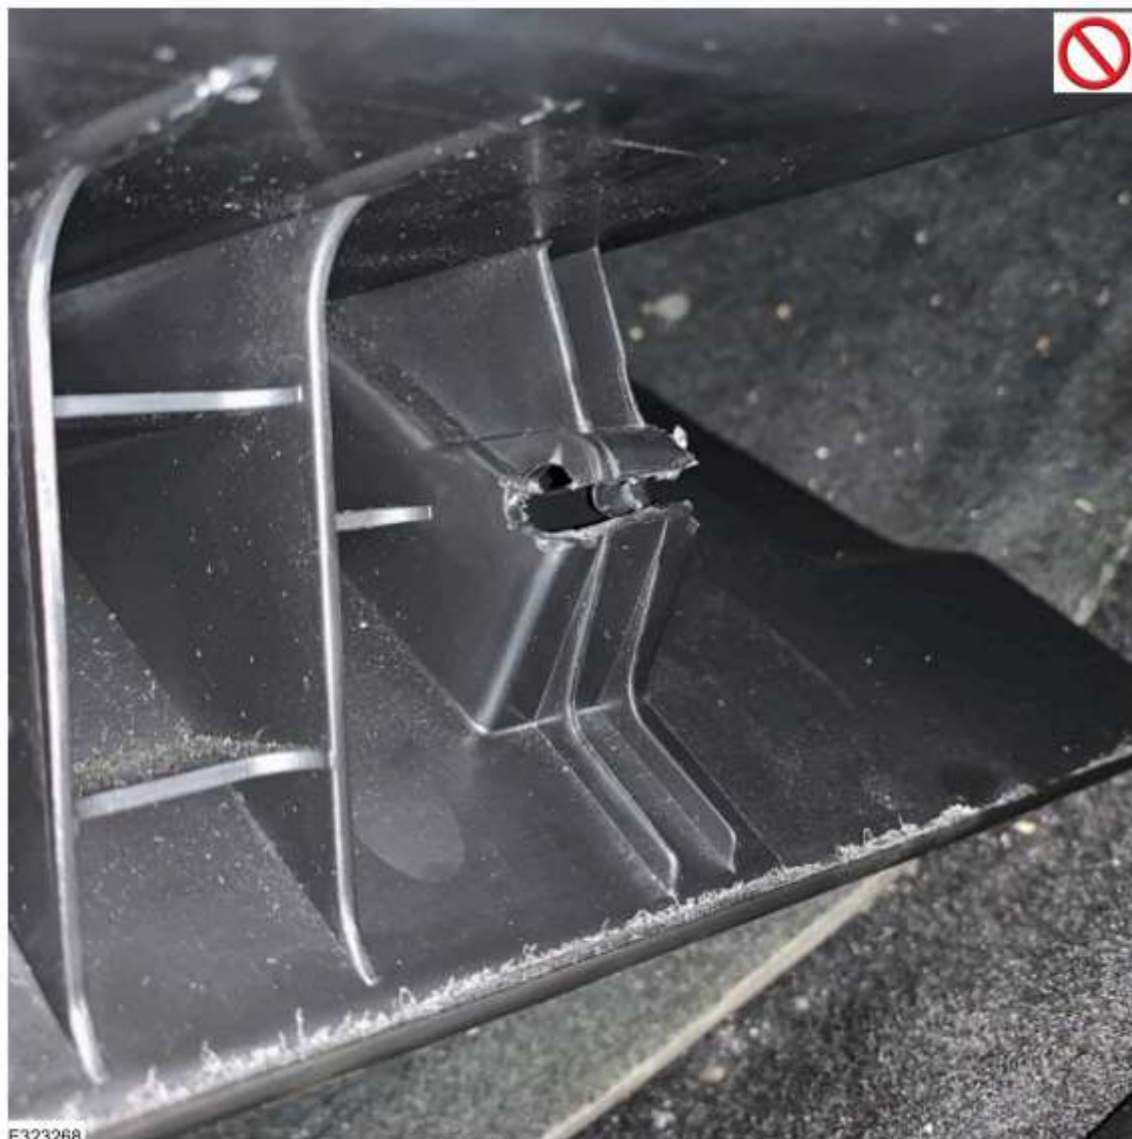
Figure 10

## Broken Attachments (Non-warrantable) (Figure 10)

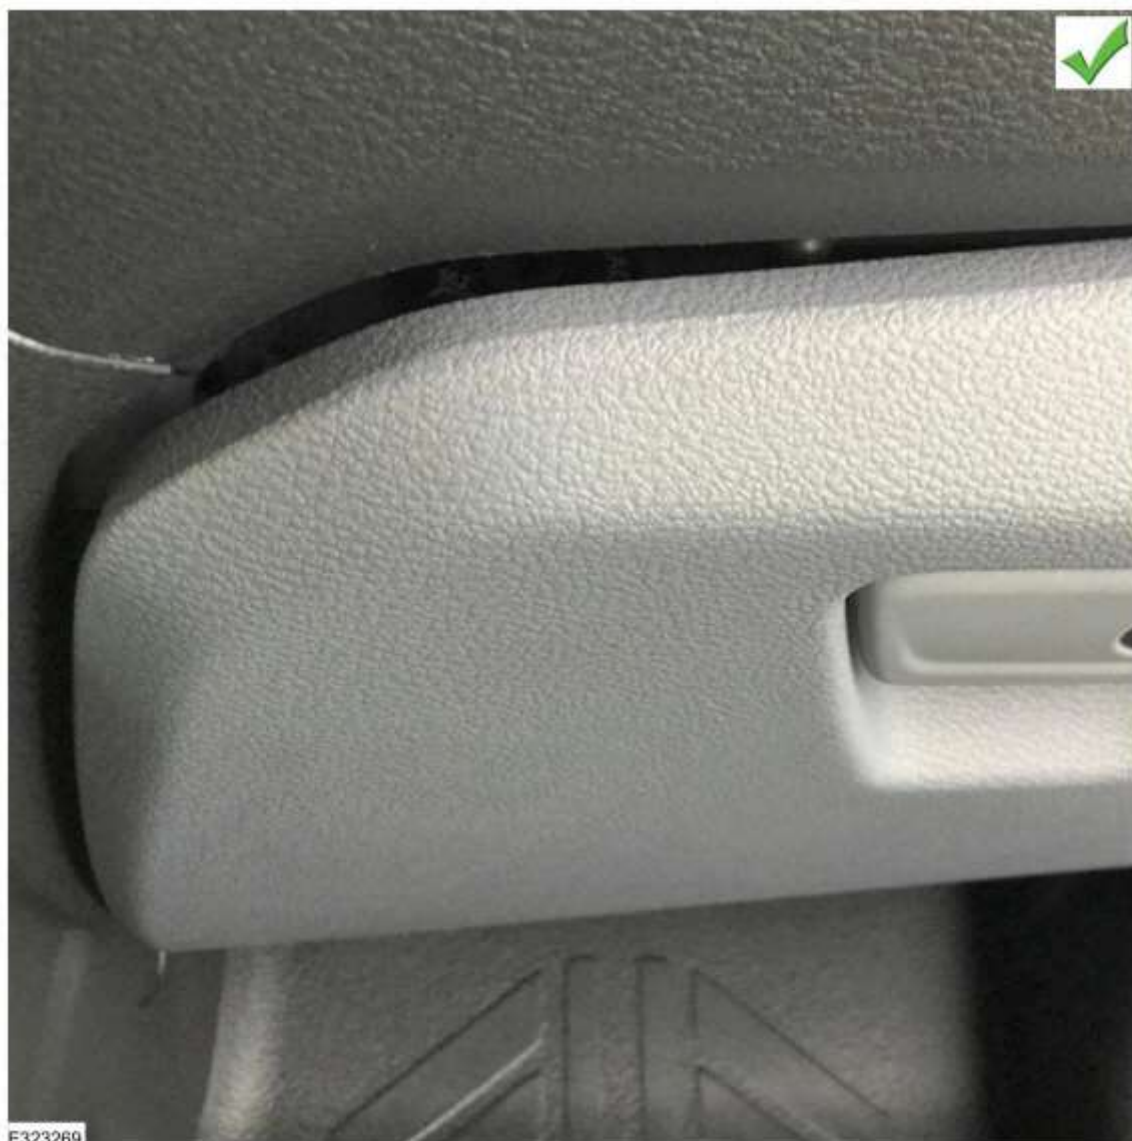
Figure 11

## **Alignment, Fit, Warped (Warrantable) (Figures 11-13)**

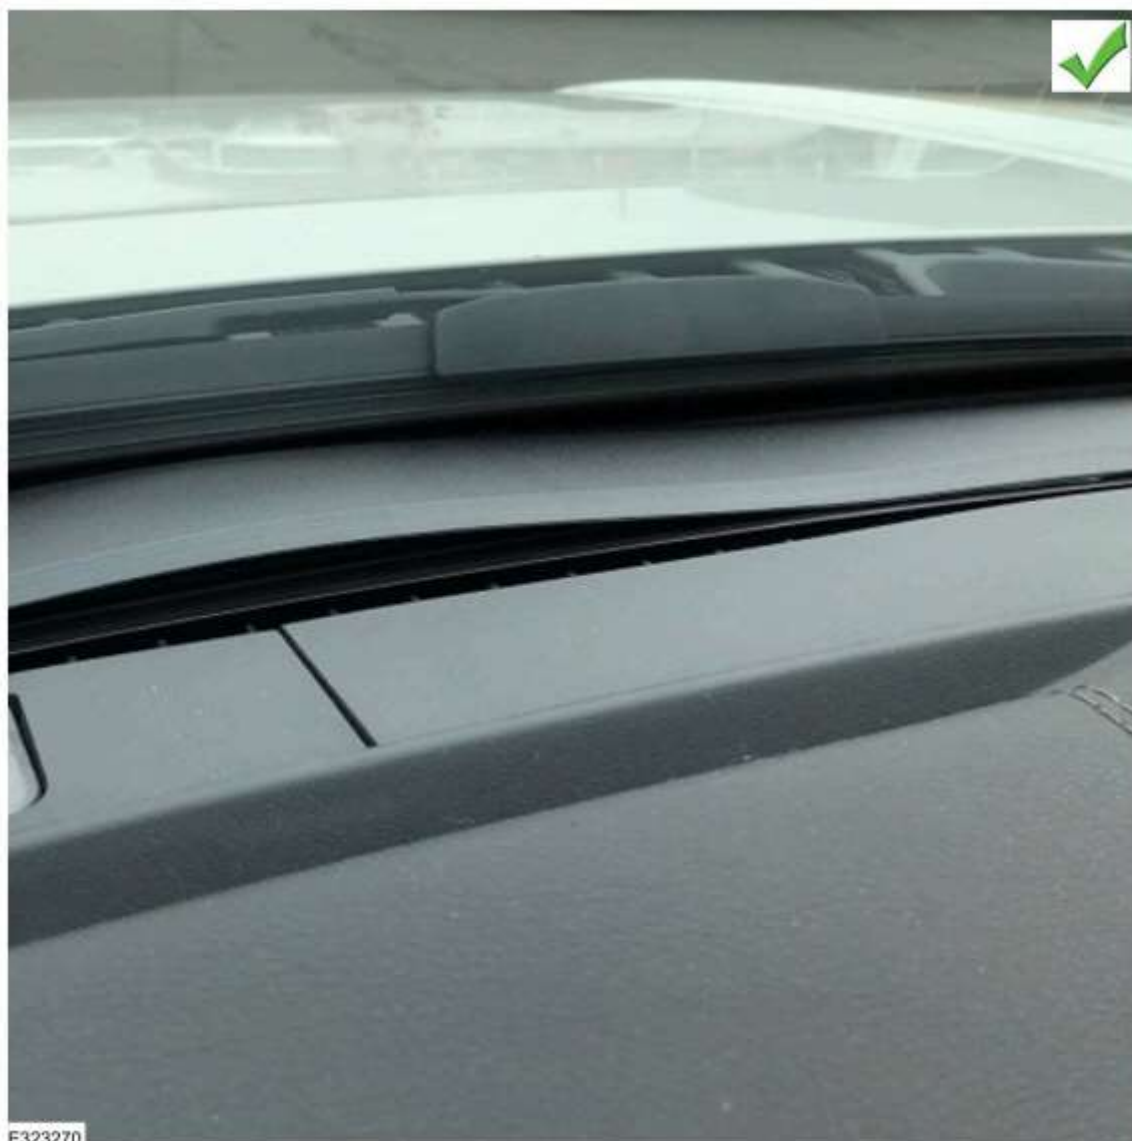
Figure 12 - Warped instrument panel (Warrantable) (Figure 12)

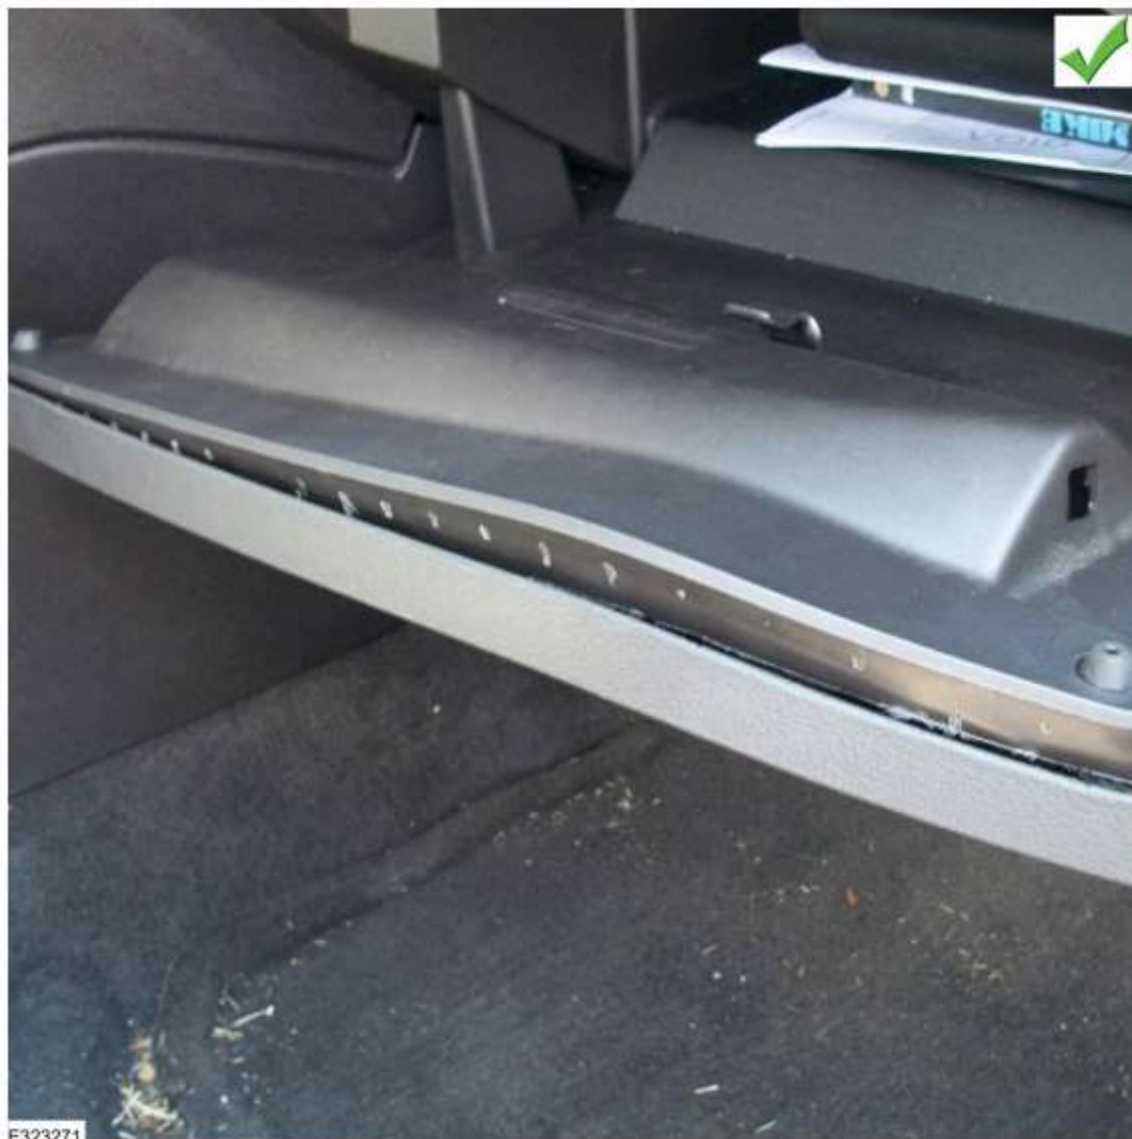
Figure 13 - Warped glove box door (Warrantable) (Figure 13)

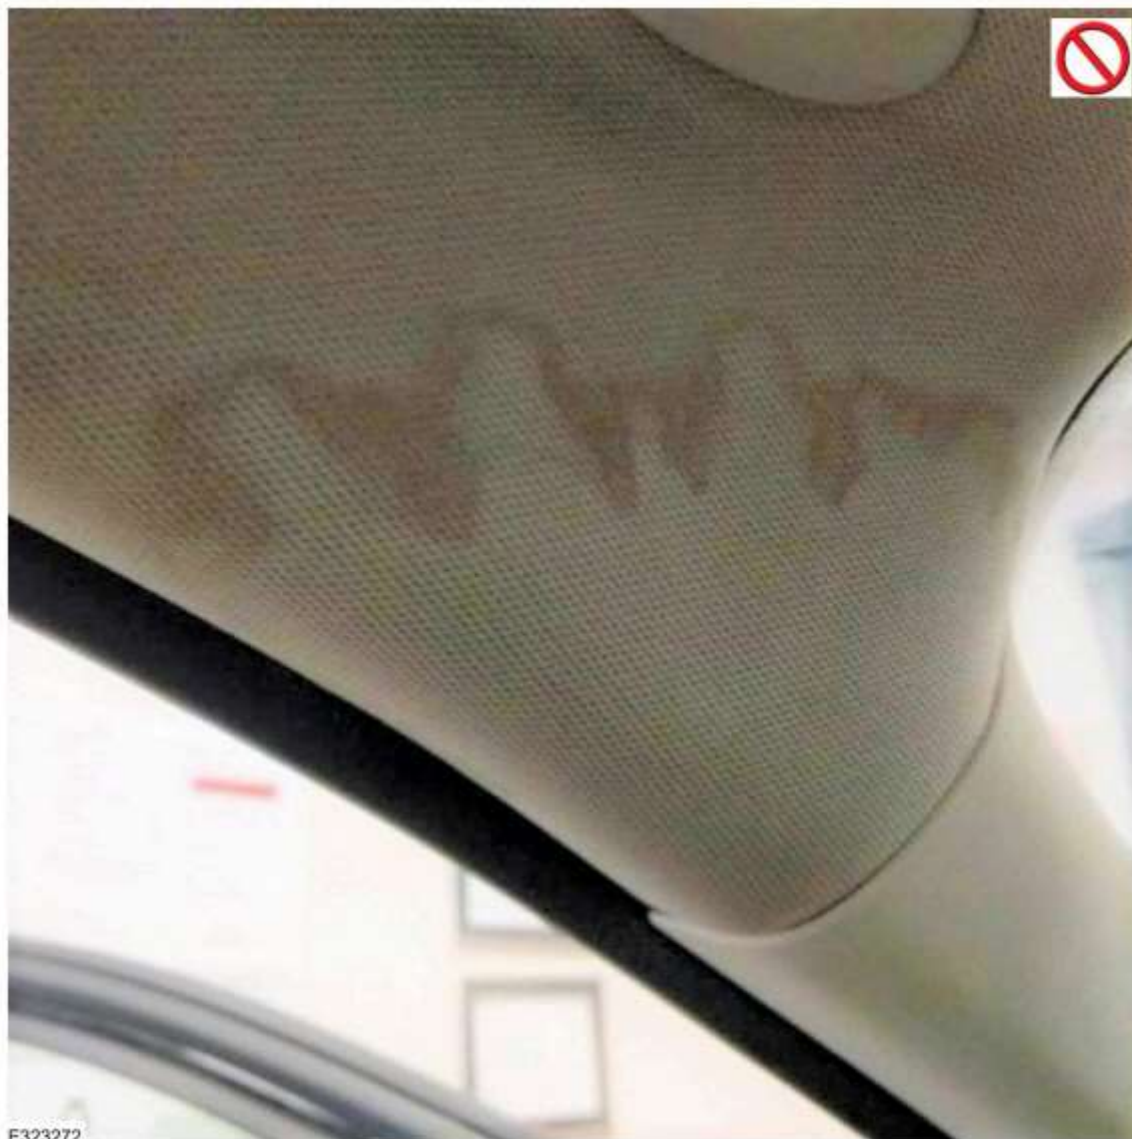
Figure 14

### Stained Headliner (Non-warrantable) (Figure 14)

**NOTE:** Staining as the result of a defect would be covered as related damage.

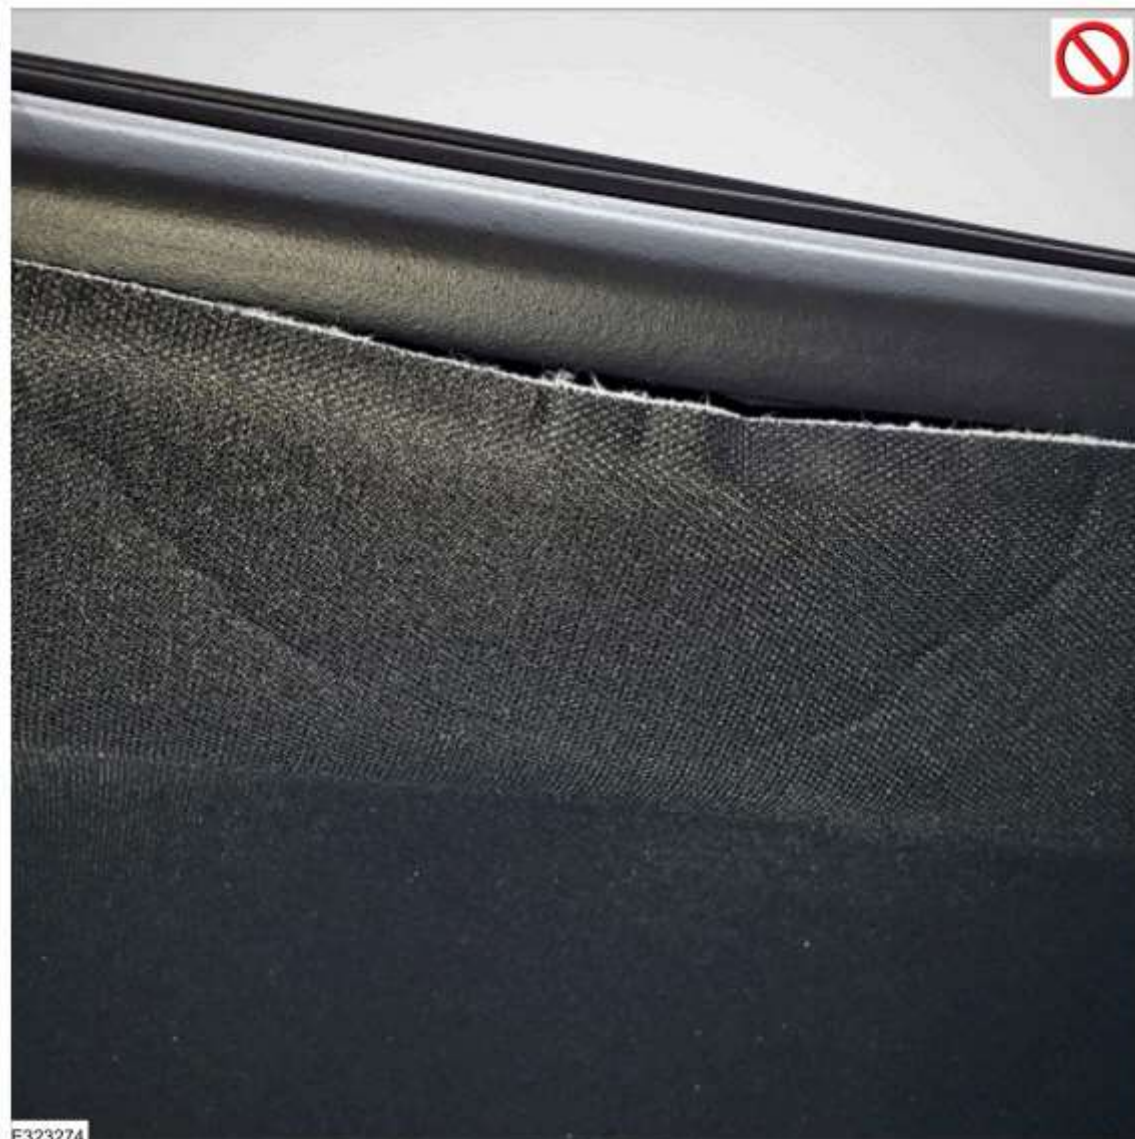
Figure 16

### **Creased Headliner (Non-warrantable) (Figure 16)**

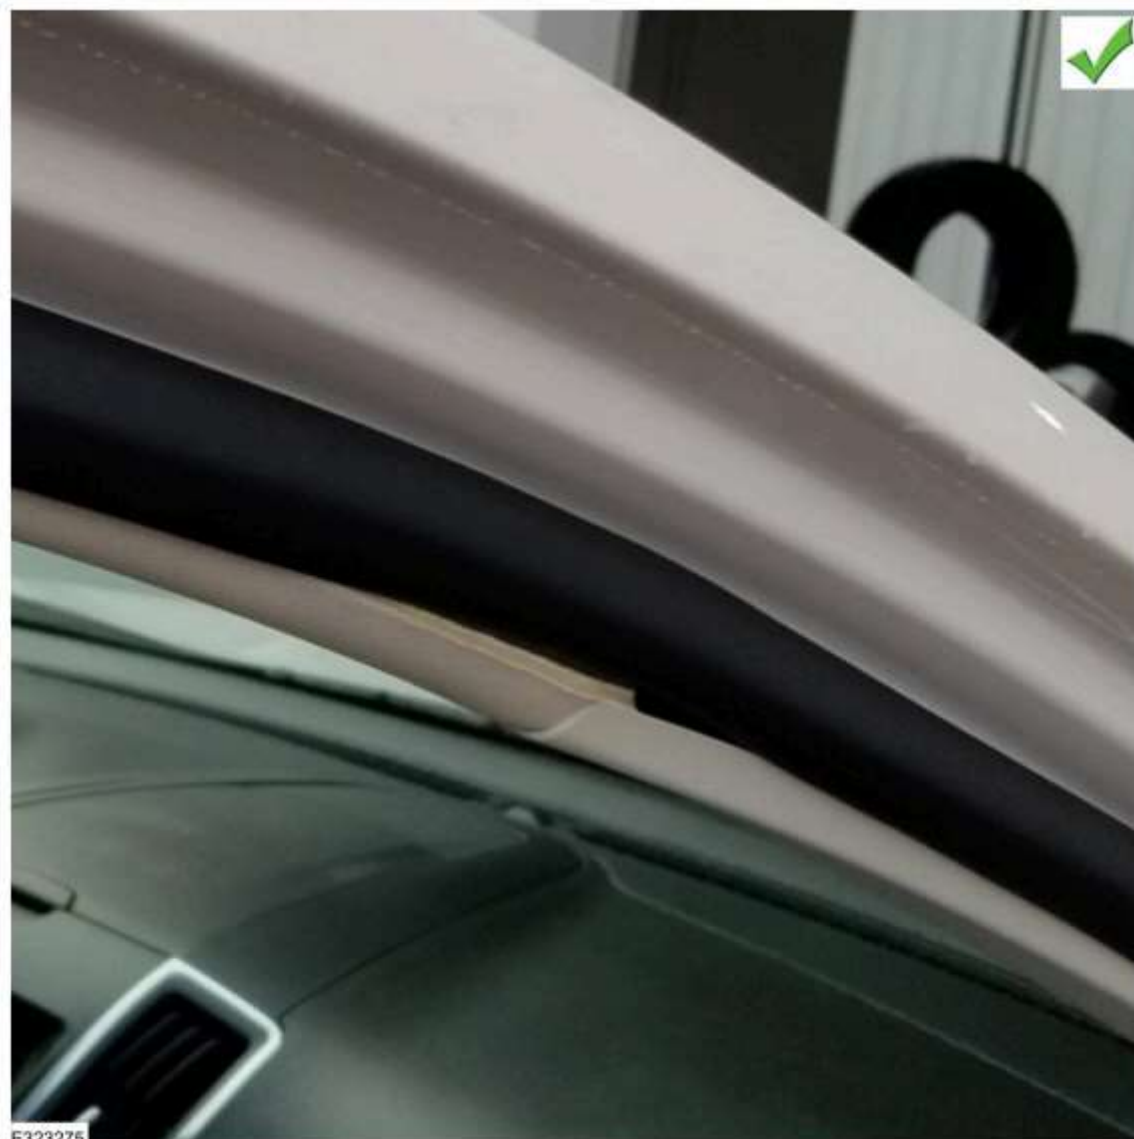
Figure 17

### Headliner Edge Visible (Warrantable) (Figure 17)

**NOTE:** Complete removal/installation may be required to ensure proper alignment.

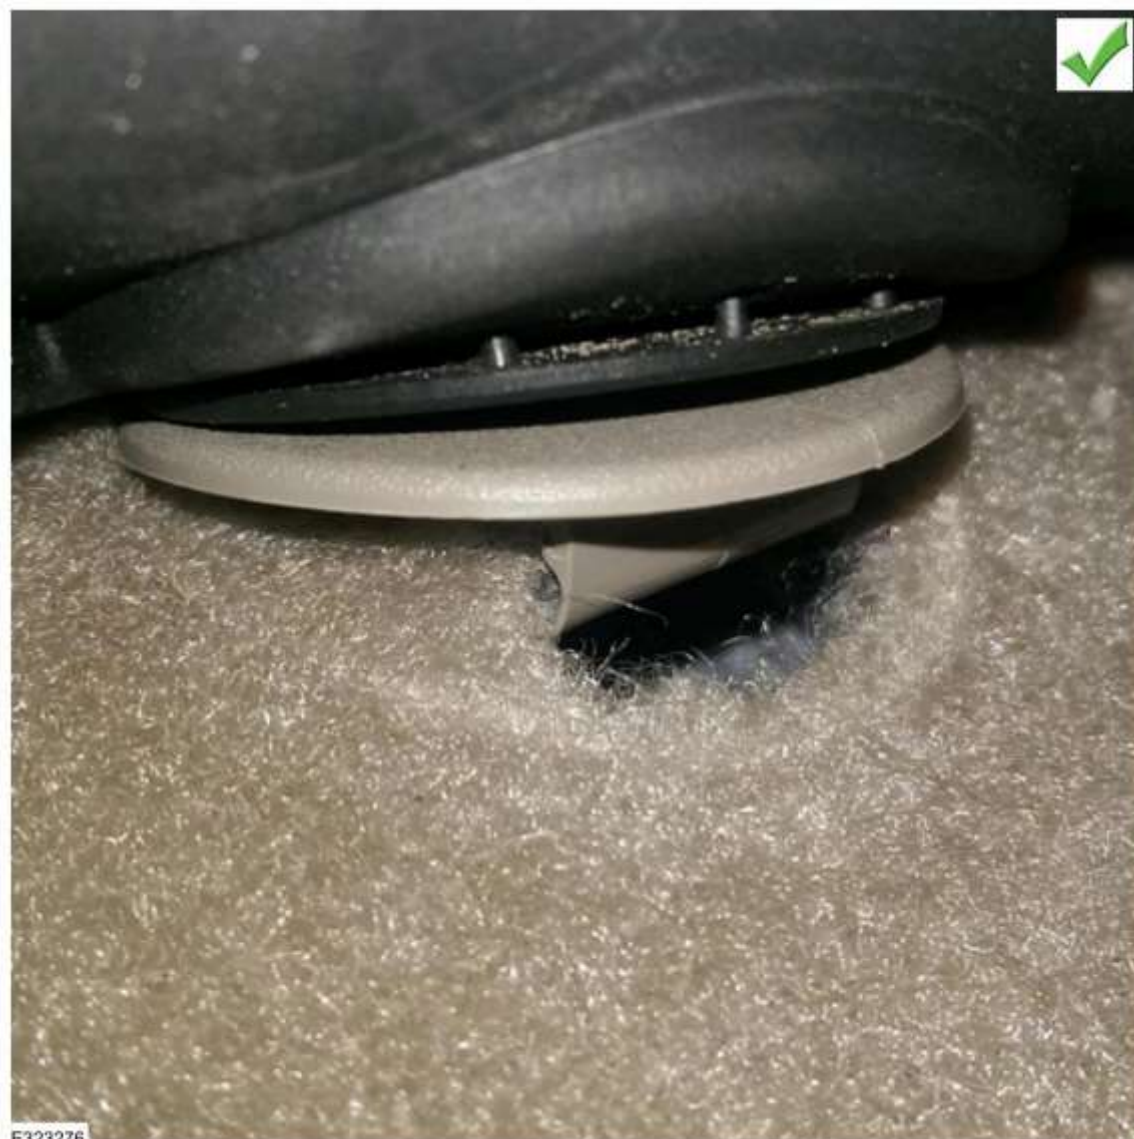
Figure 18

### **Loose Mat Anchor (Warrantable) (Figure 18)**

**NOTE:** With no associated liquid staining present.
