## GENERAL SERVICE BULLETIN

### Interior Trim Concern Analysis

**25-7000**08 January  
2025

Use this document to assist in determining warrantable interior trim and steering wheel conditions.

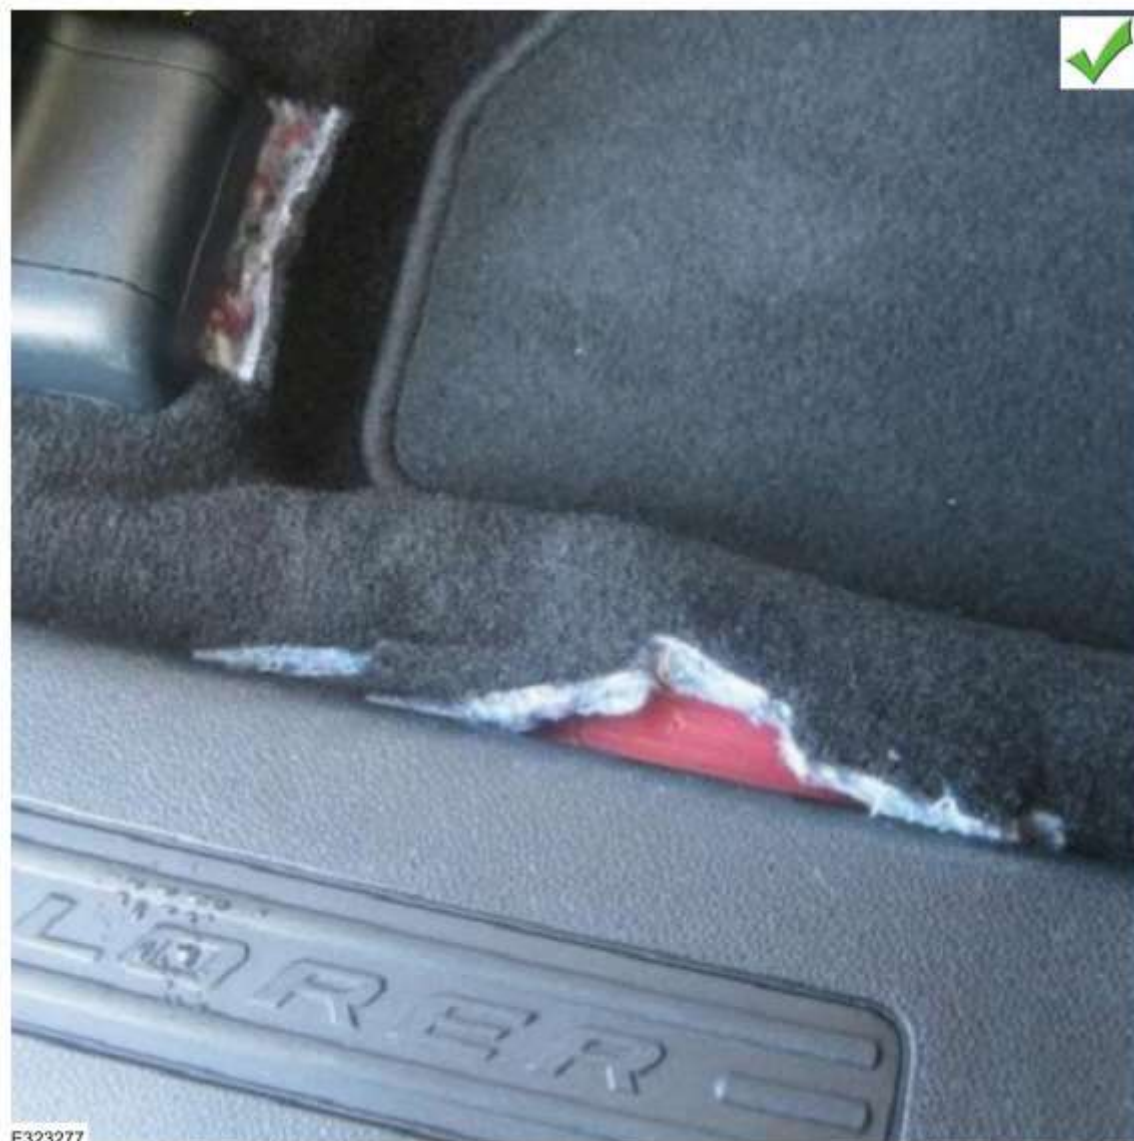
Figure 19

### Loose Carpet (Warrantable) (Figure 19)

**NOTE:** Complete removal/installation may be required to establish a proper fit.

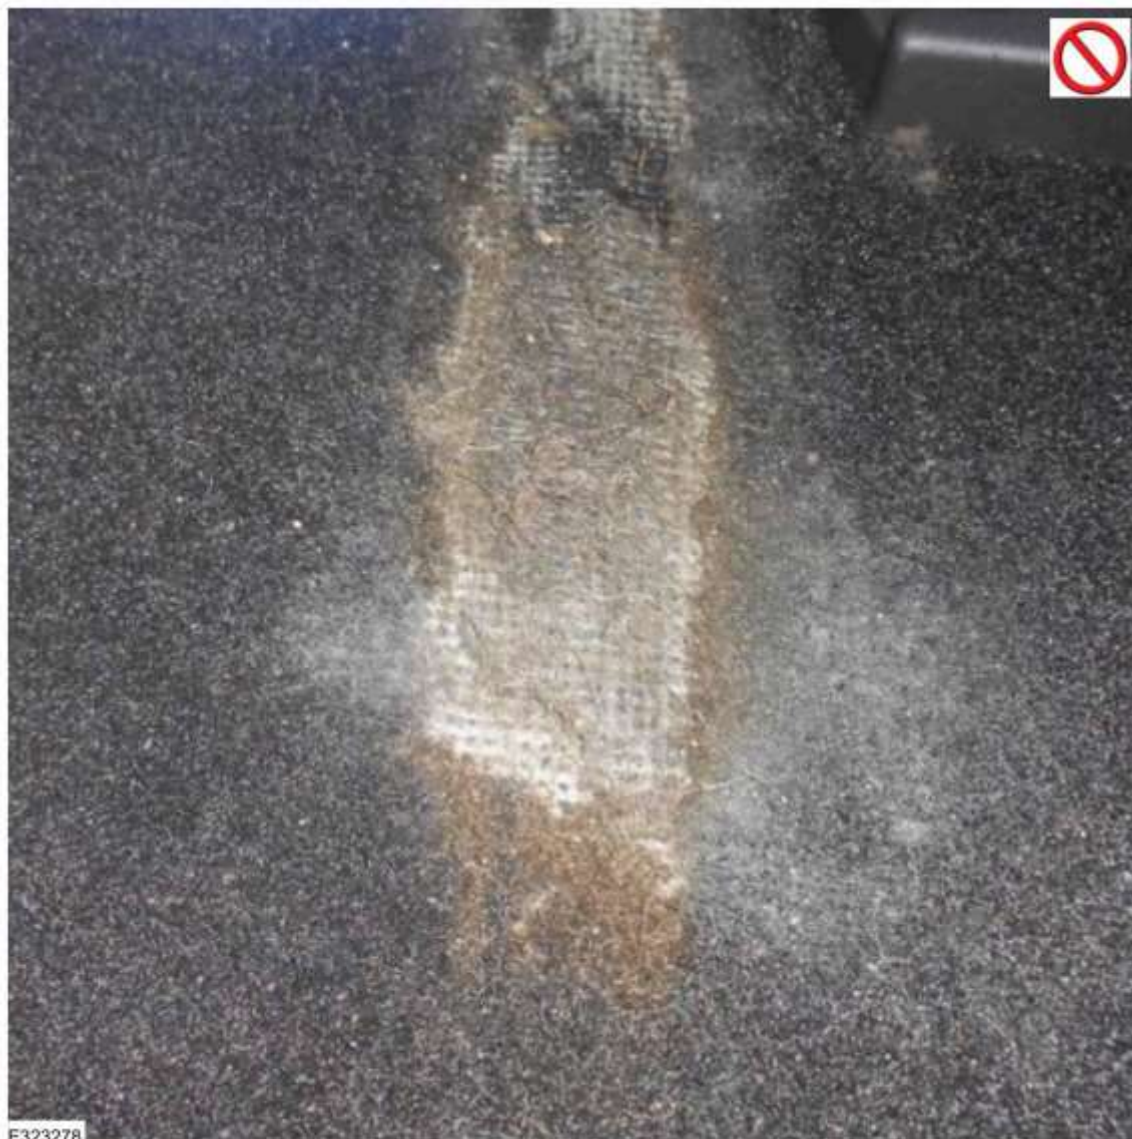
Figure 20

## Stains (Non-warrantable) (Figure 20)

**NOTE:** Abrasive liquid may dissolve carpet fibers.

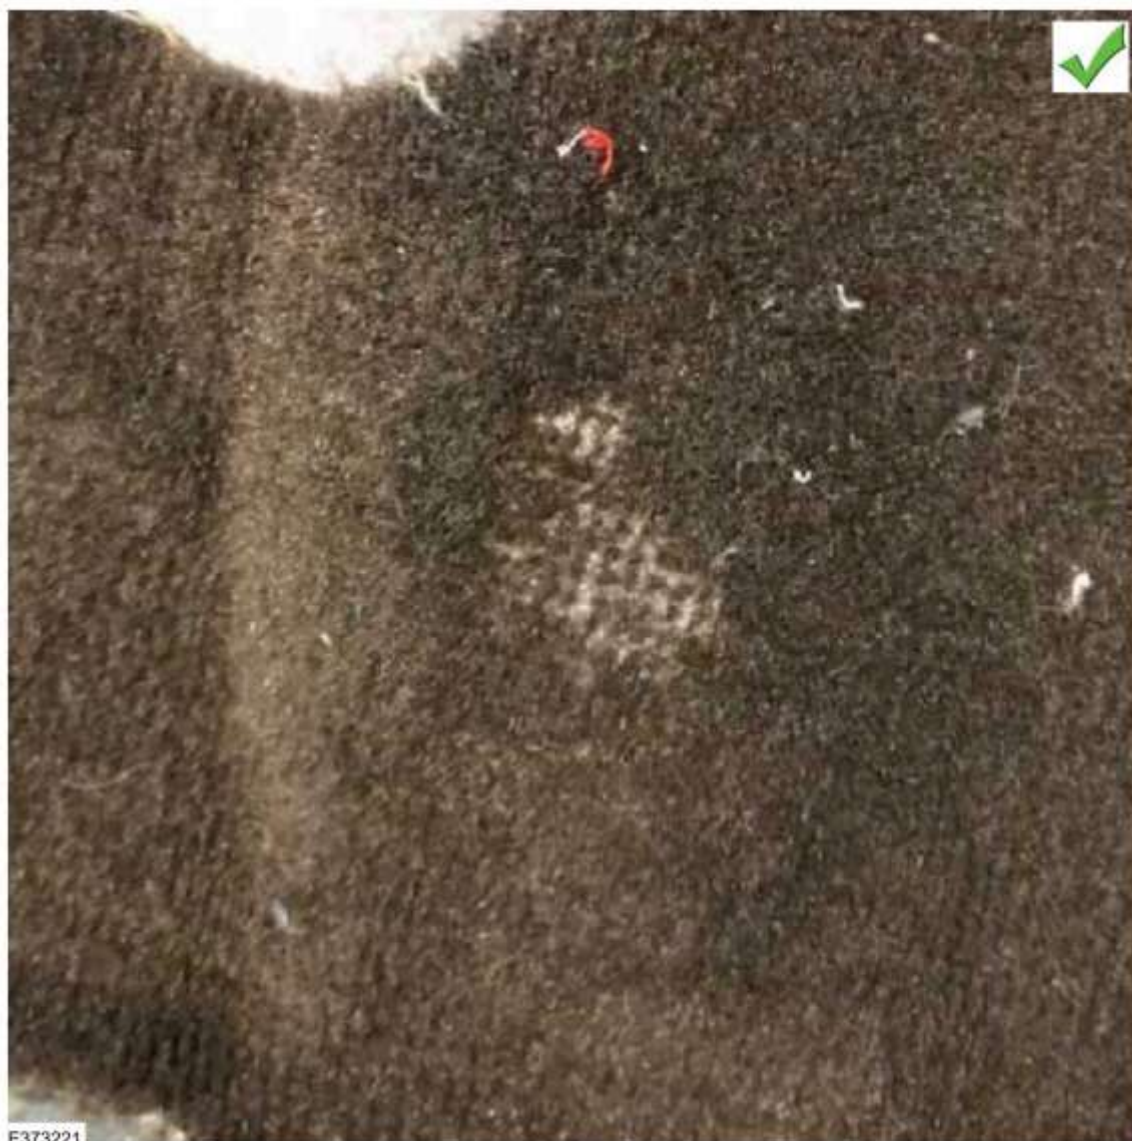
Figure 21

### **Carpet Matted Appearance (Warrantable) (Figure 21)**

**NOTE:** This appearance may be the result of depressed fibers. This can be corrected by cleaning and reanimating the fibers using a carpet/steam cleaner (with temperatures under 350 degrees Fahrenheit) in the area. If a carpet/steam cleaner is not available, this procedure can be sublet out to a local interior/detail shop. If a shop is not locally available, a steamer such as Rowenta steamer or equivalent can be purchased and used to correct this condition. This tool purchase should be claimed as an outside service part (OSP).

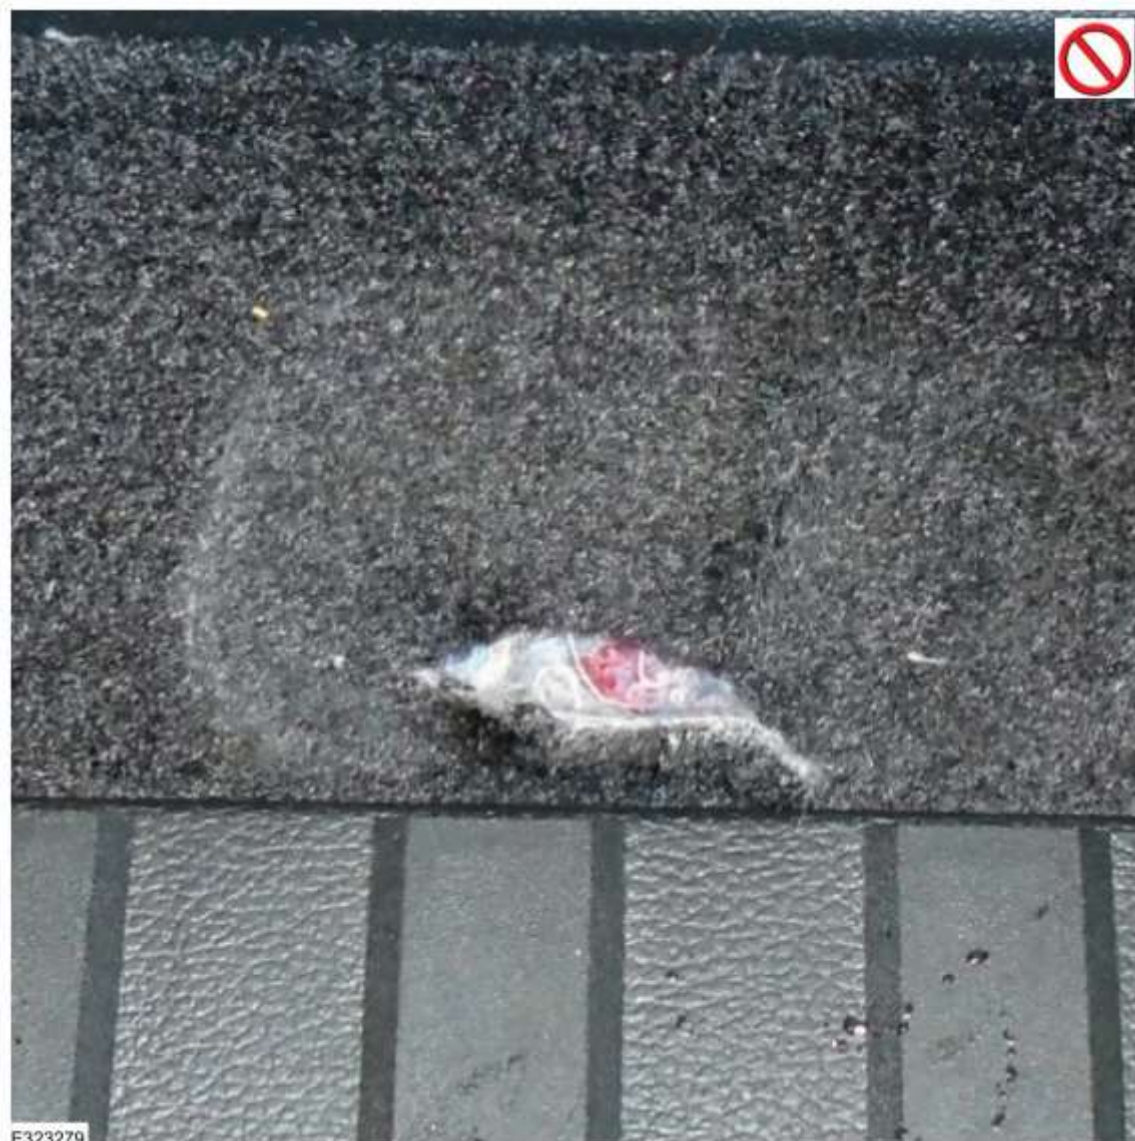
Figure 22

## **Carpet Cut (Non-warrantable) (Figure 22)**

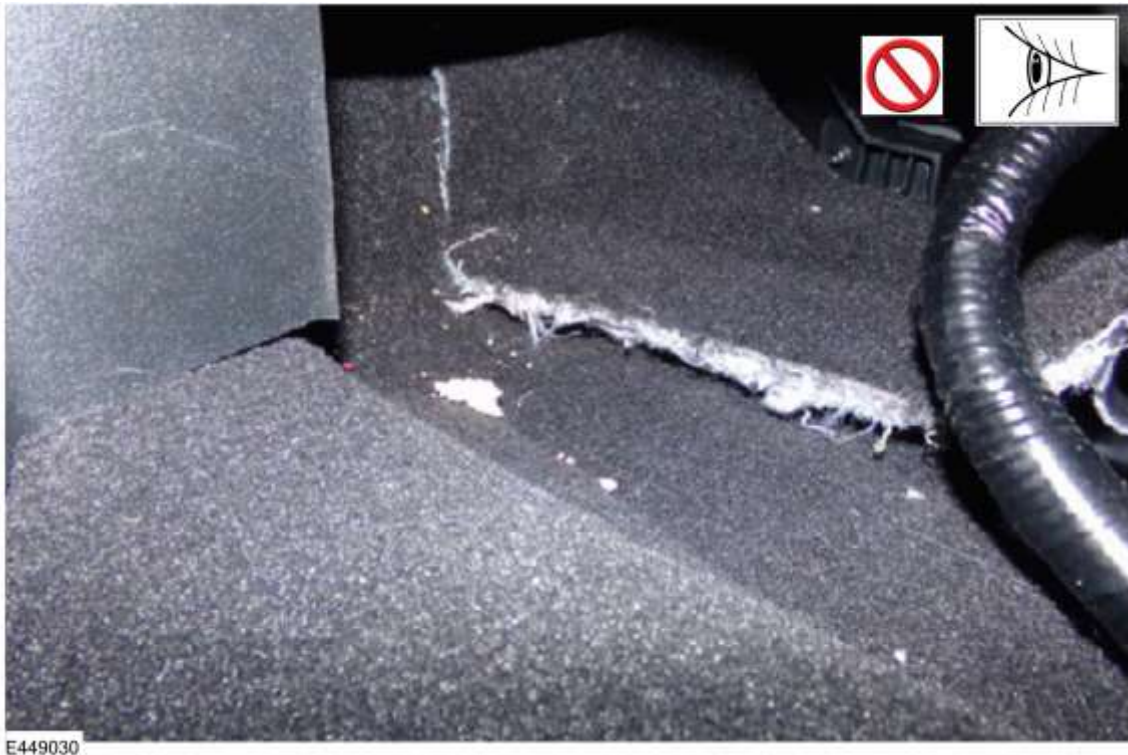
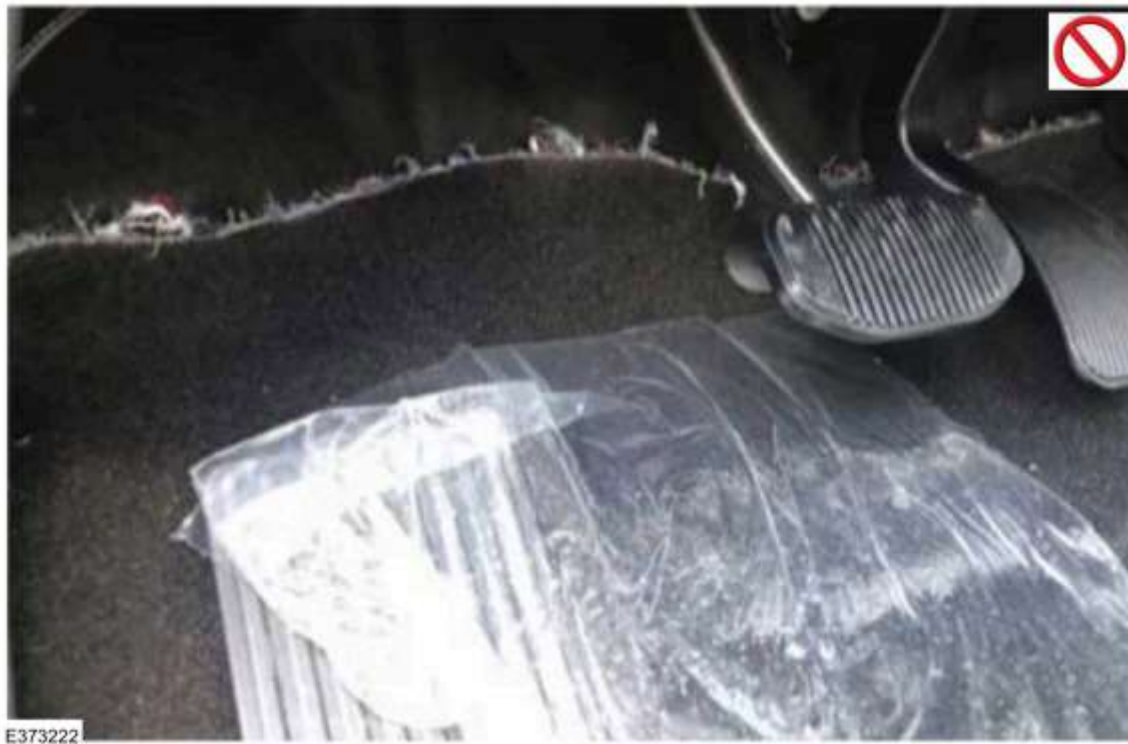
### **Carpet Edges Fraying (Non-warrantable) (Figures 23-24)**

**NOTE:** Carpet edges are typically unfinished and fraying may be a normal characteristic. Examples of this may include, but are not limited to, front/rear/side edges, overlapped edges, and cutouts. These can be improved by trimming with scissors to remove loose fibers. It is not necessary to replace the carpet for this condition.

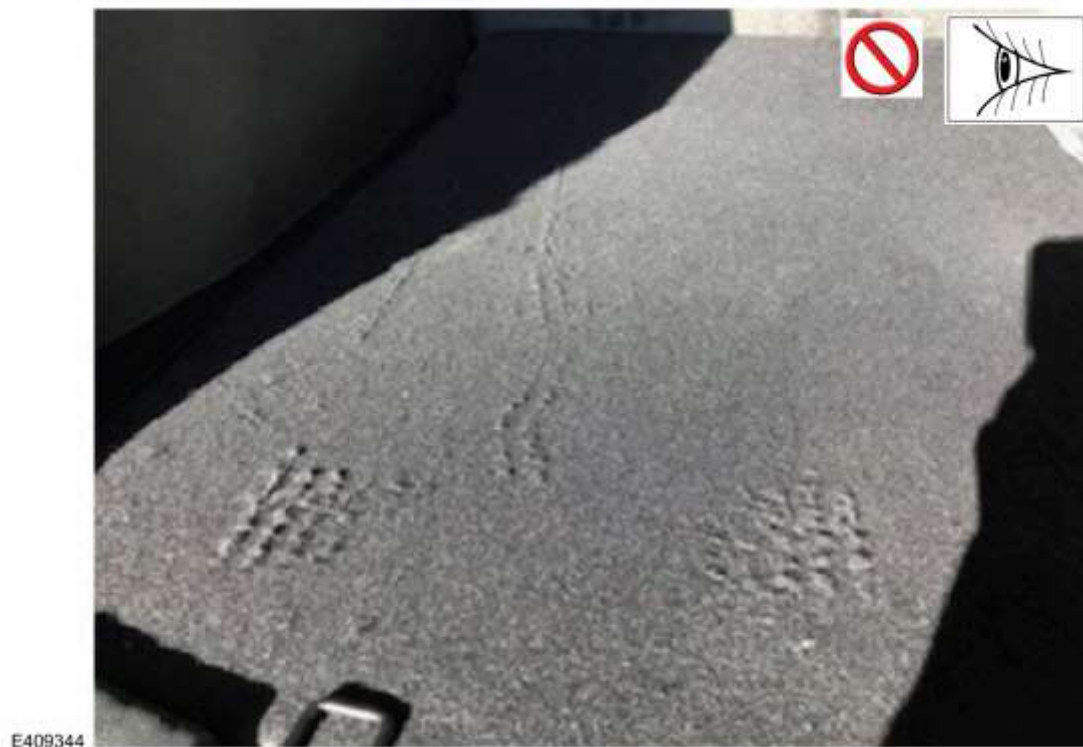
### **Carpet Pile Appearance (Non-warrantable) (Figures 25-26)**

Figure 25 - Frayed appearance can be corrected by mild brushing of the pile in a forward direction. This would be considered part of vehicle care and not eligible for warranty.

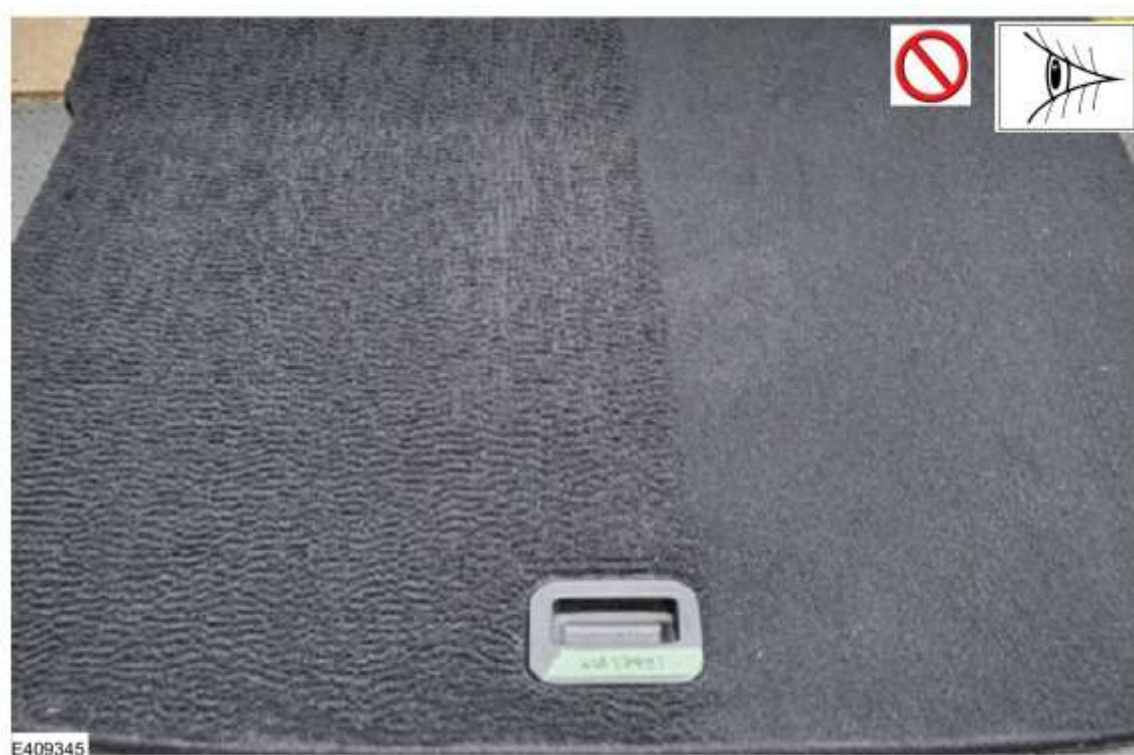
Figure 26 - Frayed appearance on left side of image can be corrected by mild brushing in a forward direction as seen on the right side.

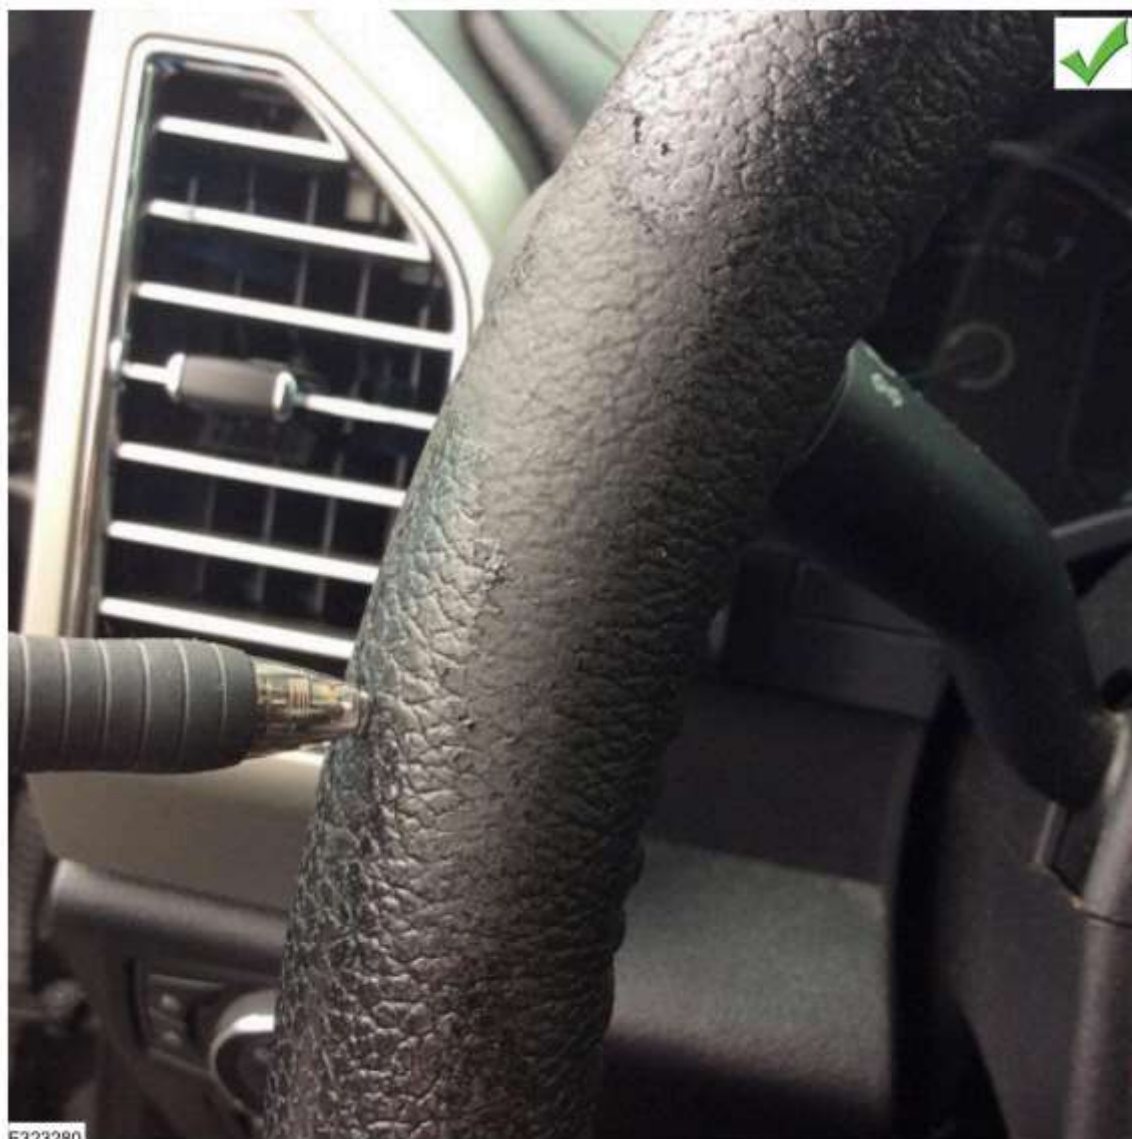
Figure 27

## Leather Steering Wheel Worn Or Peeling (Warrantable) (Figure 27)

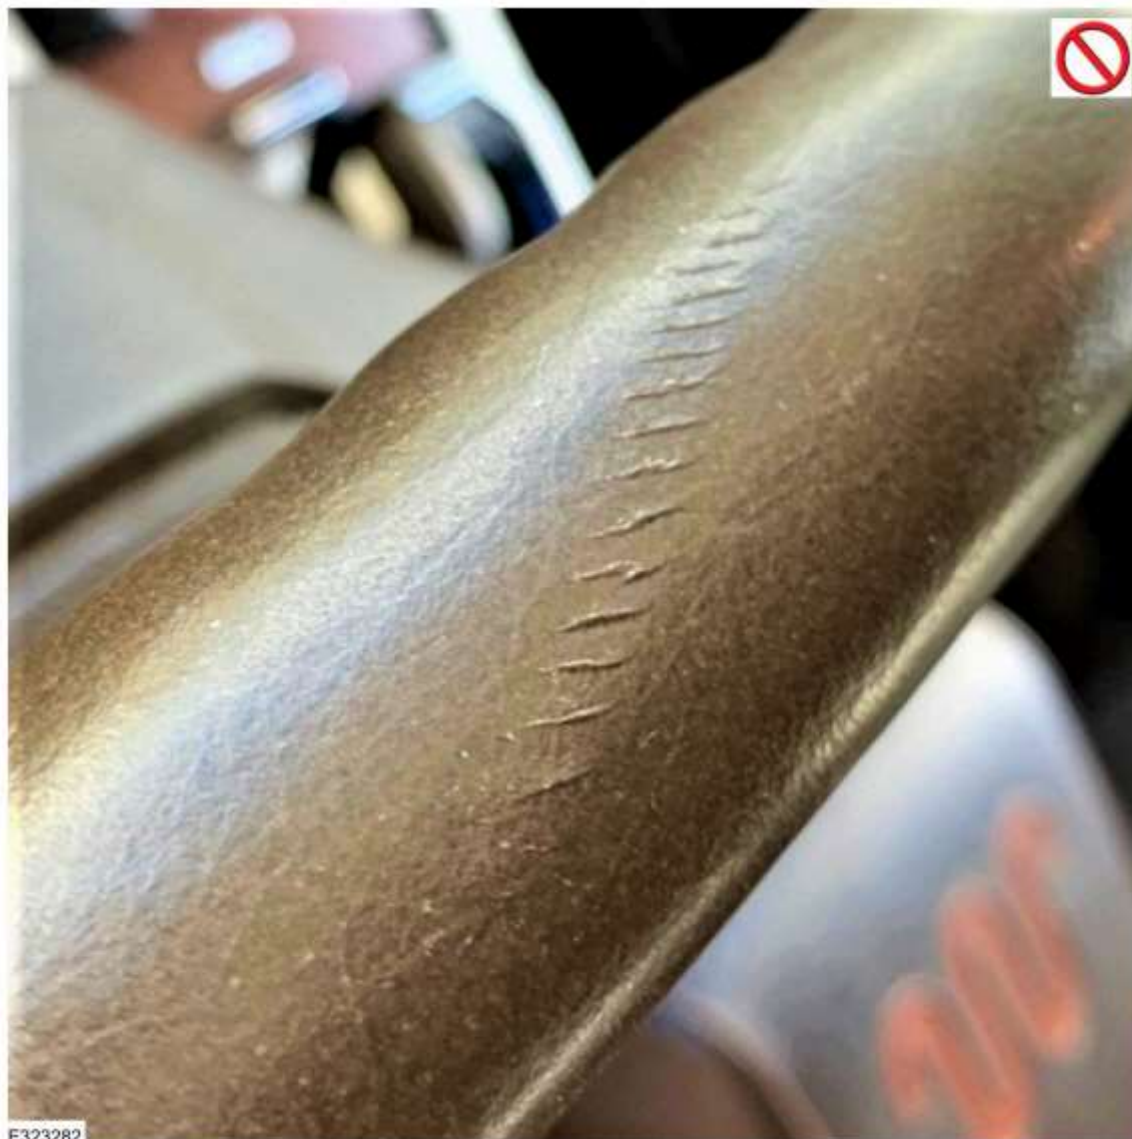
Figure 29

## Steering Wheel Abrasion (Non-warrantable) (Figure 29)

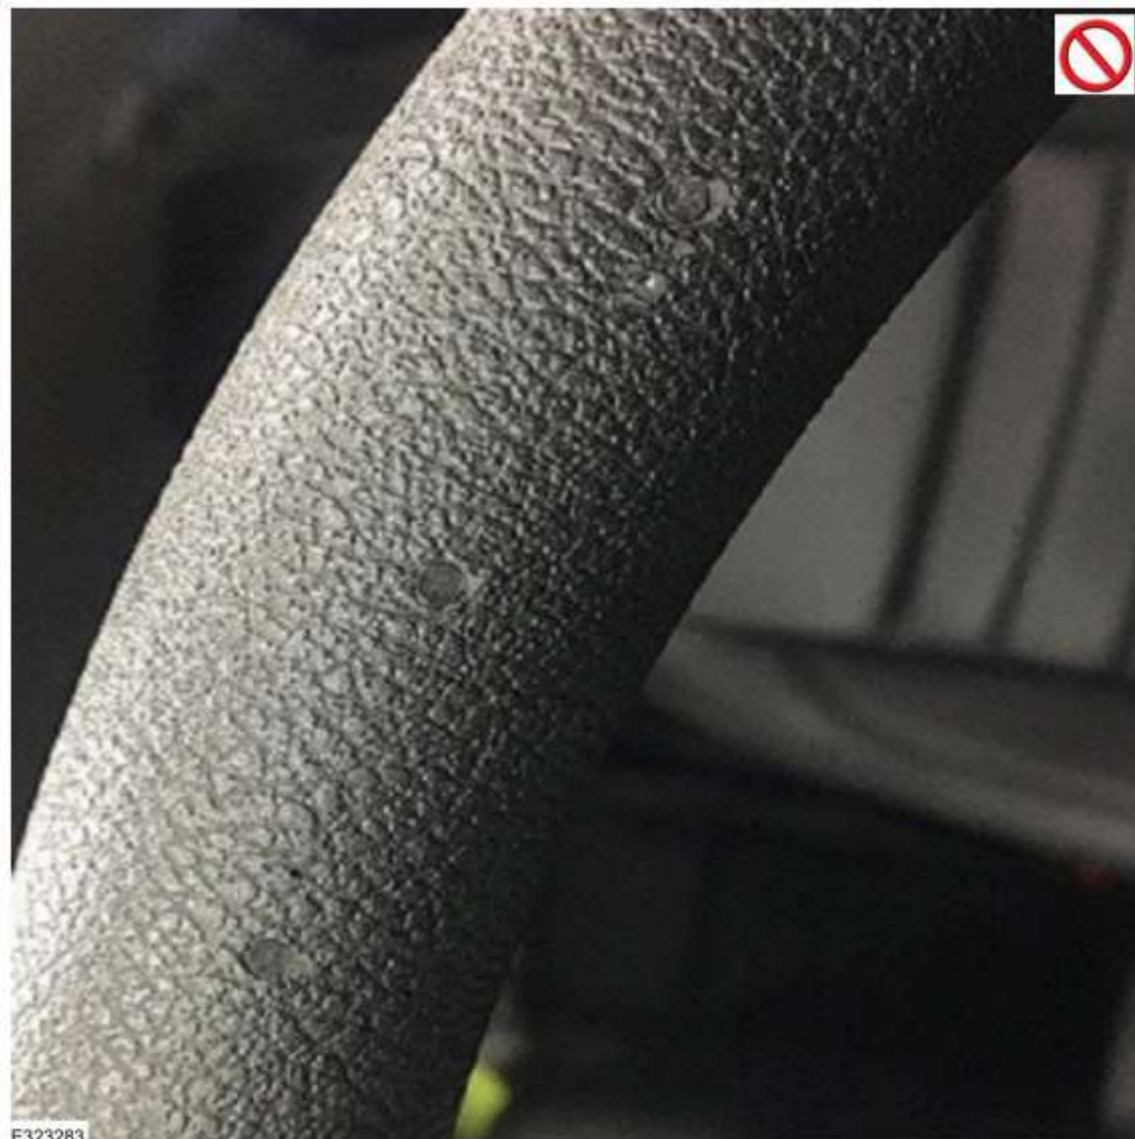
Figure 30

### Urethane Steering Wheel Mold Marks (Non-warrantable) (Figure 30)

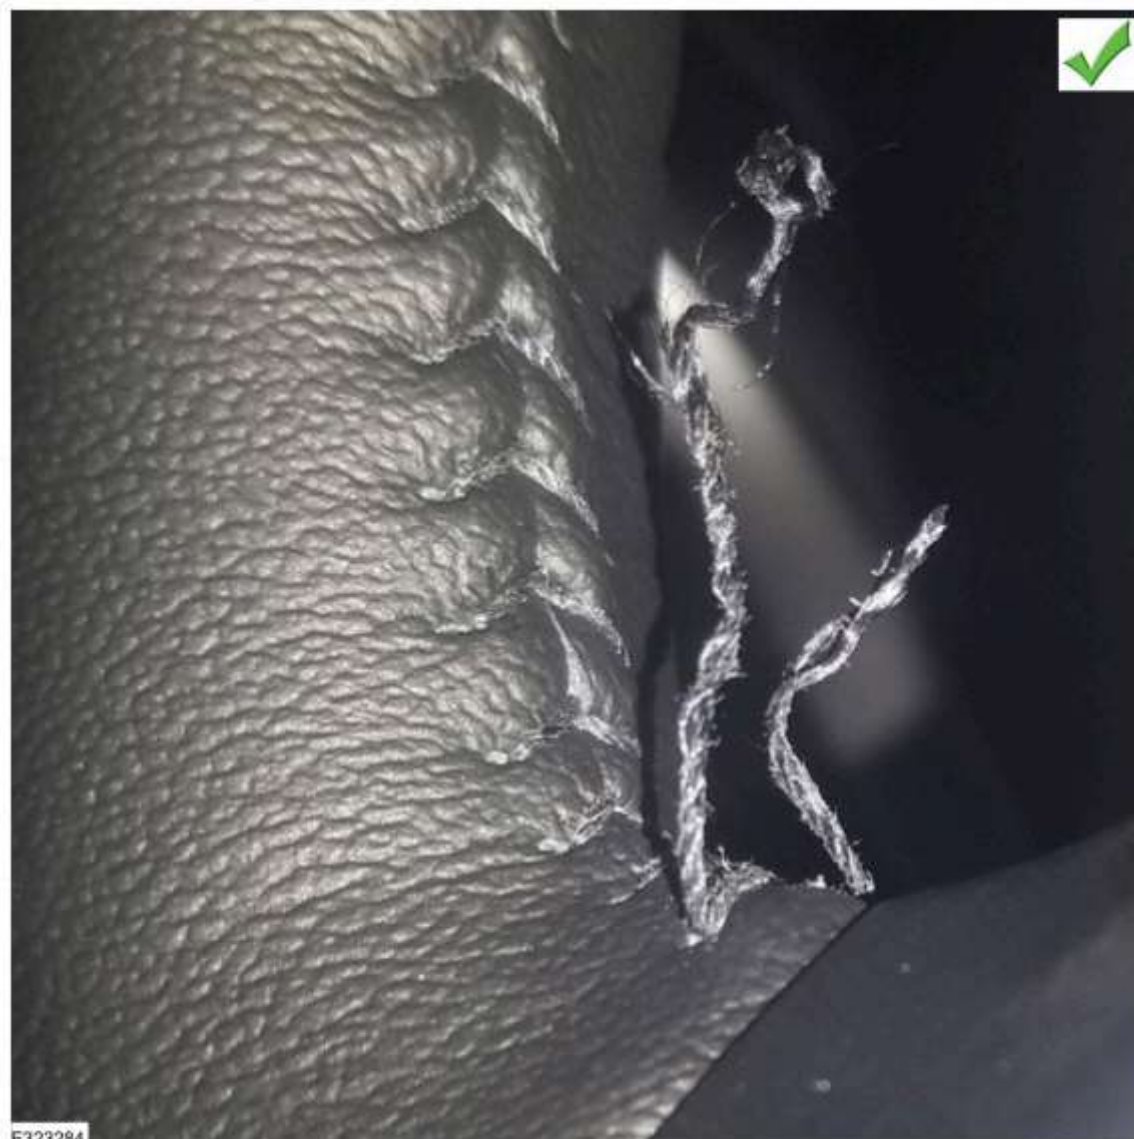
Figure 31

**Leather Steering Wheel Loose Thread, Originates At The Knotted End Of The Thread (Warrantable) (Figure 31)**

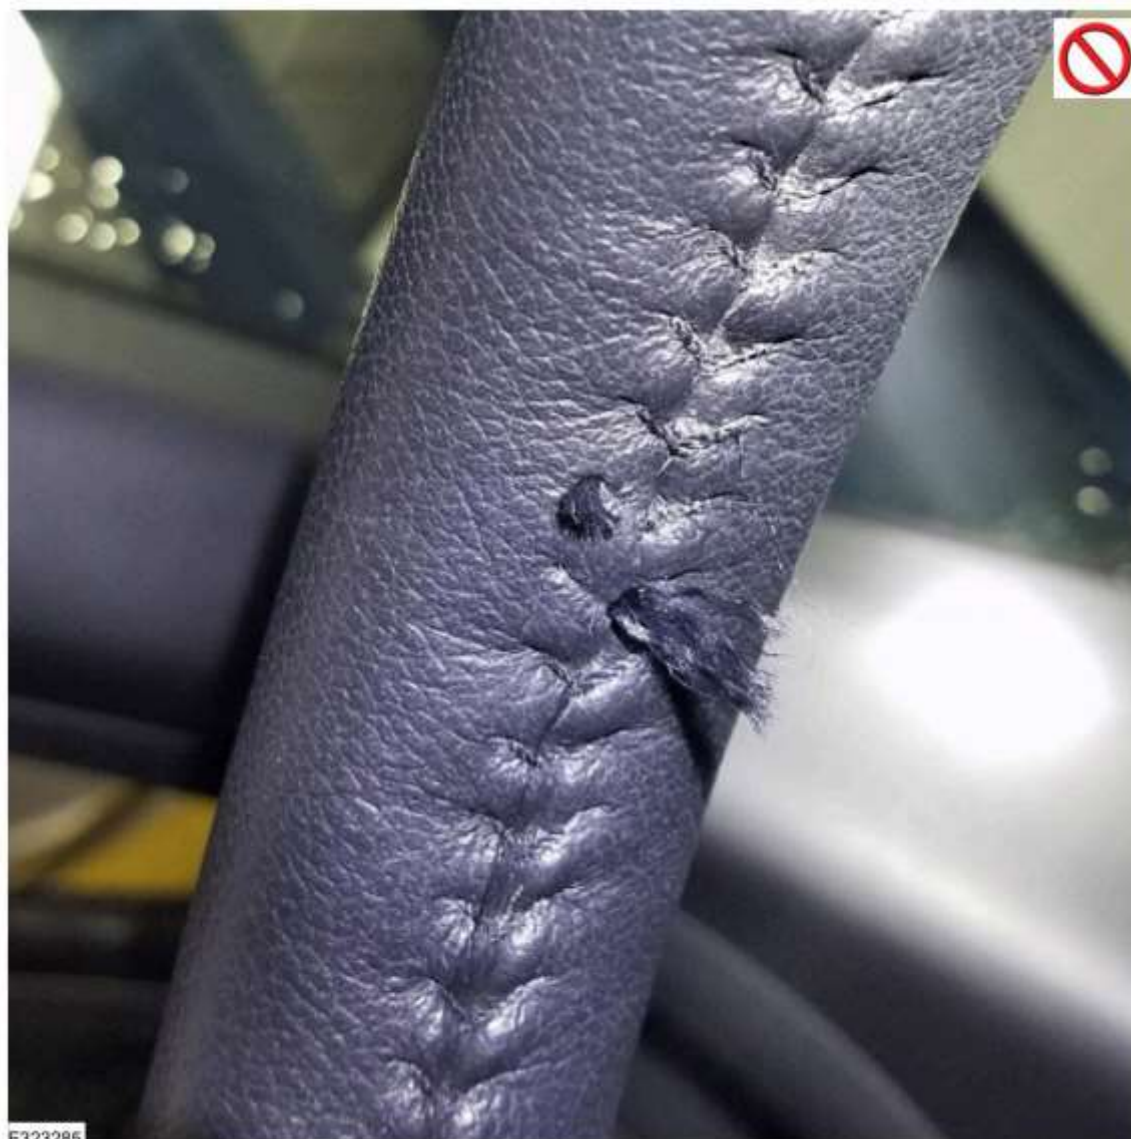
Figure 32

### **Leather Steering Wheel Cut Thread (Non-warrantable) (Figure 32)**

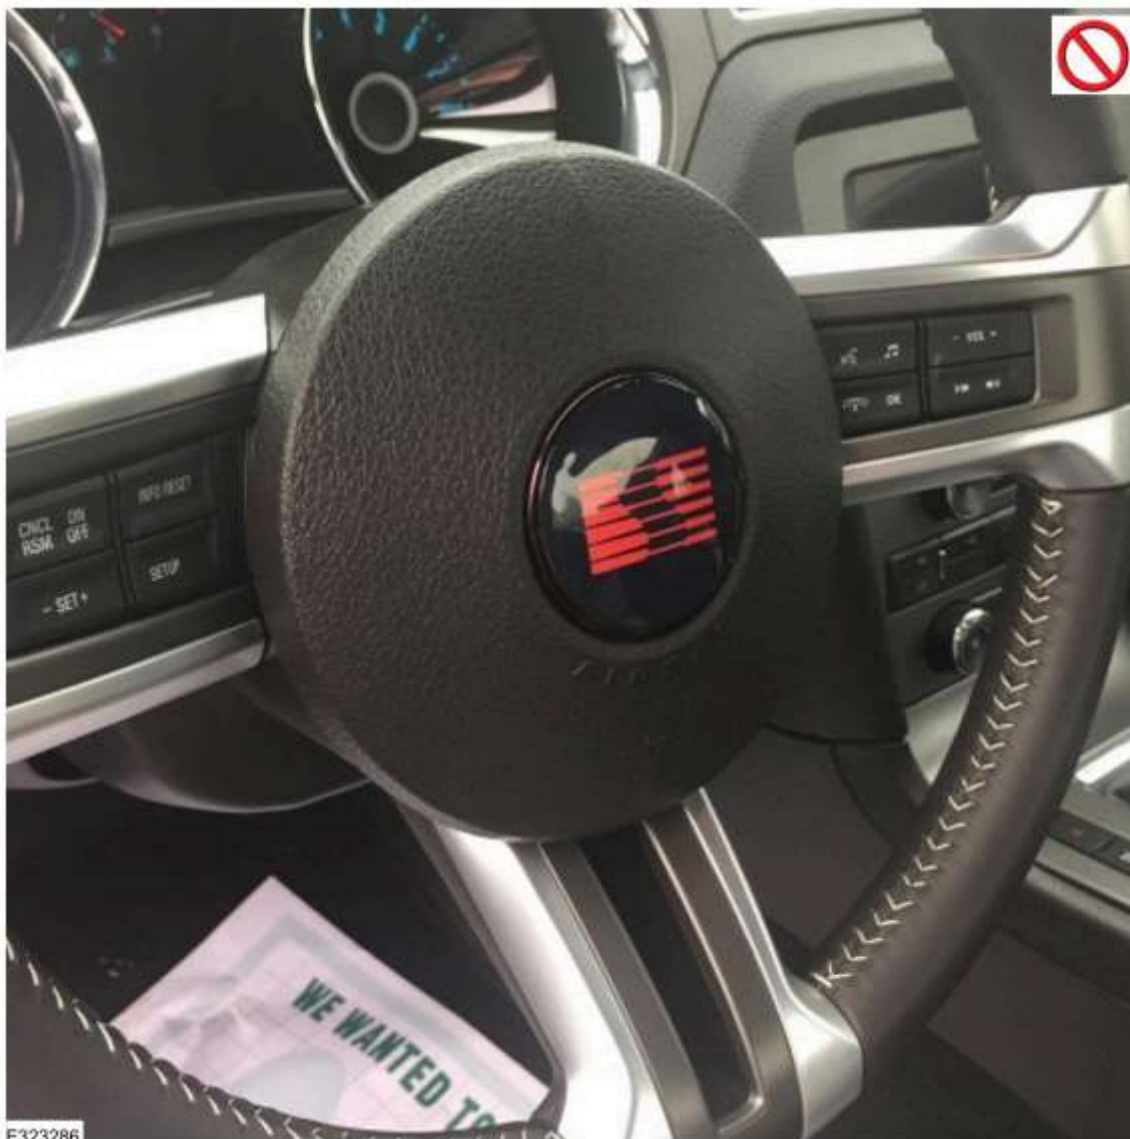
Figure 33

### **Steering Wheel Modification (Non-warrantable) (Figure 33)**

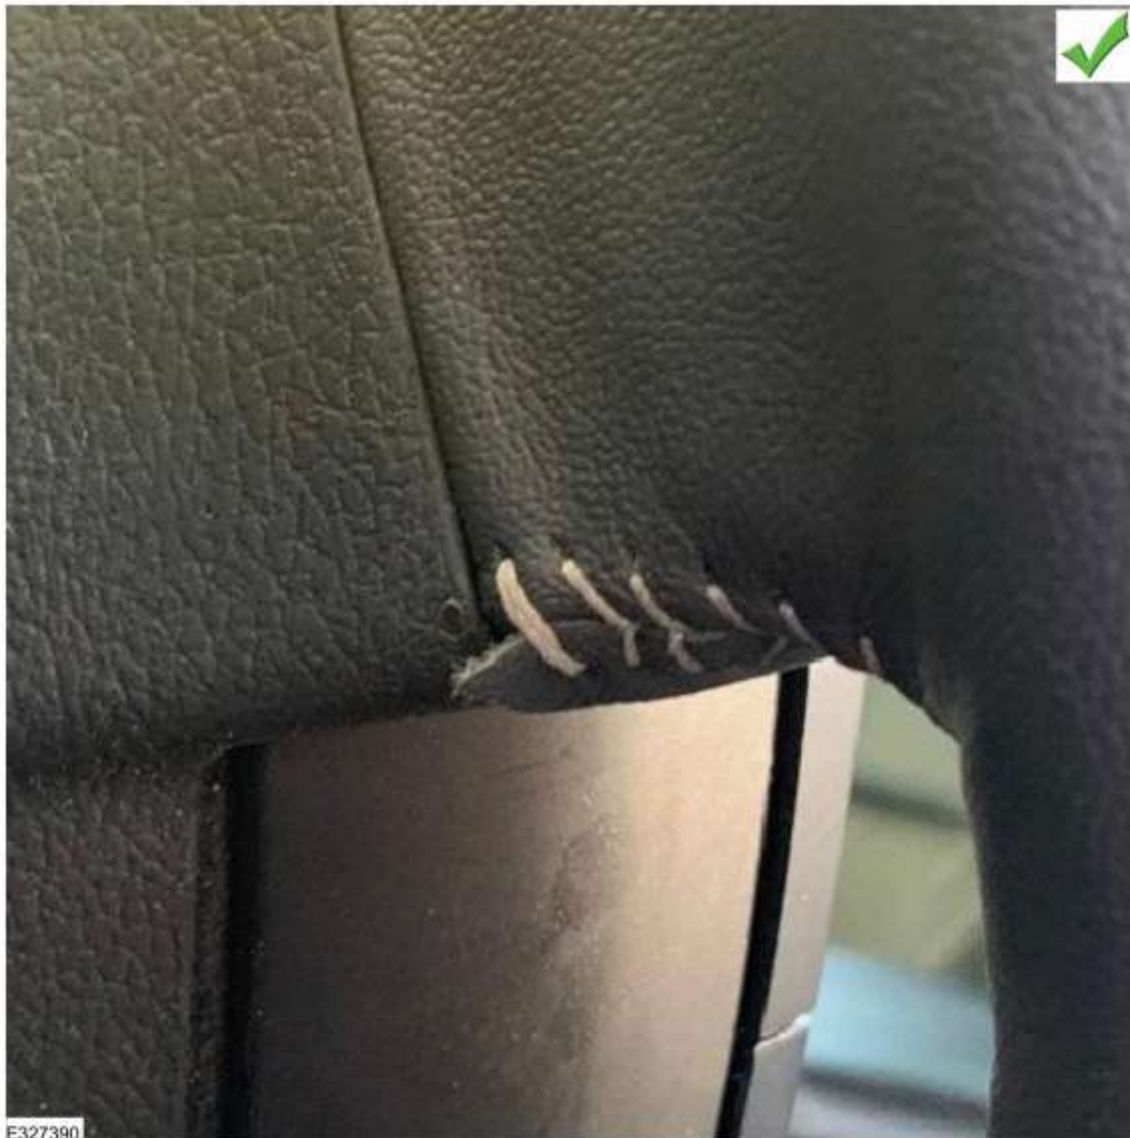
Figure 34

### Steering Wheel Cover Repair (Warrantable) (Figure 34)

Can be repaired per the Workshop Manual.

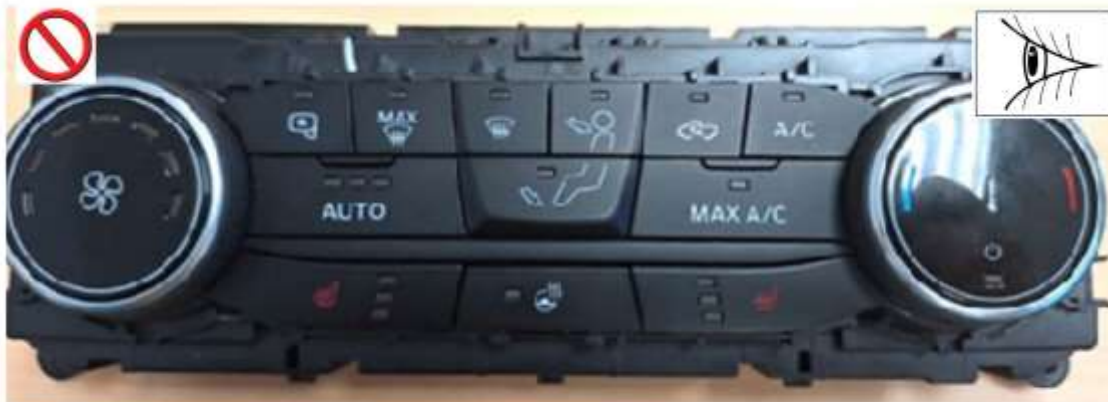
Figure 35

### Sticking Knobs And Switches (Non-warrantable) (Figures 35-36)

Interior control assemblies returned with sticking knobs and switches from contamination are subject to warranty review and adjustment.
