TECHNICAL SERVICE BULLETIN

Unable To Update The APIM, TCU Or GWM With The FDRS And USB Drive - Module Recovery

22-2404

Ford 2021 Bronco
2021 Edge
2021 F-150
2021 Mustang Mach-E
Lincoln 2021 Nautilus

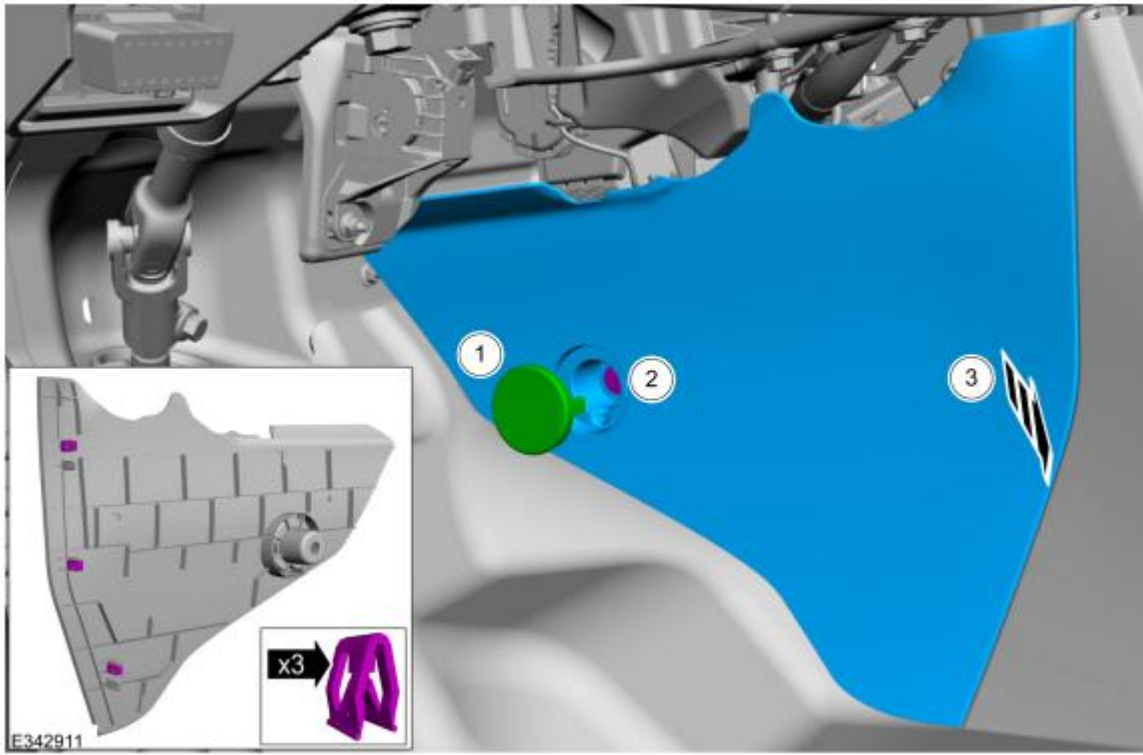
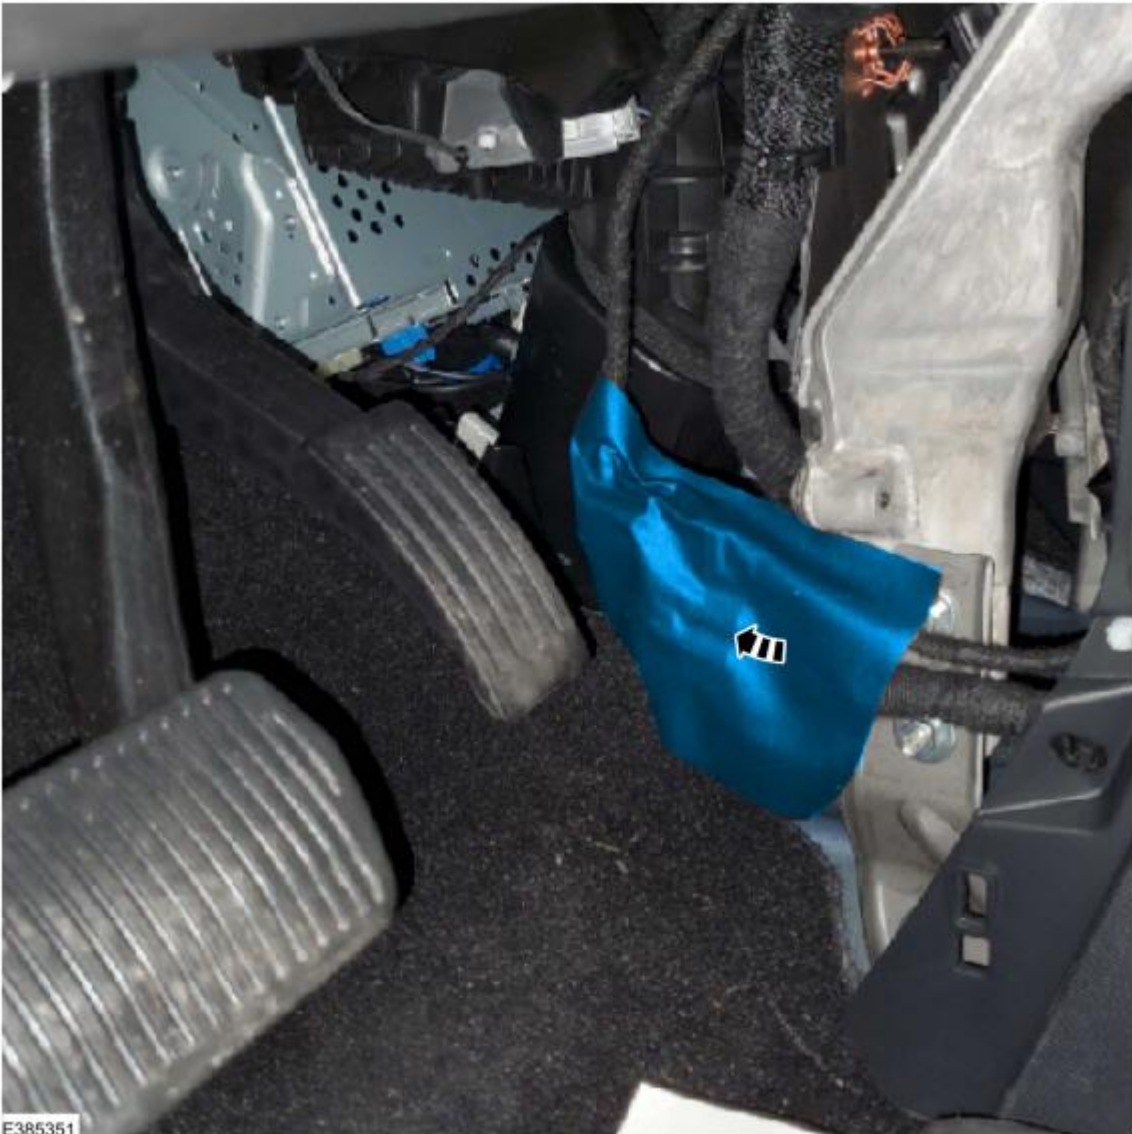
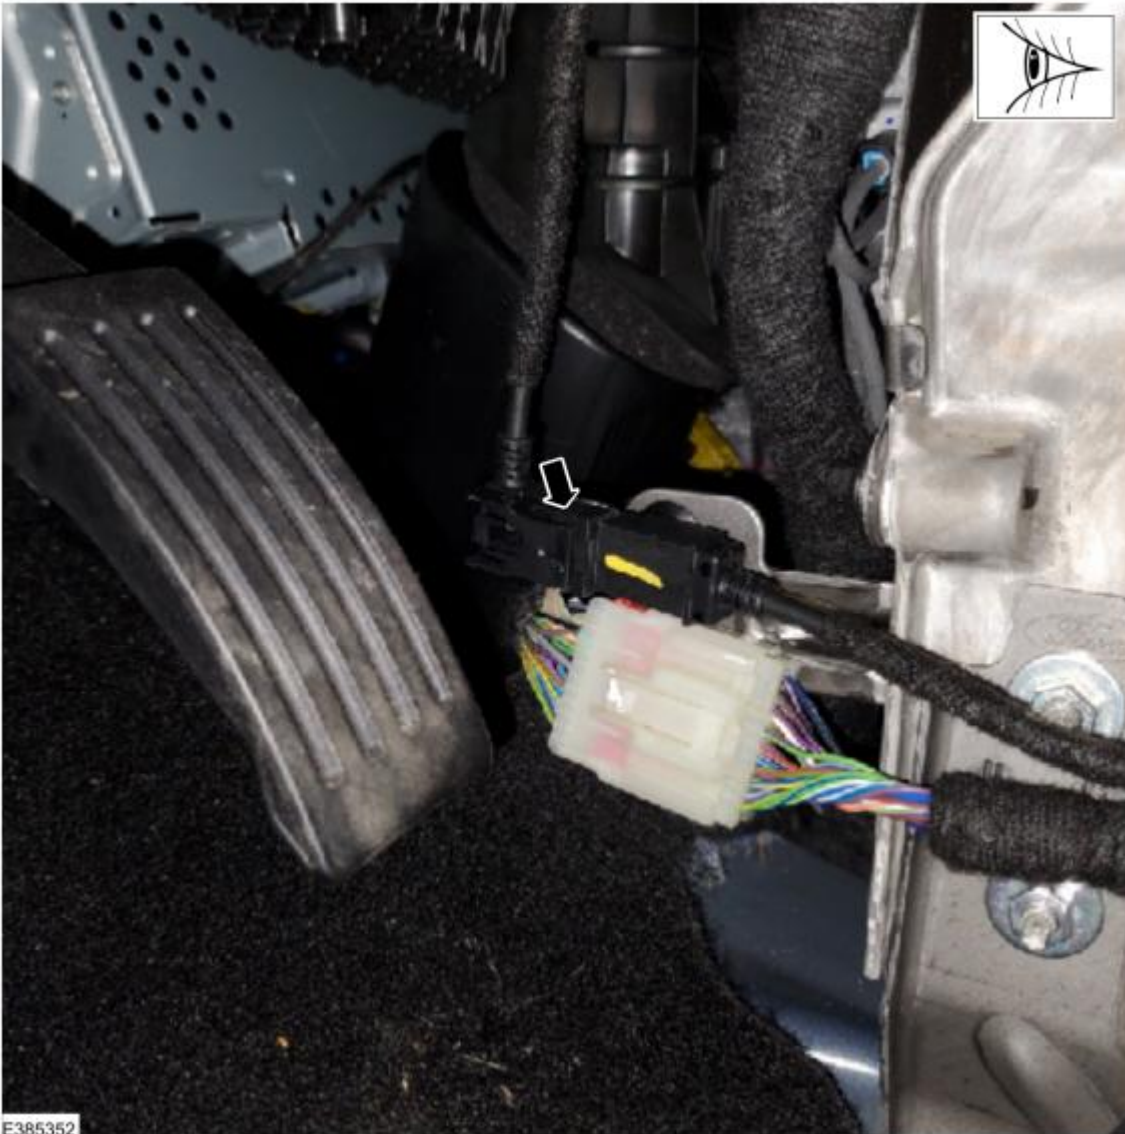
5. For Mustang Mach-E, Nautilus, and F-150 vehicles equipped with a SYNC Media hub, access the APIM in-line USB connector.
 - (1). For Mustang Mach-E vehicles, remove the left-hand side floor console front trim panel and disconnect the APIM in-line USB connector. The connector may be concealed by tape. Refer to Step 4 in the WSM Section 501-12 floor console removal. (Figures 1-3)

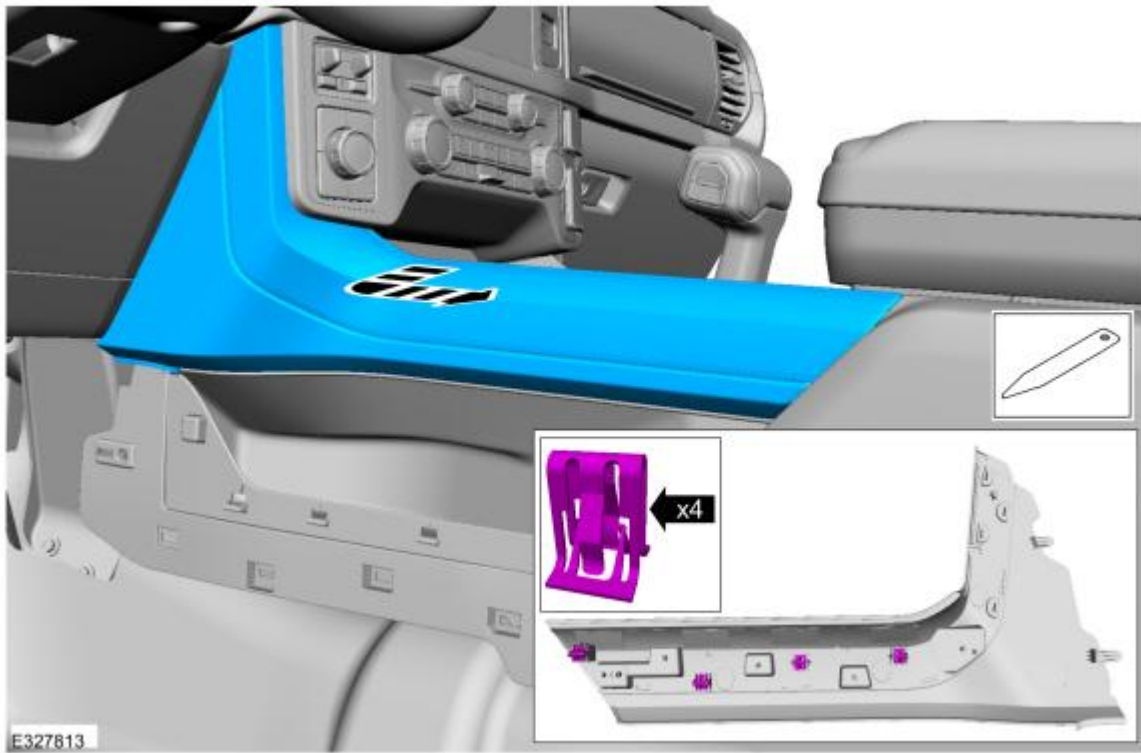
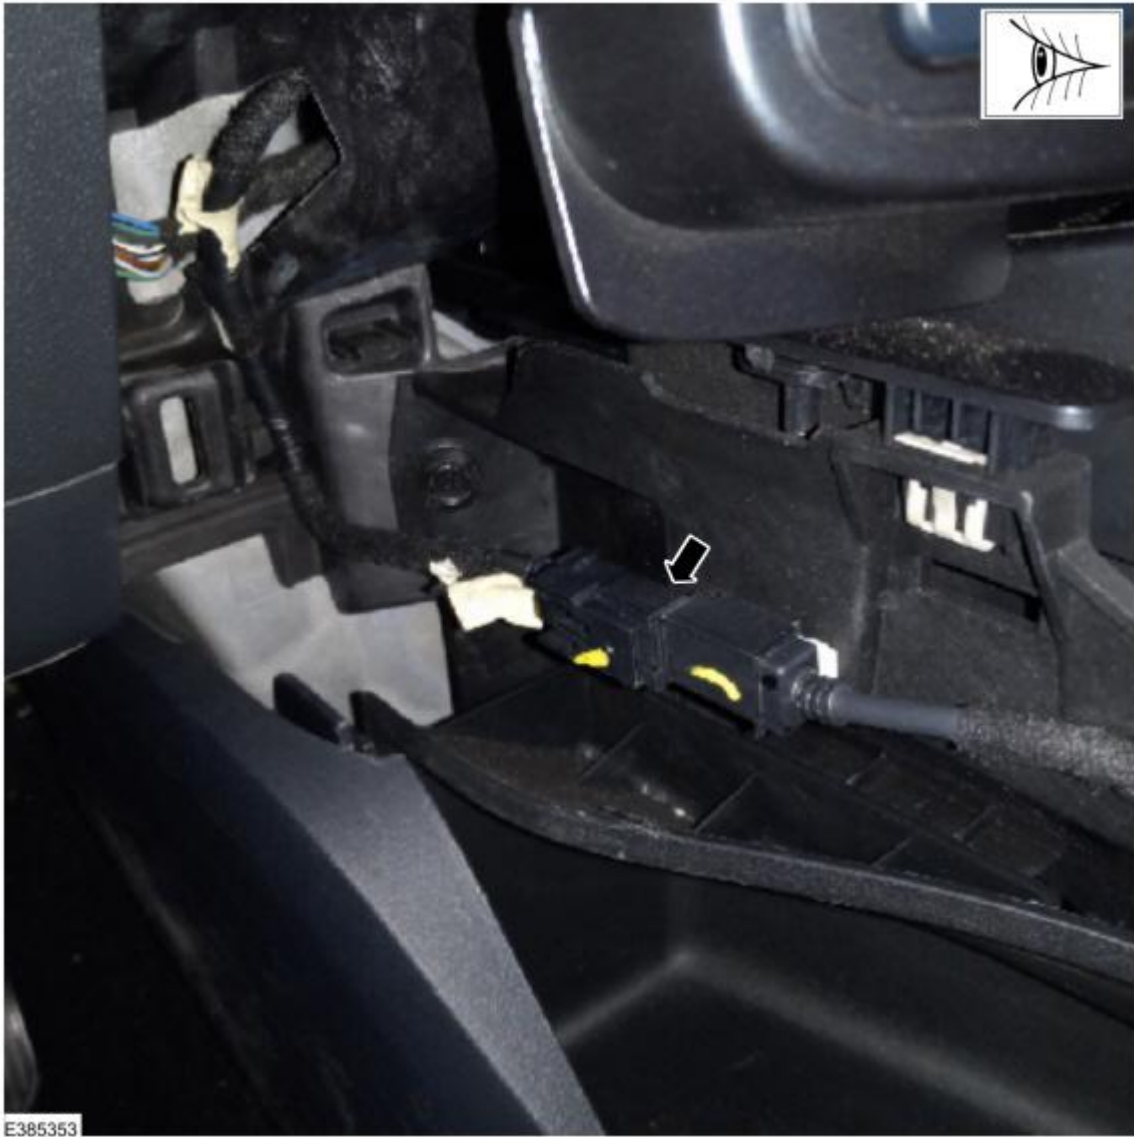
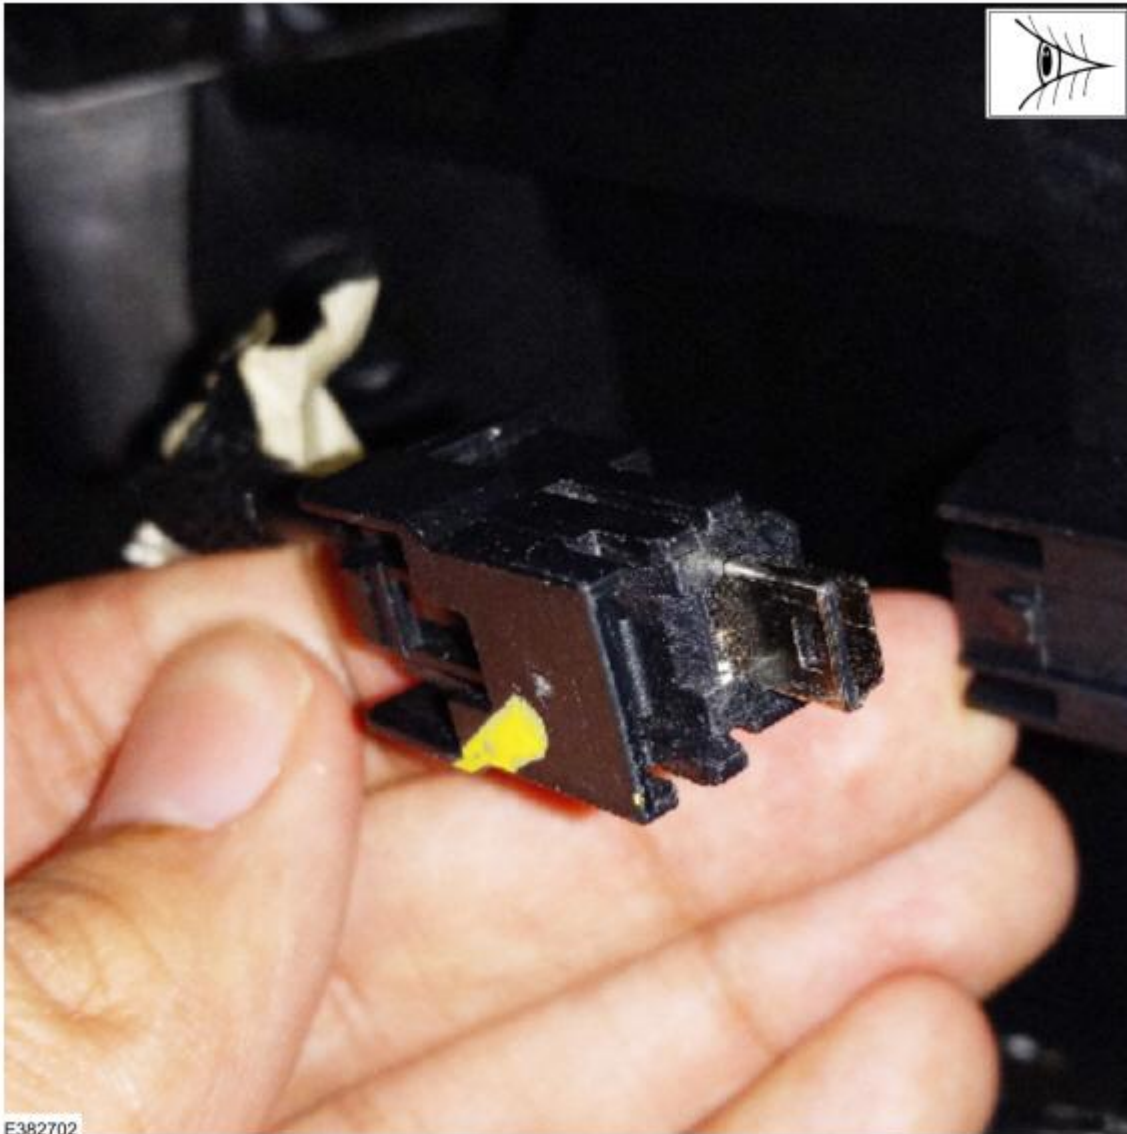
(2). For F-150 vehicles with a SYNC media hub and center console, remove the floor console lower left hand trim panel and disconnect the APIM in-line USB connector. Refer to Step 5 in Workshop Manual (WSM), Section 501-12 floor console removal. (Figures 4-6)

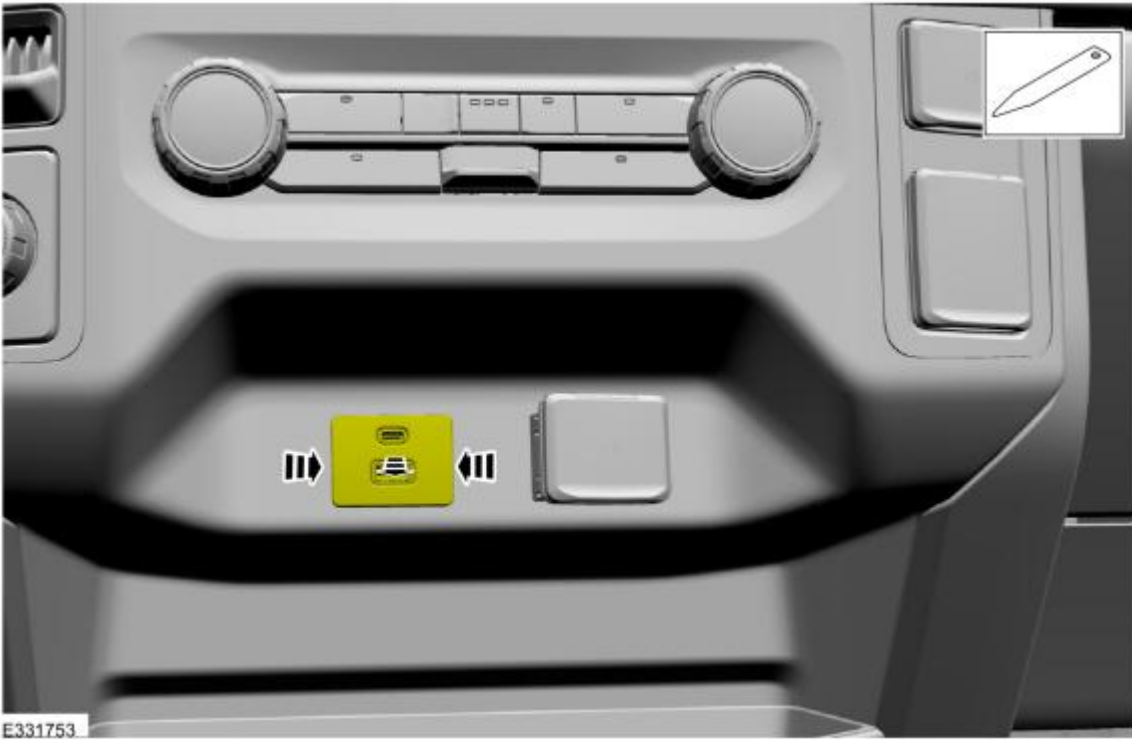
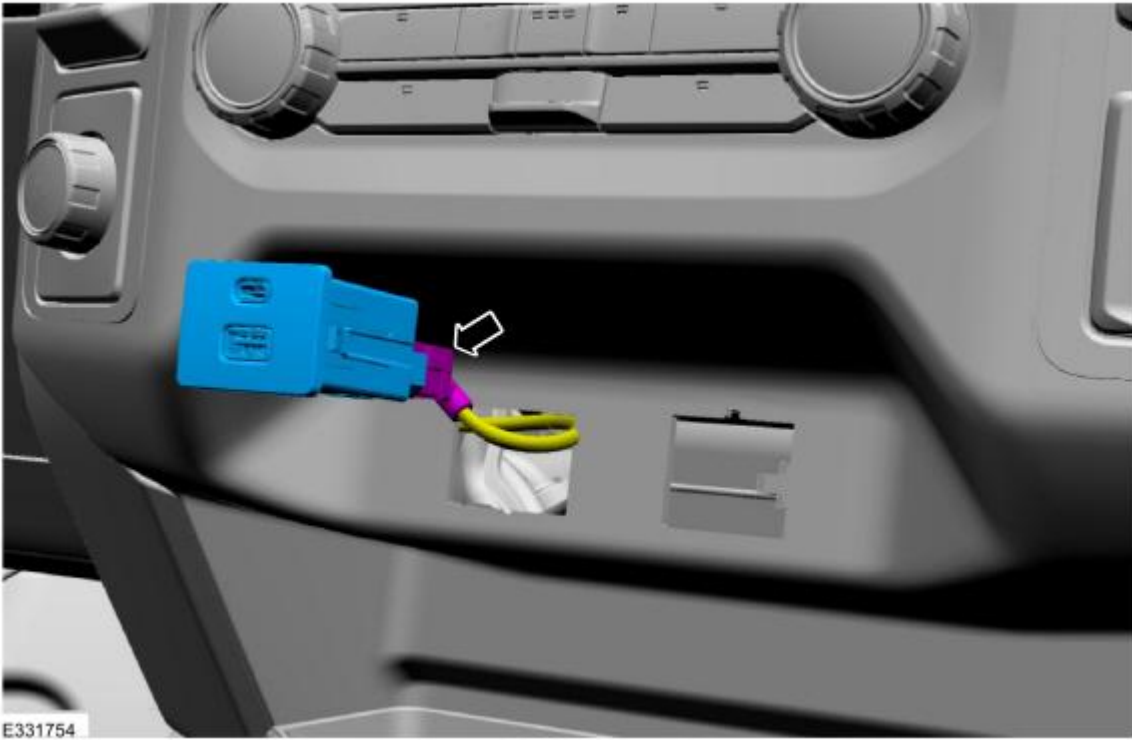
(3). For F-150 vehicles with the SYNC media hub and no center console, disconnect the SYNC media hub mini-USB connector from the back of the media hub. On some F-150 vehicles, media hub removal may not be required and the mini-USB connector can be accessed from the back of the instrument panel. Refer to Step 2 in Workshop Manual (WSM), Section 415-00 Universal Serial Bus (USB) Hub removal. (Figures 7-8)

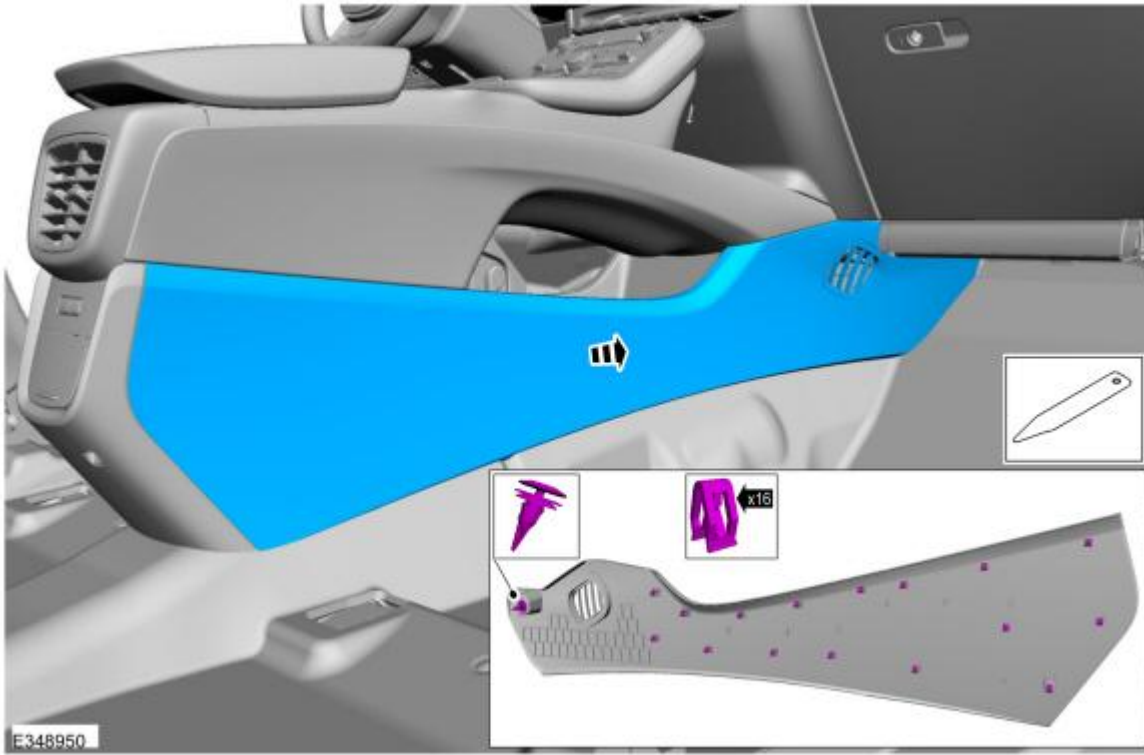
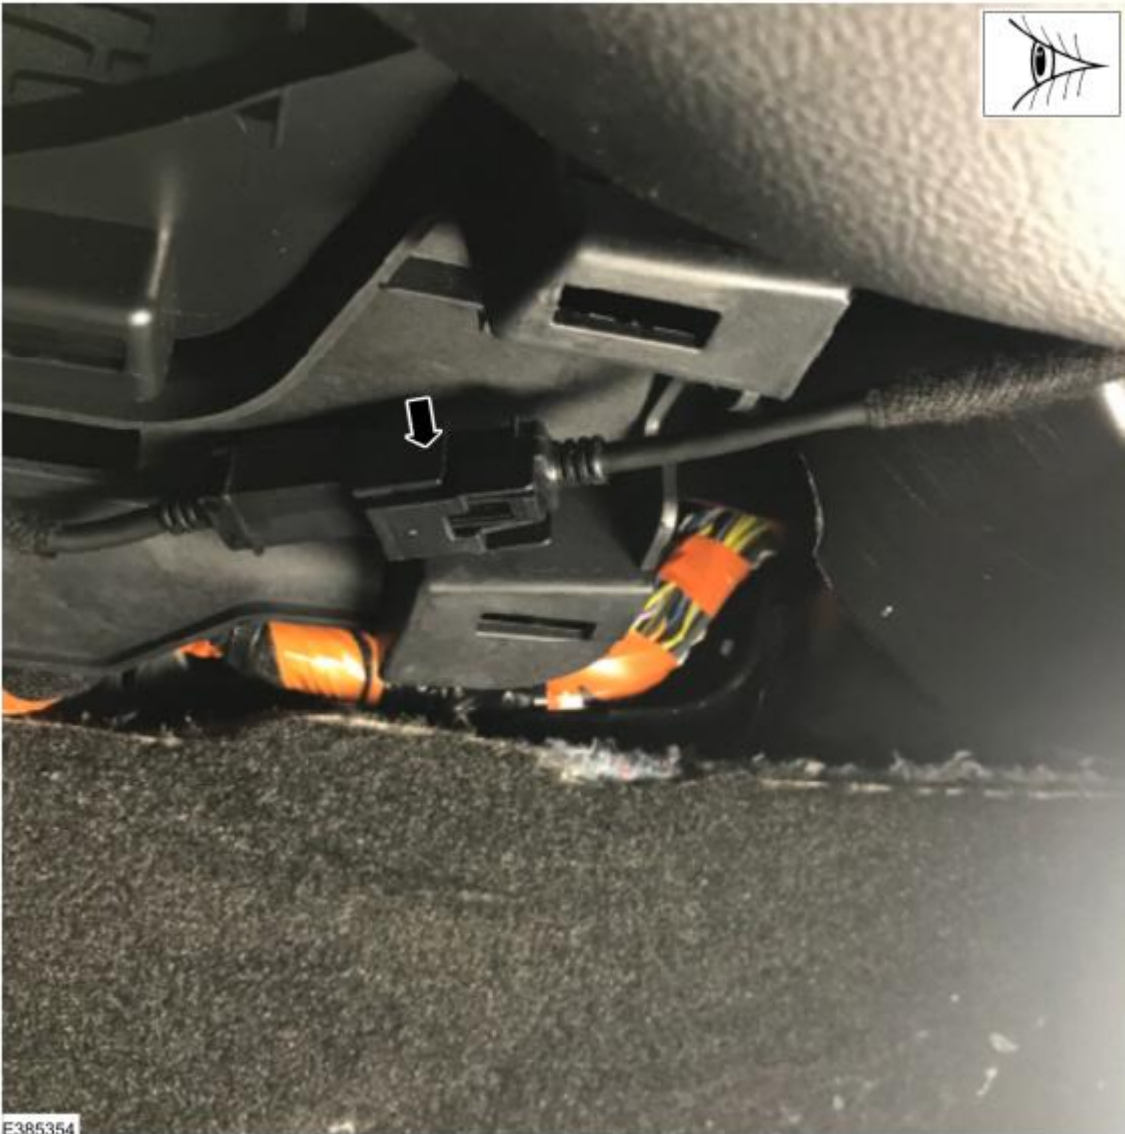
(4). For Nautilus vehicles, remove the floor console lower right hand trim panel and disconnect the APIM in-line USB connector. Refer to Step 1 in Workshop Manual (WSM), Section 501-12 floor console removal. (Figures 9-10)

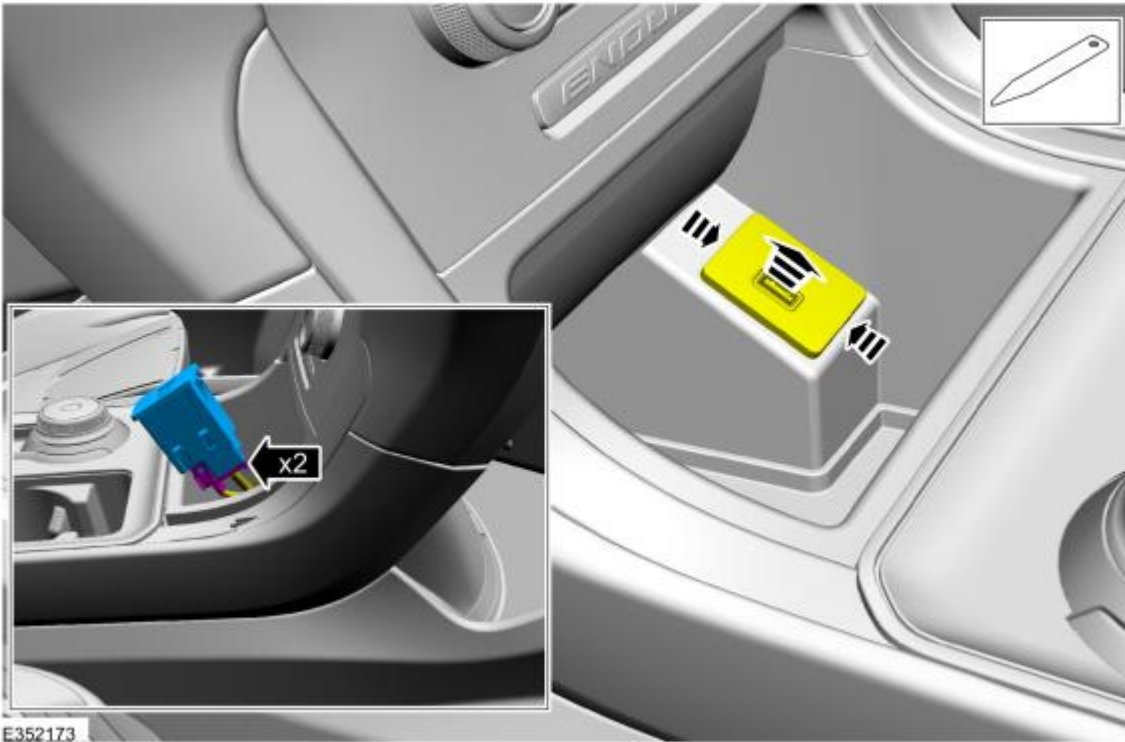
Figure 11

(5). For Edge vehicles, remove the SYNC media hub and disconnect the mini-USB connector on the back of the media hub. Refer to Step 1 in Workshop Manual (WSM), Section 415-00 Media Hub removal. (Figure 11)

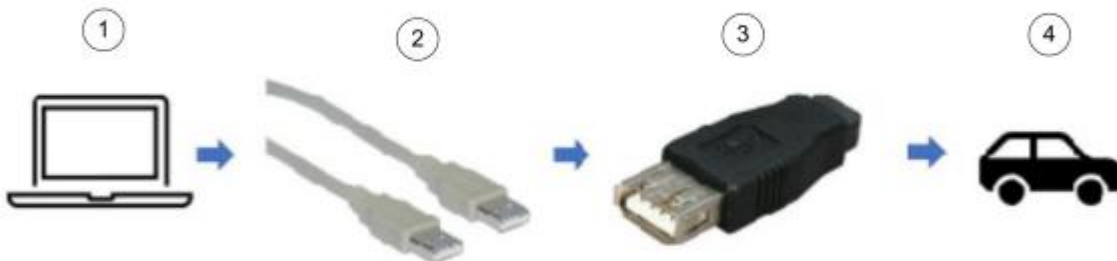
Figure 12

- Mustang Mach-E, Edge, Nautilus, Bronco and F-150 vehicles equipped with a SYNC Media hub:
 - Connect the Mini B 5-pin female adapter to the vehicle harness.
 - Connect the USB 2 Cable - male-to-male to the female adapter and the laptop USB port.

Item	Description
1	FDRS
2	USB 2 Cable (male-to-male)
3	Mini B 5-pin female adapter
4	Vehicle harness

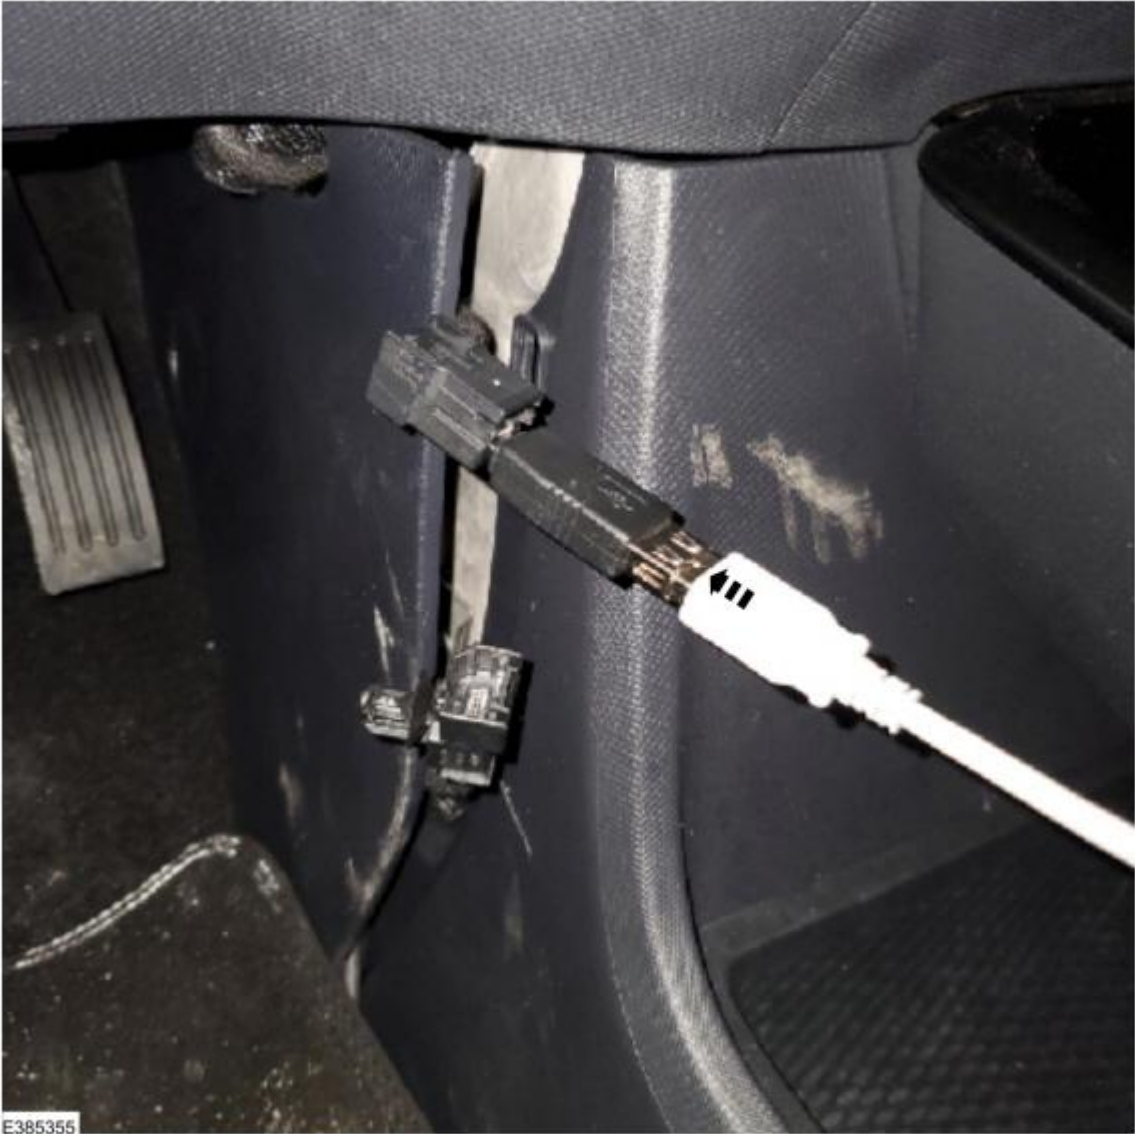
Figure 13 - Mustang Mach-E

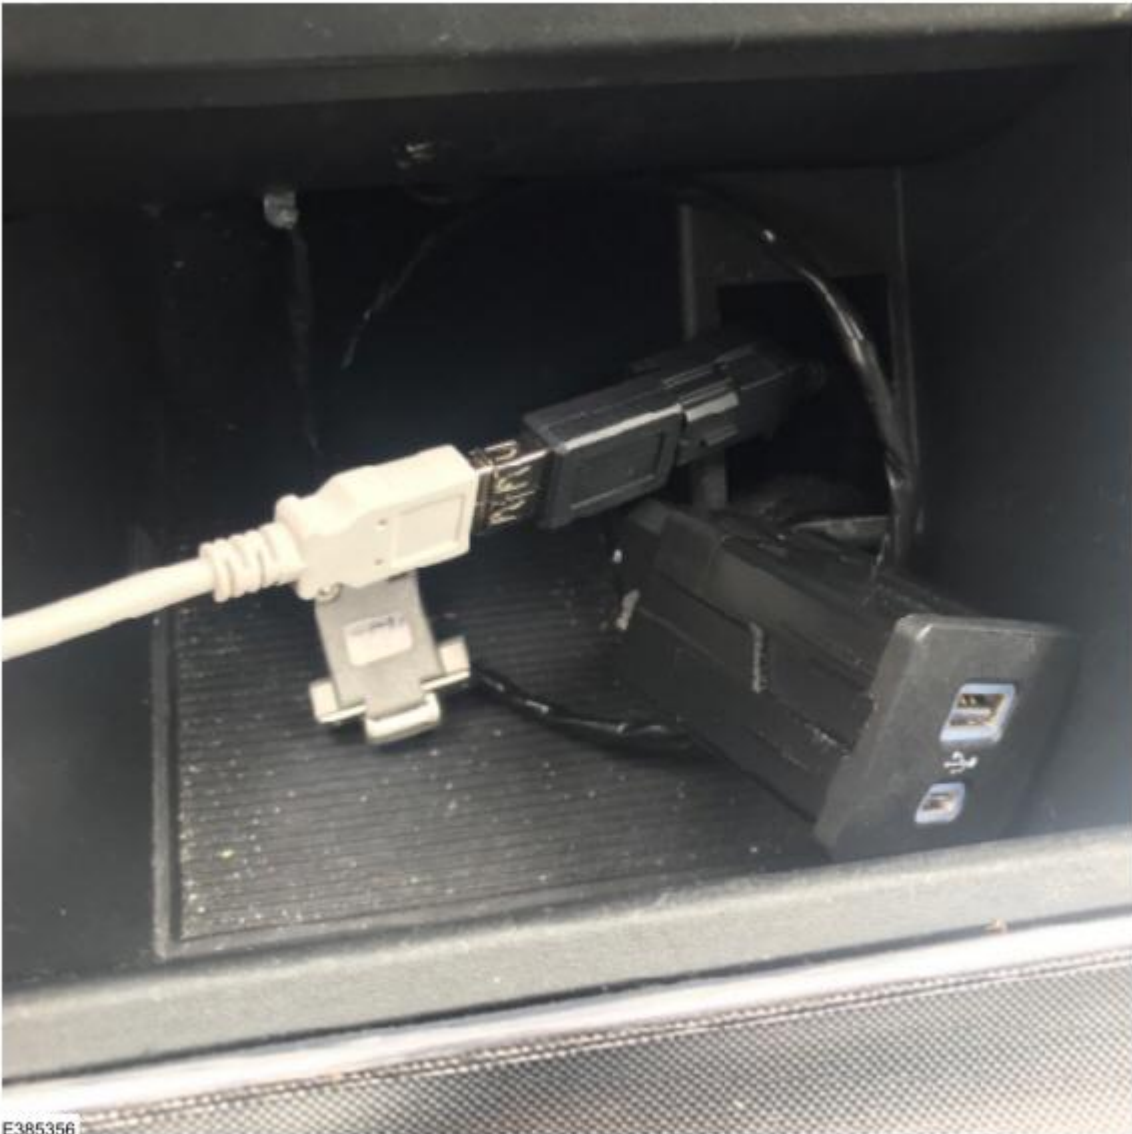
Figure 14 - Edge
